Alberto Franchi, Paolo Napoli, Pietro Crespi, Nicola Giordano, Marco Zucca, Unloading and reloading process for the earthquake damage repair of ancient masonry columns: the case of the Basilica di Collemaggio, International Journal of Architectural Heritage, Vol. 16 (11), 2022, pagg. 1683-1698.

# Unloading and reloading process for the earthquake damage repair of ancient masonry columns: the case of the Basilica di Collemaggio

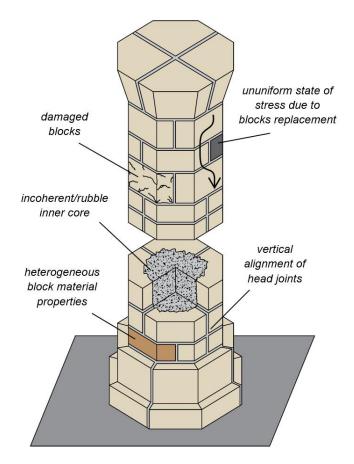
- ineffective interlocking of the stone blocks due to vertical alignment of head joints;
- presence of incoherent/rubble inner core;
- non-uniform vertical stress field over the cross-section caused by past block replacements;
- presence of damaged masonry units;
- heterogeneous blocks' material properties resulting from repair activities.

Fig. 2. Typical defects and imperfections in stone masonry columns.

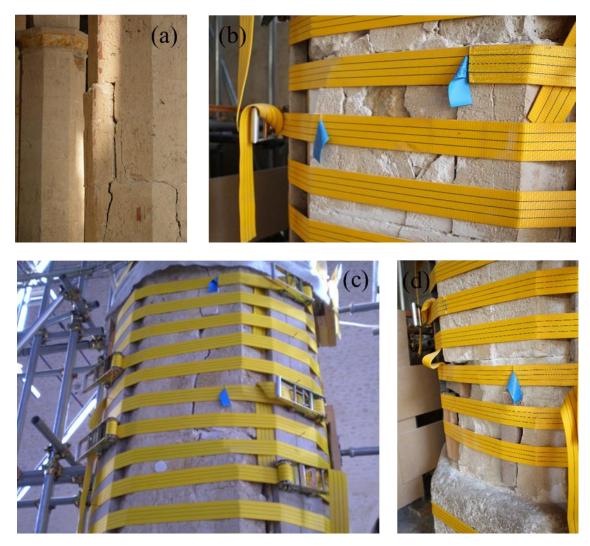
The post-earthquake survey showed that the central columns of both colonnades were sensibly damaged with respect to the external ones. In fact, as discussed in previous works (Crespi *et al.* 2016), seismic forces acting in transversal direction with respect to the naves generate high bending moments on the central columns. Different types of damages have been identified during the survey:

- relative sliding of adjacent ashlars (Fig. 3a);
- local crushing/spalling of blocks and opening of pre-existent cracks (Fig. 3b);
- vertical cracks due to excessive compression stress (Fig. 3c);
- toe compression failure at the base of the columns (Fig. 3d).

Fig. 3. Typical columns' damage observed after the 2009 earthquake: (a) sliding of ashlars, (b) crushing/spalling, (c) vertical cracks, (d) toe compression failure.

- the central columns (heavily damaged) were completely disassembled and rebuilt using a combination of new blocks and original undamaged ashlars. In particular, the damaged blocks were substituted by new elements of *'breccia aquilana'*. In addition, the inner part of the column, originally constituted by rubble masonry, was substituted with a new core of high strength lime mortar;
- the lateral columns were interested by local block replacements and mortar injections, avoiding the complete disassembling of the elements.

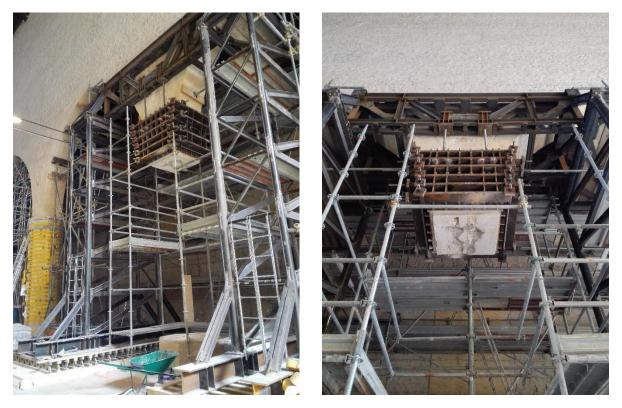
Fig. 13. The clamping system: disassembling of the column.
