Case Studies in Engineering Failure Analysis

Case study

Collapse of prestressed reinforced concrete jetties: durability and faults analysis

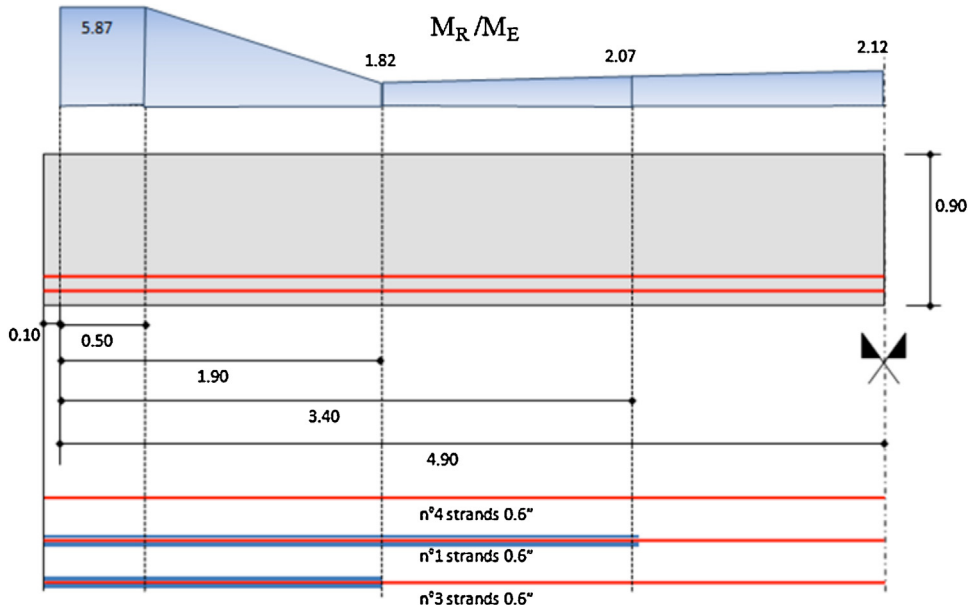
Fig. 2. Ratio between resistant bending moment and design bending moment along the longitudinal axes.

1.3, according to the technical standards of that time [11] (see Fig. 2). It is evident from an examination of Fig. 2, that this ratio is always observed, but with different values. The points of least resistance (minimum values of the ratio M_R/M_E) are 2 m far from the support and not in the midspan section.

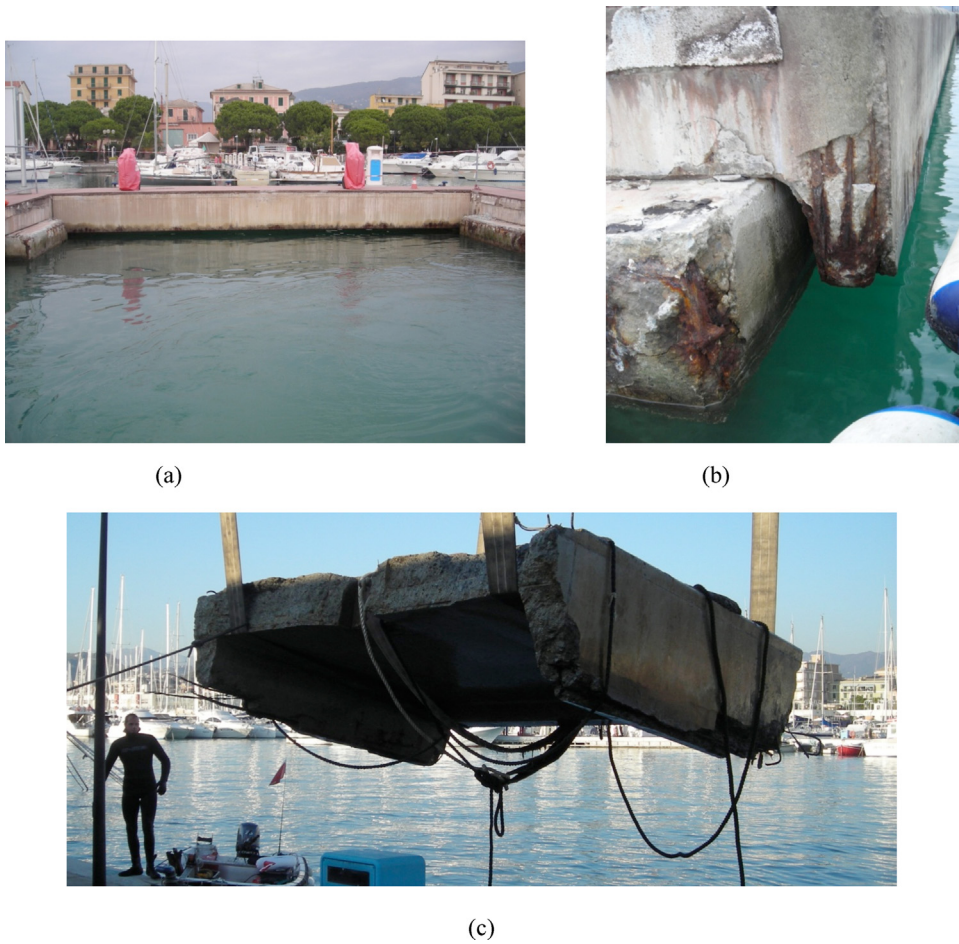
Several cracks have appeared along different jetties in the marina starting from the nineties. The collapse, as shown in Fig. 3, occurred in autumn 2011.

After the collapse, the damaged jetty was recovered and this was the starting point of the post-failure analysis. It is clear (see Fig. 3(b) and (c)) that this is a durability problem, or more precisely, a corrosion problem. The aggressive marine environment and some execution flaw caused the failure.

Fig. 3. Empty space left by the collapsed jetty (a), degradation of concrete (b), the recovery of the collapsed jetty (c).

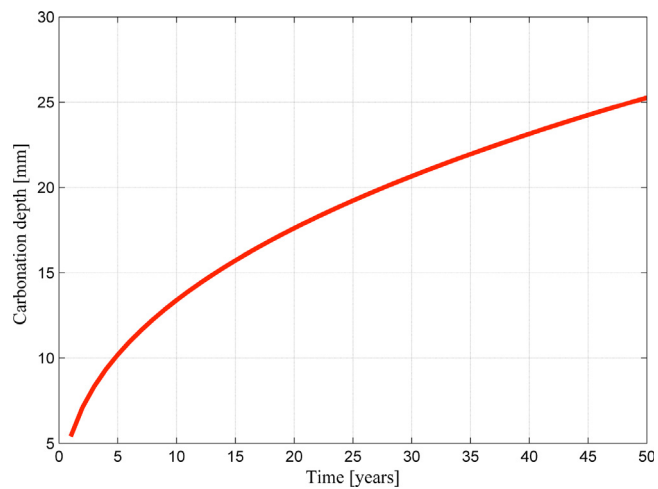
The first analysis conducted by the authors regards the depassivation limit state for carbonation induced corrosion. Fig. 4 shows a sketched carbonation parabolic model (see Eq. (1)) adopted by the Model Code 2010 [6]. It is visible that after 25–30 years the carbonation depth is greater than the concrete cover of 20 mm.

Fig. 4. Depassivation limit state for carbonation corrosion according to Model Code 2010 [6].

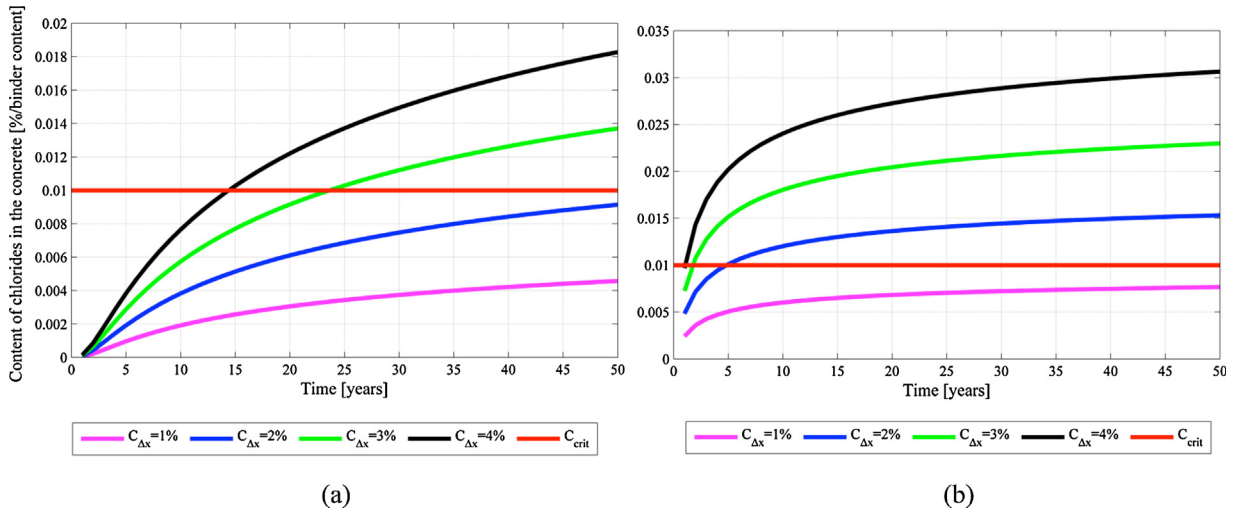
According to this approach, Fig. 5 represents the content of chlorides in percentage of binder content. Two concrete cover depths with different $C_{\Delta x}$ chloride concentration at the concrete surface are being considered here. In case of 50 mm thick concrete cover (Fig. 5(a)), the critic chloride concentration of 0.01% can be reached for a concentration of chloride at the

Fig. 5. Depassivation limit state for chloride induced corrosion with 50 mm thick concrete cover (a) and 20 mm thick concrete cover (b), according to Model Code 2010 [6].

concrete surface of 3% after 23 years or in less time, if $C_{\Delta x}$ is greater than 3%. The situation changes in case of the top part of the cross-section where the concrete cover is 20 mm thick (see Fig. 5(b)). In this case, the critic chloride content is reached in different scenarios after a few years. Taking into account that the real concrete cover may vary at different positions of the jetties, it is likely that a chloride induced corrosion could have occurred.

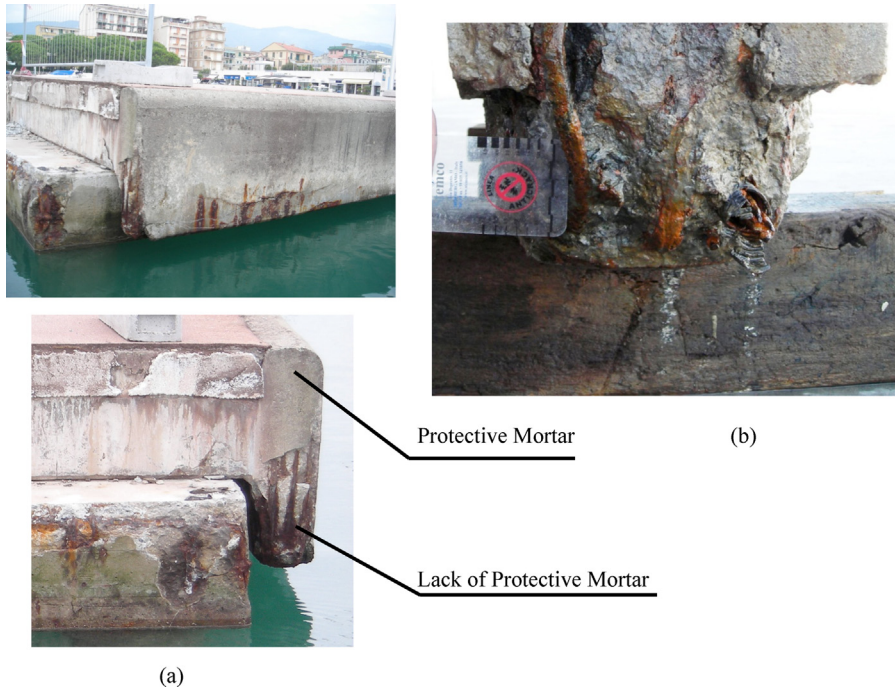
Fig. 6. Spalling of the protective mortar (a) exposes the prestressed cable ducts to weathering. In (b) the sea water comes out from the duct of the recovered collapsed jetty.

Furthermore, some minor details and the lack of preventive measures may have exacerbated the situation. Fig. 6(b) shows the condition of the collapsed jetties after its recovery: the terminal section of the duct did not have an adequate protection. Actually only a thin cover of mortar (almost 10 mm) protected the head of the ribs in almost all jetties (see Fig. 6(a)).

The spalling of the protective mortar due to the corrosion of the stirrups exposed the prestressing cable ducts to weathering. Corrosion of the tendons could have started immediately. In this case the durability of a prestressed concrete structure is jeopardized by the lack of an adequate external protection of the strands.

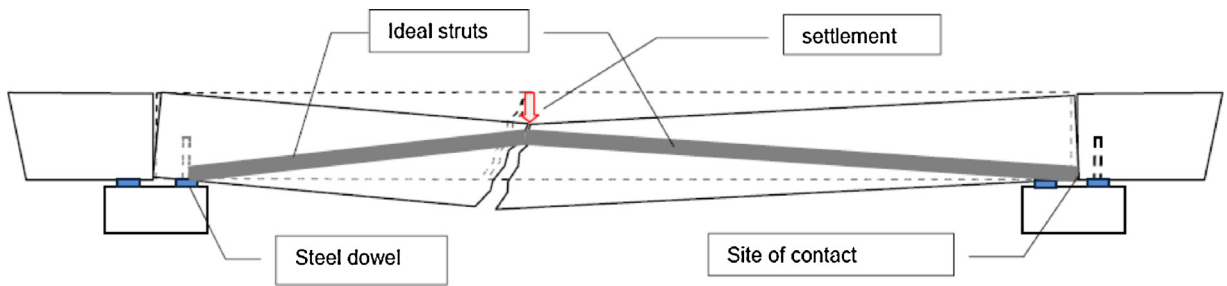
Fig. 7. Mechanism of collapse.

- (4) The collapse of the jetties took place in the section of least resistance, at about 1/4 of the span length distance from the support.
- (5) Thanks to the non-contemporaneous failure of the two ribs, the jetty could have resisted by means of a strut and tie mechanism (see Fig. 7). It is obviously neither reliable nor permanent. The jetty remained in place with a settlement. The latter is clearly visible in other still resisting jetties where presumably a rib is close to collapse, while the adjacent one is still resistant.

- (6) The failure of the steel dowel (see Fig. 7) or of parts of the jetty in contact with the adjacent element, or other causes (e.g. shock, high shots mooring, and piling-induced movements of the waves) suddenly made impossible the balance of the element, which fell down into water.

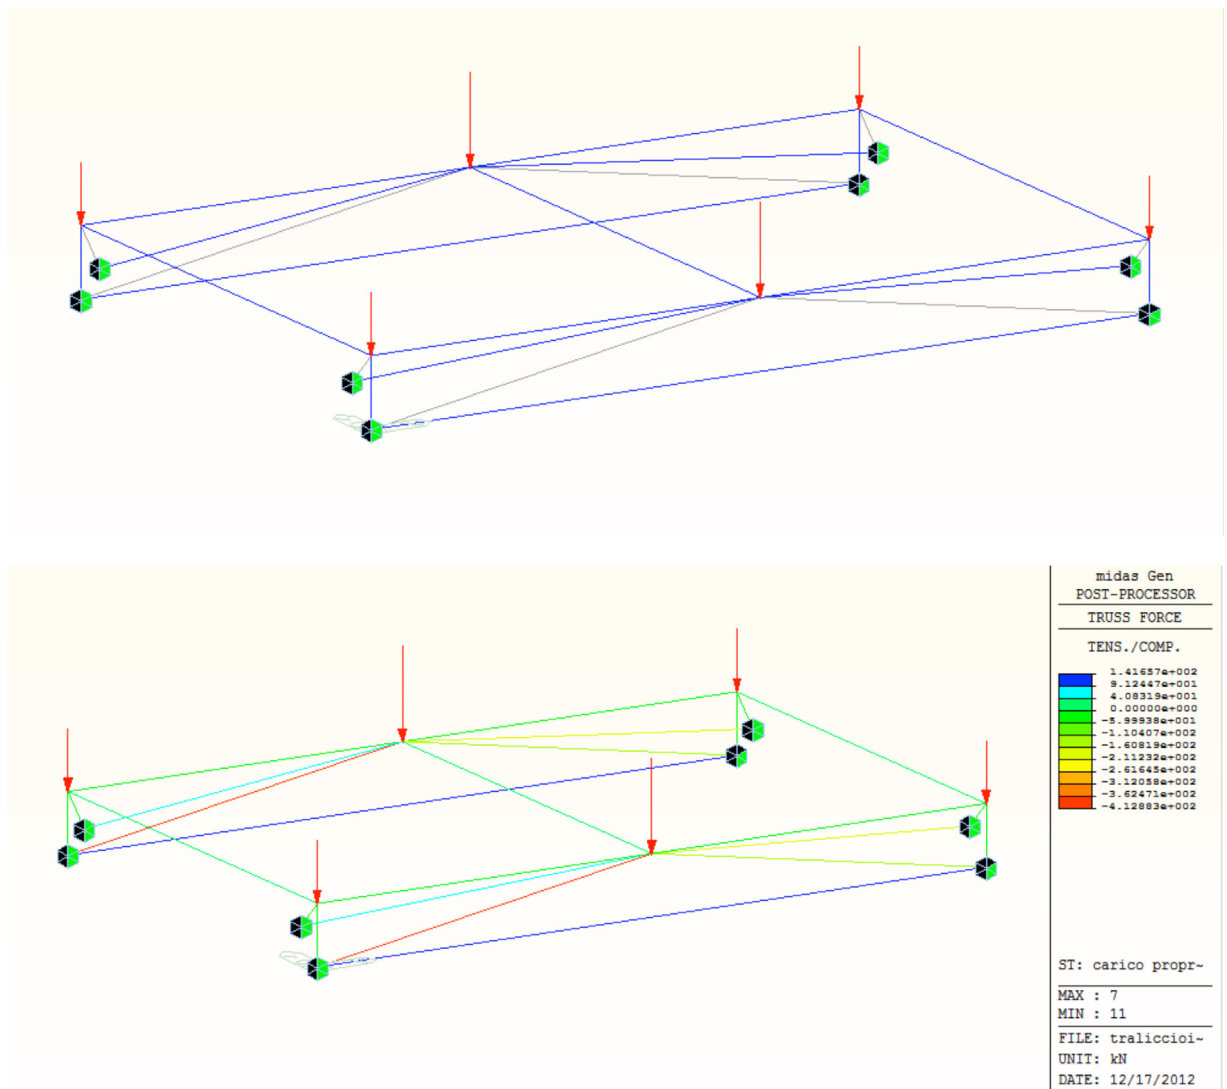
Fig. 8. Strut and tie model of the jetties before the tendon collapse.

Fig. 8 shows the strut and tie model that can represent a resistant mechanism of the jetty in ordinary condition. In particular, the ribs on the sides of the element can be noted. There are prestressing tendons on the bottom part and sloping concrete strut on the top part.

Constraint system simulates the actual supporting condition: hinged on the left and simply supported on the right. An elastic linear structural analysis was performed. It is important to consider the value of the force acting on the ties: 142 kN plus the prestressing force (see Fig. 8). This result shows the paramount relevance of the prestressing strands. During the corrosion process the tendons of one rib were being gradually broken.

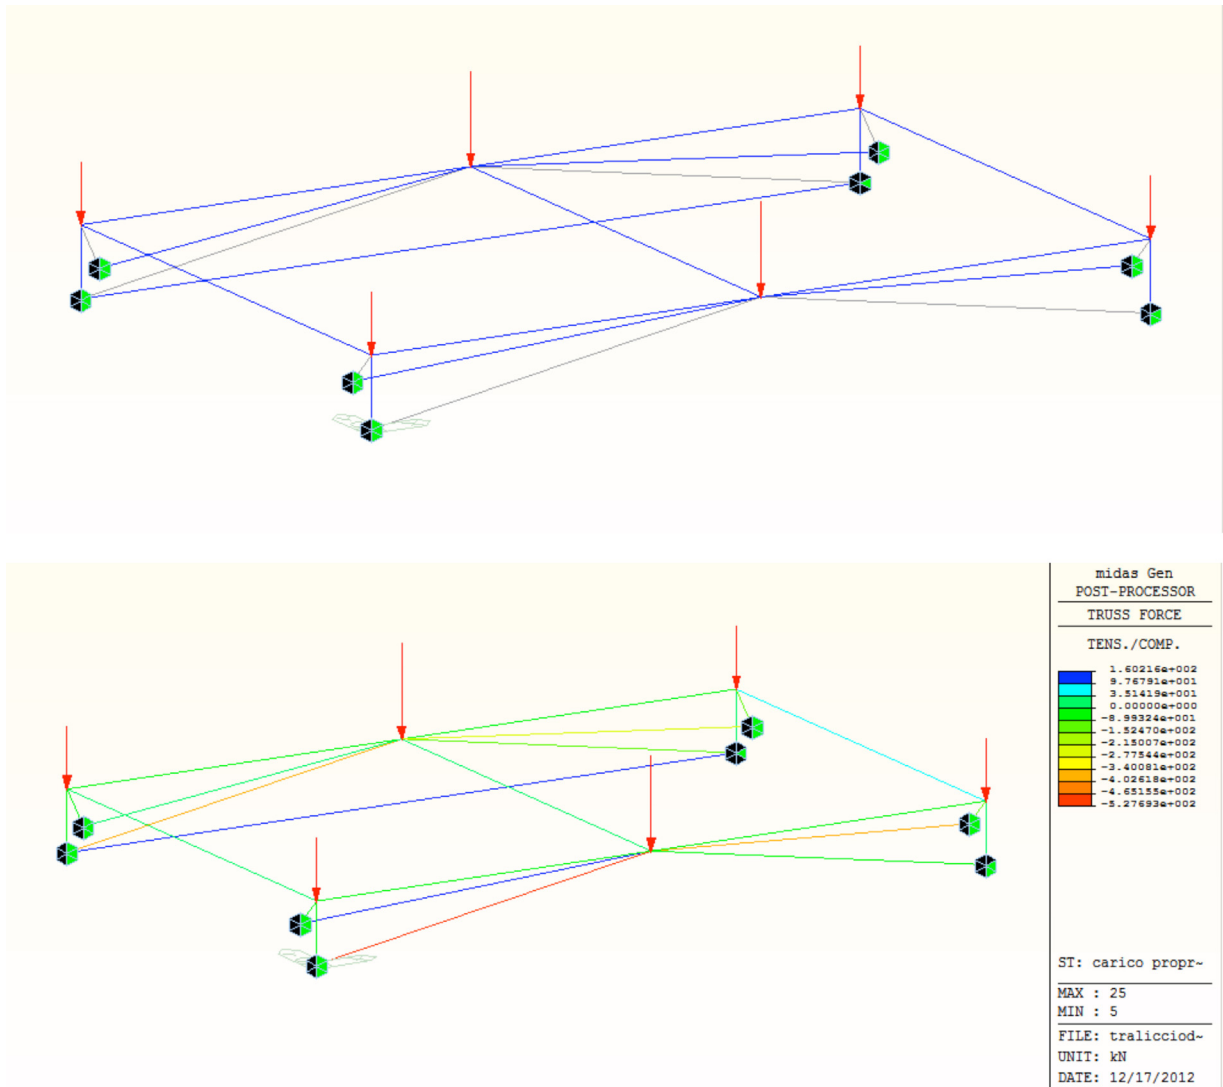
Fig. 9. Strut and tie model of the jetties after the tendon collapse.

Fig. 9 presents the strut and tie model of the jetty after the collapse of the tendon of one rib. The result of the structural analysis highlights that the force acting on the last prestressing tendon is equal to 160 kN. Therefore, in this damaged system, an increase of the 11% of the stress on the prestressing strand is expected. It seems not such a big rise, but the corrosion of the other strand has reduced the resistant cross-section of the last reinforcements. Thus, this system is neither reliable nor permanent and the total collapse is pending.
