M. Vanzi, G. Mura, *Peculiar failure mechanisms in GaN power transistors* in *Microelectronics Reliability*, Volume 114 (2020), art. 113896.

Peculiar Failure Mechanisms in GaN Power Transistors

M. Vanzi, G. Mura

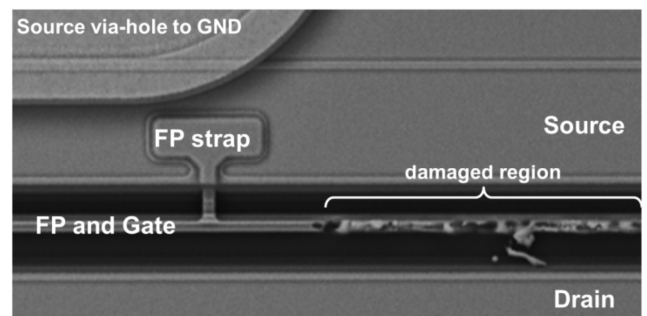
The failure modes were a resistive short circuit between gate and source, with a measured resistance ranging from few tens to some hundreds of a Ohm.

The observation of the failed devices, first at the OM, and then at the SEM (fig.4) showed an extended damage of the overlying FP and Gate metals, that will be discussed in the next session.

Fig.4. A typical damage along the gate finger, after the HAST test.

The extended thermal damage in fig. 4,8 and 9 should be considered a side effects of the root cause: the short circuit between Gate and Field Plate, whose evidence is in the circled part of fig.9b. The point is to understand the reason for that short circuit.

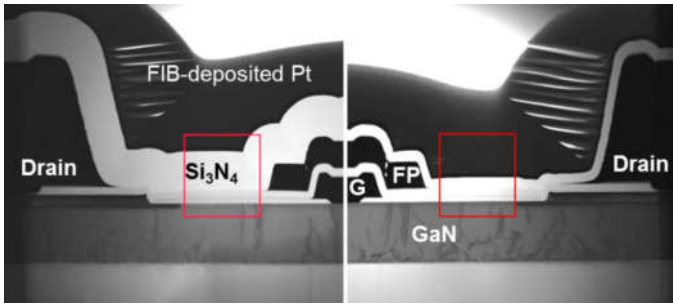
The evident role of humidity in causing failures prompted the vendor to improve both the sealing glue of the ceramic package and the passivation of the chips (fig.5).

Fig.5. Specular TEM images of the Gate-Drain region of two devices with different thickness of the Si_3N_4 passivation layer (boxed).

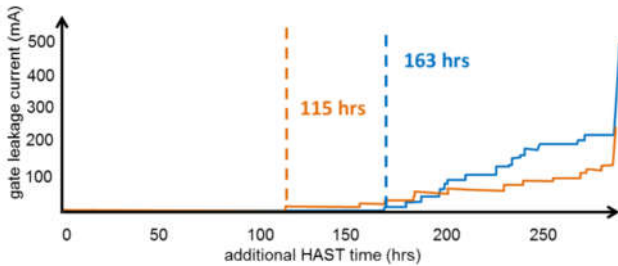
Despite a relevant improvement in device survival, none of the corrective actions was able to solve the problem. Glue and passivation have been modified three more times. After the last adjustment, a lot of 177 devices passed the HAST, surviving 96 hours. But, allowing the test to continue, two devices failed after about 100 additional hours, and two more devices, that passed HAST, failed at a supplementary THB test. Monitoring the gate leakage current at the nominal bias during the HAST continuation, revealed that failures are not sudden, but follow gradual kinetics (fig.6). The corrective actions only delayed the timing of the failure mechanism, but not solved the problem.

Fig.6. Gate leakage current for two devices under HAST conditions after additional test hours beyond the required 96 hours.

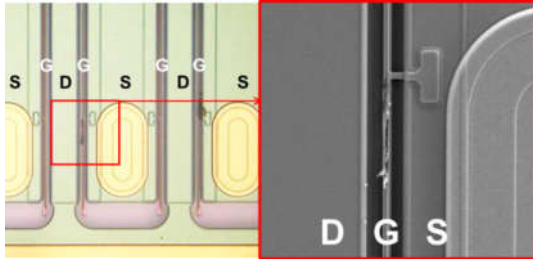
Leaky points were identified at a glance, by simple inspection at the OM and the SEM, of the devices failed during the first test, where the gate current was allowed to reach 10 mA, and then confirmed at the SEM (Fig.8 to be compared with fig.4).

Fig.8. a) Optical image and b) SEM magnification of a damaged region in a device failed during the partially biased 85°C/85%RH test.

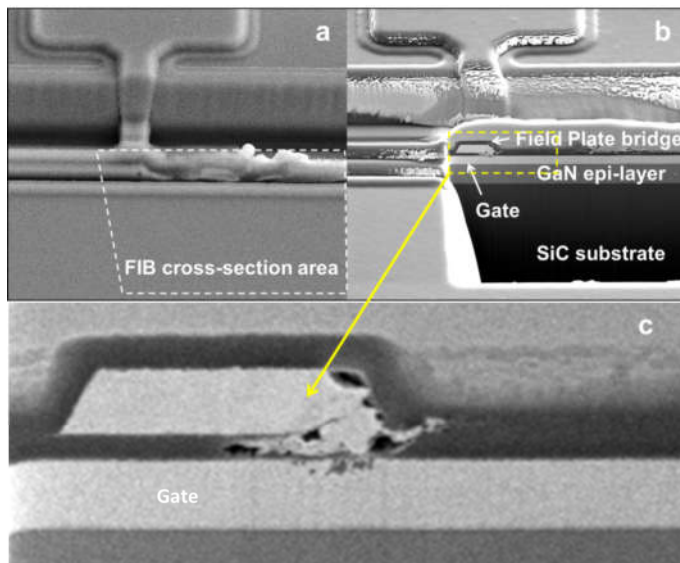
At the damaged points, vertical analysis was performed by sequential slicing by means of FIB milling, up to reveal the contact point between the Gate and the Field Plate metal lines (Fig.9)

Fig.9 a) Surface view and b) FIB cross-section of the damaged region in fig.9, revealing a contact point between metal lines c).

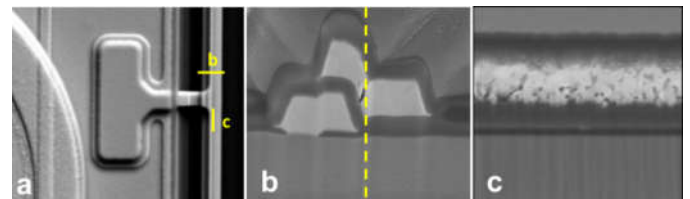
Several clues were found: the Field Plate displays a steep step when climbing over the gate. Two phenomena occur at that step: *i*) the step coverage is not uniform in metal with relevant porosity (fig.10); *ii*) the upper passivation easily cracks locally, where a cusp forms in coverage of the steepest step (fig.11).

Fig.10 a) Plan view, b) cross-section and c) longitudinal cross section of a FP-Gate structure showing the porosity of FP at the step.

Going back to fig.10 and 11, they tell that passivation cracks and metal porosity jointly build direct access to the maximum field region between Field Plate and Gate.

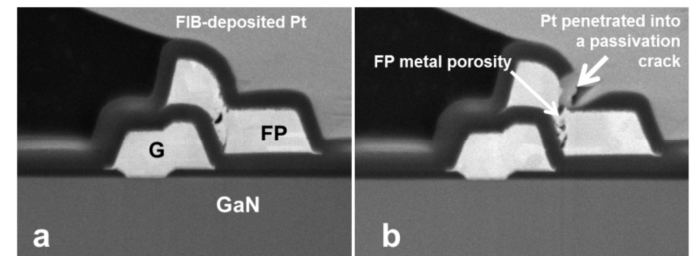
Fig.11 a) reference cross-section and b) evidence for passivation crack at the FP steps.

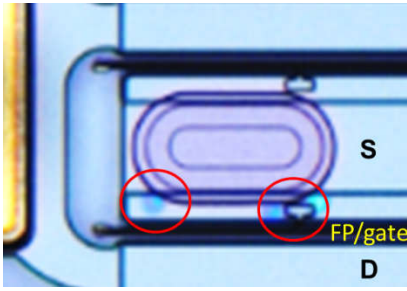
Passivation cracks are not a surprise in such devices. Fig.12 shows the discoloration visible at the optical microscope in devices after HAST or THB, while fig.13 correlates discoloration with surface cracks. None of the discoloured areas was present before the tests.

The systematic occurrence of delamination at the curved edges of the vias (that are metal pillars passing through the whole chip thickness) and at the pads of the Field Plate on the Source large finger strongly addresses the origin of fractures towards thermomechanical stresses.

Fig.12 Delamination of the passivation layer, revealed at the optical microscope by discoloration at the circled areas.

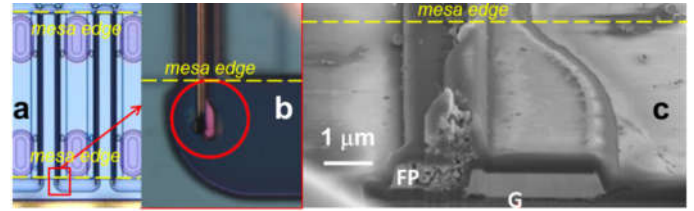
Fig.14 shows the optical image of the location and a detail of a leakage point of a device failed during the first HAST tests. The point stands outside the GaN area, at the end of both gate and FP lines. This evidence should be sufficient for excluding GaN-specific mechanisms from the possible explanations of the observed failures.

Anyway, the interesting point is the FIB cross-section in fig.14c. It is evident as the anode of the metal couple, that is the Field Plate, is completely corroded, while the Gate electrode is nearly intact. This image should be compared with images of nearly 40 years ago [14] dealing with Anodic Gold corrosion in microelectronics. The key point is that in presence of humidity, temperature and a high electric field, as that between Gate and FP at the given conditions, gold can react with water and create a brittle hydroxide that grows in volume, cracks the surrounding dielectrics and still preserves conductivity high enough to create resistive short circuits with the neighbouring metal lines.

Fig.14. Location (a) and detail (b) of a leakage spot, outside the GaN area (the dashed lines indicate the boundaries of the mesa region). In (c) the FIB cross section of the leaky point shows the corrosion of the anode of the Gate-FP pair.

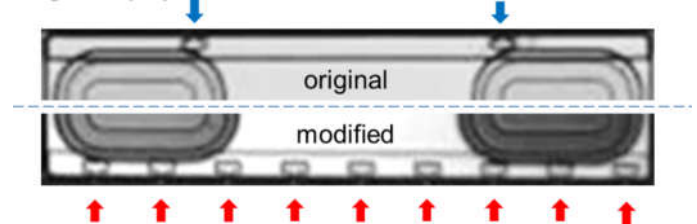
The second additional element supporting the thermomechanical hypothesis comes from the results of another HAST performed on a further modified family of devices. The new family (fig.15) had an increased number of straps bridging the FP to the Source metallization.

Fig.15. The modified layout of the devices of the last HAST tests. The number of bridging straps (arrowed) from FP to Source has been increased from 2 to 9 per finger.

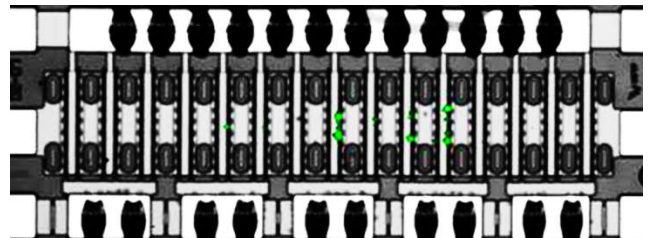
The resulting effect has been that failures occur as in the previous tests, but the mechanical damage is much more distributed, which causes many more contact points (fig.16), not visible at the OM or at the SEM, but revealed by OBIRCH

Fig.16 Optical Beam Induced Resistance Change (OBIRCH) of the leakage points (green spots) in devices with modified layout as in fig.15, after a HAST test.

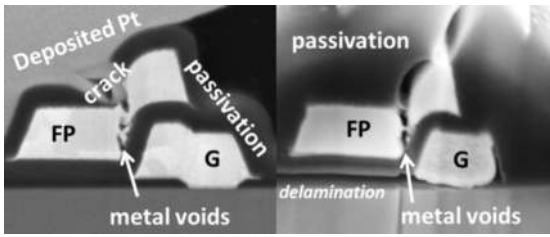
Also the local intensity of the damage results intensified (fig.17), with the dielectric not only cracked but also delaminated from the semiconductor surface.

Fig. 17. Transversal FIB cross-section of a Gate/FP structure in two devices, showing metal voiding at FP and different levels of dielectric cracks. On the left, a device with the original layout; on the right, a device with the modified one.

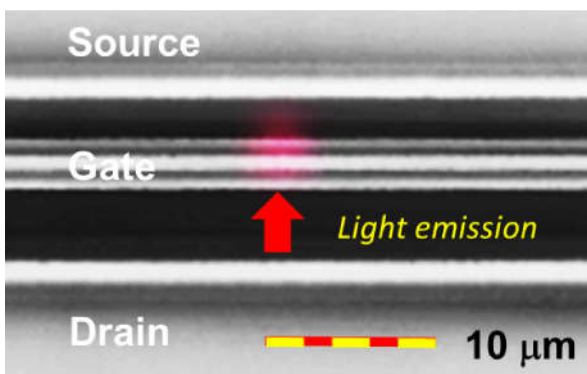
Fig.18 shows indeed the intact appearance of one of the two devices at that same point where Photon Emission Microscopy locates a leakage spot. It was then decided to try a sequential FIB cross-section, one transversal and one parallel to the gate length.

Fig.18. Optical plan view of the GaN power transistor under investigation, and the detected light emission spot.

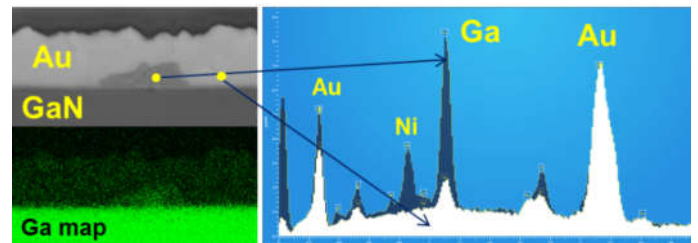
expectations. The first result was disconcerting: a complete sequence of longitudinal cuts across the overlap region of FP and gate at the leakage point did not show anything abnormal (fig.19 a,b). It was then decided to simply ultimate the sequence, in order to analyse also the final edge of the gate, not covered by the Field Plate. Here, on the edge (fig.19c), a strong contrast appeared in the Au layer, that was demonstrated to be rich of Gallium by Energy Dispersive x-ray spectroscopy at the SEM (fig.20).

Fig.20 EDS analysis of the contrast area of fig.19c, that is identified in a Ga rich region inside the gate Au metal.

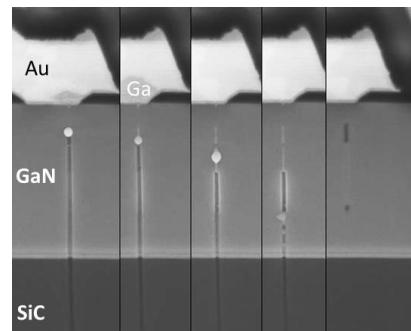
Even more intriguing, the cross section sequence, perpendicular to the gate length, at the second PEM emission point, fig.21 and fig. 22, showed a complex structure, where Ga/Au interdiffusion in Gate is vertically aligned with a hollow vertical pipe, where even a droplet of liquid Ga forms during the observation at the SEM after FIB milling.

Fig.21 Sequence of sectioning planes across the second PEM emission spot

In a polished surface as in fig. 21 and 22, the droplet points out the intrinsic local dissolution of GaN along the pipe.

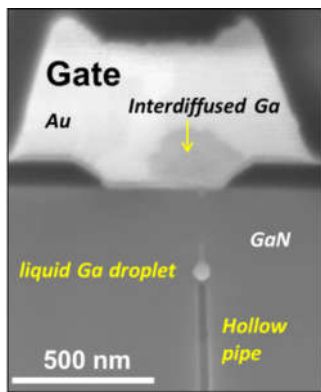
Fig.22. Enlarged view of one of the cross sections in fig.21

The Ga liquid droplet is not rare in SEM imaging of GaN or also GaAs devices, at the non-polished sides of the FIB trenches. It simply indicates that, at that points, the GaN or GaAs structure has been so damaged that the electron beam energy is sufficient to lead the nearly unbound Ga to liquefy.
