## EXPERIMENTAL IN-PLANE LATERAL RESPONSE OF A FULL-SCALE ADOBE MASONRY WALL WITH OPENING

### Abstract

**Keywords:** Full-scale tests; Adobe masonry; Walls; Cyclic tests; Seismic capacity.

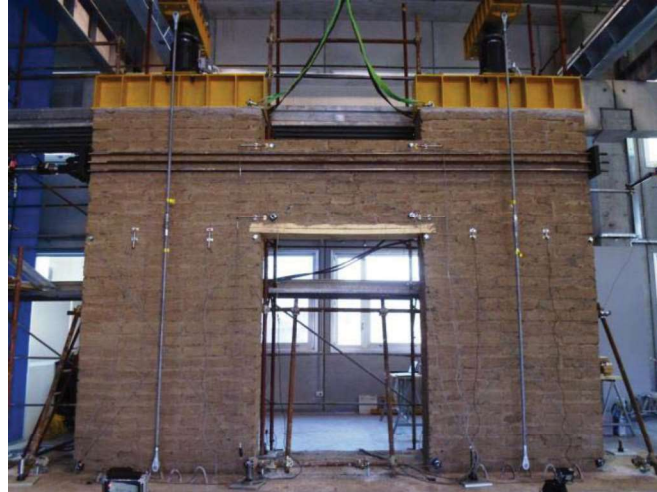
Figure 5: Test set-up and instrumentation installed on the adobe wall specimen before testing.

The specimen was erected on a rigid reinforced concrete (RC) beam, acting as wall-foundation. Such basement was anchored to the strong floor of the testing laboratory by means of pre-tensioned high-strength steel rebars. Vertical load on piers, kept constant during the test, was applied by means of two hydraulic jacks (one for each pier). Each hydraulic jack pushed against a steel reaction closed-system made of a rigid short beam, perpendicular to the wall, to which two steel rebars were connected. These latter were hinged to both ends so that any parasite contribution of the test set-up to the overall response of the specimen was prevented. Similarly, spherical hinges were introduced in-between hydraulic jack and the overlying beam. In order to uniformly distributing the vertical load, two rigid I-beam were interposed between hydraulic-jacks and pier tops, on which levelled mortar layers were priorly realized. Horizontal cyclic displacement was applied to the wall top by means of a servo-hydraulic actuator, with a nominal capacity of 1250 kN and  $\pm 25$  cm stroke, anchored to a vertical RC contrast. The actuator was equipped with a hinged head, with the aim to accommodate the actual deformed shape of the wall, fixed to a steel collar made of a couple of rigid plates located on the opposite sides of the wall and interconnected each-other by means of six steel bars, slightly pre-tensioned.

Main deformation sources were monitored during the test by means of a proper instrumentation system installed on both front and back sides of the wall specimen. Specifically, on the front side, a total of eight linear variable differential transformers (LVDTs) were installed at the location of critical end sections of the piers and central spandrel element, in order to measure axial displacements due to bending. On the backside, specific vertical LVDTs were mounted piers/foundation interface in order to measure the width of rocking-induced cracks. Those displacement transducers were complemented by two couples of vertical wire potentiometers (PTs) that measured the axial and bending deformations of each pier. Additional PTs were arranged along diagonals of piers and spandrel panel with the aim of monitoring shear deformations. Finally, a horizontal PT was installed at the same elevation of the actuator (i.e.,  $y = 3055$  mm) and connected to a wall edge.

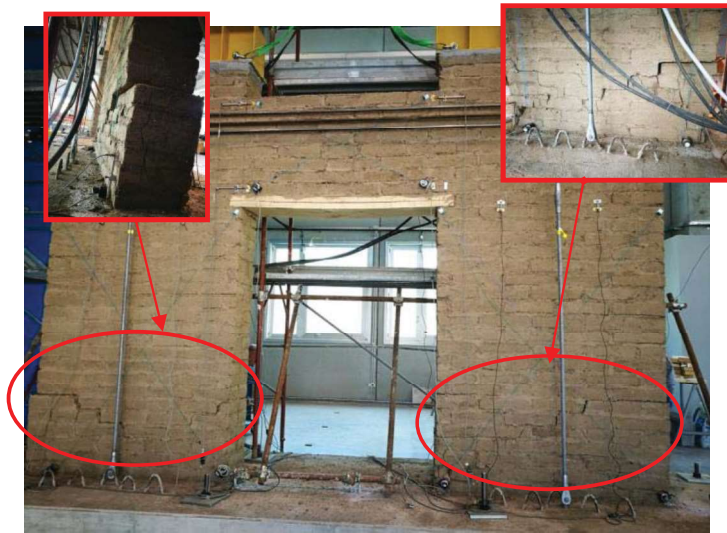
Figure 7: Damages observed on the specimen at the end of the experimental test.

Figure 7 shows the damage occurred to the specimen at the end of the experimental test. Horizontal cracks were observed on both sides of the spandrel panel along different bed joints and extended to the whole length. On the lower part of the spandrel, in the proximity of the lintel, a partially inclined crack was observed towards the left-hand side end. Such a crack pattern is representative of shear failure mode. Overall, a quite moderate damage was observed on the spandrel. Conversely, both piers suffered large cracks on the bottom part. Specifically, sub-horizontal cracks concentrated in the first six/seven masonry layers from the base were firstly observed, subsequently evolving along inclined directions, mainly developed along mortar-joints. Corresponding to peak load condition, vertical cracks were observed within piers thickness due to failure of masonry in the compressed zone. Therefore, bending failure was experienced by the piers. Beyond the peak load, the wide cracks located at the base of the piers caused piers buckling and the experimental test was arrested when significant out-of-plane deformations were identified.
