Marco Zucca, Sergio Tattoni, Marta Di Castri, Marco Simoncelli. "On the collapse of a post-tensioned reinforced concrete truss bridge during the construction phases". *Engineering Failure Analysis* 2024, 158, 107999.

On the collapse of a post-tensioned reinforced concrete truss bridge during the construction phases

Abstract

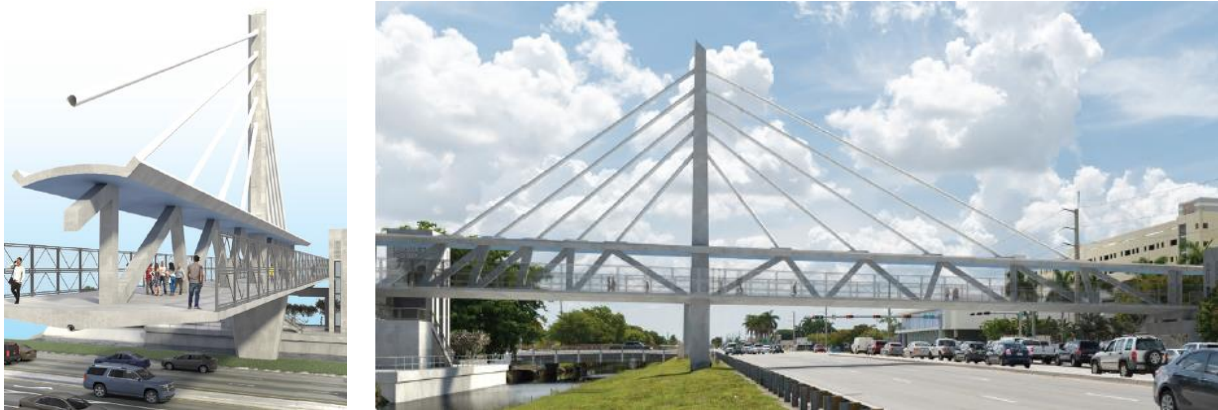
The analysed post-tensioned RC truss pedestrian bridge having a total length of 81 m, has been designed to be built inside a North American university campus. The bridge was conceived as an “I-like” shape RC beam with the deck as the lower part of the I-beam and the upper part has the function of canopy. Finally, the web of such ideal I-beam, is made by a non-symmetric truss beam (Fig. 1).

Figure 1: The analysed RC truss bridge [19].

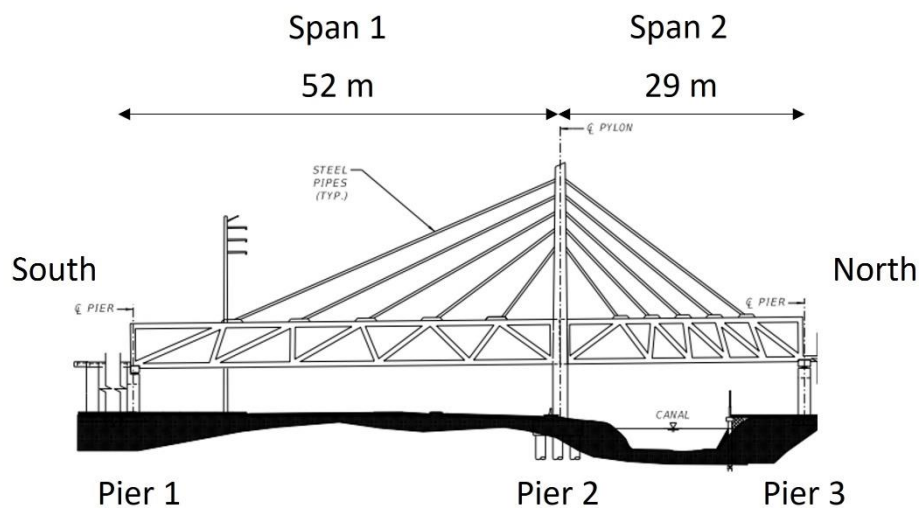
As mentioned before, the bridge is characterized by the presence of three RC piers which support the truss beam (Fig. 2).

Figure 2: Longitudinal view, with piers highlighted [24].

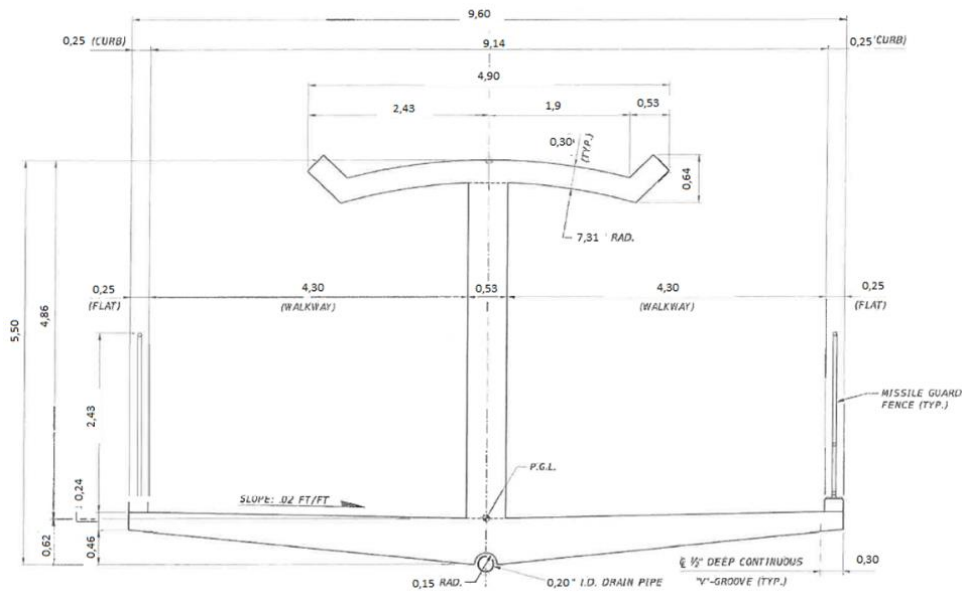
The deck, 0.45 m thick and 9.60 m wide, is characterized by the presence of 12 longitudinal post-tensioned tendons (D1-D6) in span 1 while span 2 presents 6 longitudinal post-tensioned tendons (D7-D9). The tendons D7, D8 and D9 of the span 2 are located in the same position of the span 1 tendons D3, D4 and D5 but there are no tendons that continue along the length of both spans. Figs. 3 and 4 show the cross-section of the deck and the disposition of the post-tensioned tendons, respectively.

Figure 3: Drawing of the deck cross-section (dimensions in meter) [24].

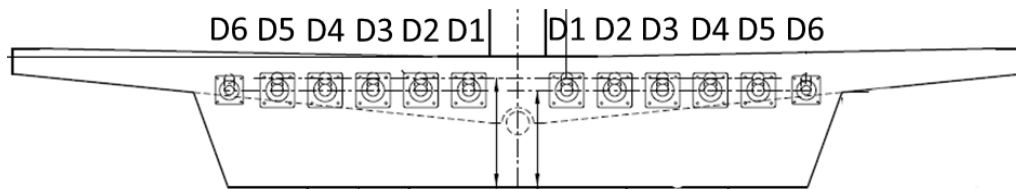
Figure 4: Drawing of the deck post-tensioned tendons [24].

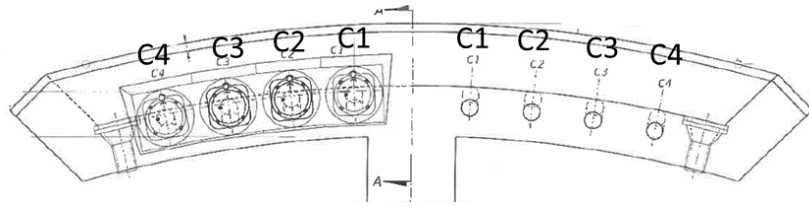
The canopy is characterized by a thickness equal to 0.30 m and by a width equal to 4.90 m. In this case, 8 post-tensioned tendons (C1-C4) have been used in span 1 while in span 2 other 6 post-tensioned tendons (C1, C4 and C5) are present. It possible to notice that tendons C1 and C4 are continuous along the two spans and the tendon C5 (span 2) is located in the same position of the

tendon C2 (span 1). The disposition of the canopy post-tensioned tendons is shown in Fig. 5 while Table 3 reports the related main characteristics.

Figure 5: Drawing of the canopy post-tensioned tendons [24].

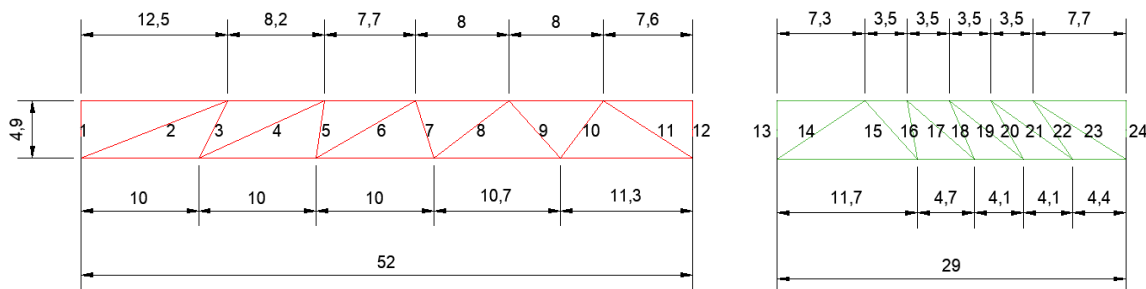
The concrete truss is made with 24 diagonal and vertical elements: 12 located in the span 1 and other 12 in span 2, which follow the external cables direction (Fig. 6).

Figure 6: Span 1 (red) and span 2 (green) diagonal elements (dimensions in meters).

The diagonal elements are characterized by a rectangular section 0.53x0.61 m except for diagonal 2 which has dimensions 0.53x0.91 m. The vertical elements located at the far end of the truss have cross-section dimensions equal to 0.53x0.91 m while the other vertical elements present cross-section dimensions equal to 0.53x0.88 m. It can be noted that the elements 2, 3, 5, 6, 7, 8, 10, 11, 15, 16, 17, 18, 19, 20, 21, 22 and 23 are post-tensioned. Table 4 summarizes the main characteristics of the elements of the truss.

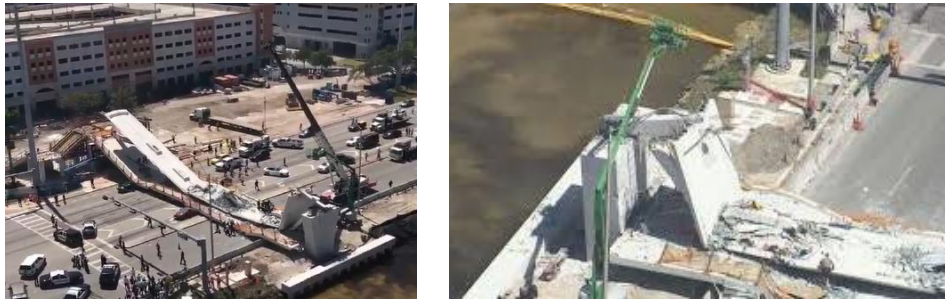
As reported in [26], the collapse of the bridge occurred at the end of the phase 3 on March 15, 2018 during its construction. In fact, at the end of February the presence of several cracks has been observed in correspondence to the node between the elements 11 and 12 (node 11, 12) after the post-tension remotion in the elements 2 and 11. Consequently, a new application of post-tension in element 11 has been considered (phase 3a). During the execution of this phase the bridge collapsed (Fig. 7). In

particular, it is important to highlight that the re-tensioning of the element 11 was not considered during the bridge design phase where the above-mentioned construction phases have been defined. In fact, the reapplication of the post-tension had increased the axial force of the diagonal element and consequently the shear action of the node. In addition, numerous contradictions were highlighted in the design report: the main problems were having underestimated the forces acting in the truss and having overestimated the resistance capacity of nodes 1, 2 - 2, 3 and 11, 12.

It can be assumed that the bridge has never been in safe conditions, mainly because the interface surface of the cold joints had not undergone any type of work and remained smooth, contrary to what the designers assumed in the design report. This happened probably because the necessary processing had not been accurately indicated in the design [26].

Figure 7: Collapse of the bridge.

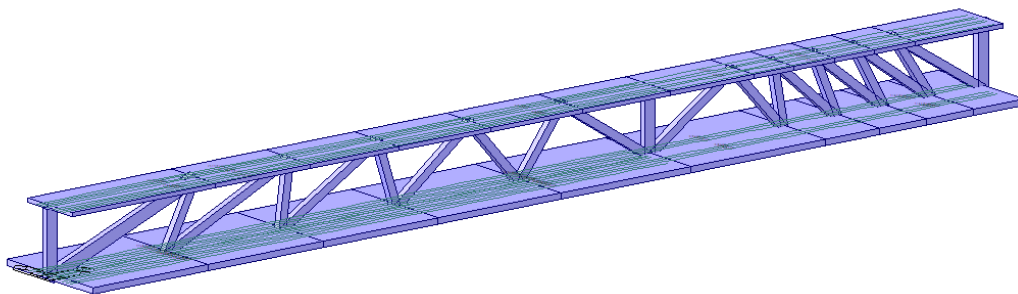
To analyse the initiation of the failure mechanism of the pedestrian bridge during its construction, a Finite Element Model (FEM) has been implemented using MIDAS Gen [27] commercial software where the deck, the canopy and the elements of the truss have been modelled using Timoshenko beam elements, in order to reduce the computational effort (Fig. 8) [28-30]. The choice to implement the truss with beam elements has been made to be able to obtain the value of bending moments caused by the eccentric post-tensioning and to consider the joints between the different elements of the truss as fixed.

Construction Stage Analysis has been performed, considering the different phases described in previous Section 2, to analyse the evolution of the internal actions acting on the different structural elements during the construction process. All the construction phases were implemented changing the post-tensioning and the boundary conditions (Table 5). The loads considered during the analysis are (i) the self-weight of the structural elements and (ii) the post-tension. No live and temperature loads have been added to the bridge because the analysis wanted to understand the reason of the collapse during the construction process.

Figure 8: FEM of the RC bridge.

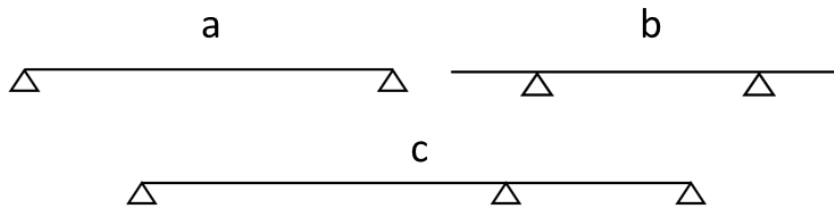
one for the canopy, creating a discontinuity surface between them (cold joint). When the concrete reached a compressive strength equal to 41 MPa, the post-tension of the deck, canopy and truss elements has been applied; during this stage the span can be considered as a simple beam with pinned boundaries (Fig. 9a). The second phase that was considered is the transportation phase, in which four SPTM were used to move the span: two of them were positioned in node 3, 4 and the other two in node 9, 10, creating cantilevered end (Fig. 9b). In the third phase, after transportation, the main span went back to a simple pinned truss and diagonal 2 and 11 were de-tensioned. In the fourth stage (called phase 3a, not foreseen in the design) the post-tension of diagonal 11 was reapplied, and this brings to the global collapse of the bridge. Finally, the whole bridge with both spans has been modelled, even though it has never been built, as a continuous beam (Fig. 9c).

Figure 9: (a) Simple pinned beam (phase 1, 3 and 3a); (b) beam with cantilevered end (phase 2); (c) continuous beam with 2 spans (phase 5).

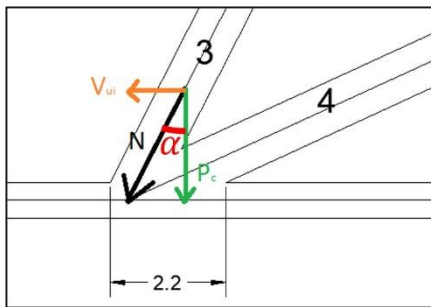
where V_{ui} is the interface shear force, V_{ni} is the nominal interface resistance and Φ is the shear resistance factor, in this case considered equal to 1. In particular, V_{ui} is calculated breaking down the axial force (N) acting on the structural element obtained from the construction stage analysis (Fig. 10) considering that the horizontal component is the shear force while the vertical component (P_c) is the normal force to the shear plane as shown in Eqs. 3-4 [31].

$$V_{ui} = N \cdot \sin \alpha \quad (3)$$

$$P_c = N \cdot \cos \alpha \quad (4)$$

Element	Angle	Element	Angle
[-]	[°]	[-]	[°]
1	90	7	108
2	21	8	37
3	63	9	131
4	25	10	53
5	82	11	147
6	30	12	90

Figure 10: Breaking down of the axial force and inclination of the elements of the truss.

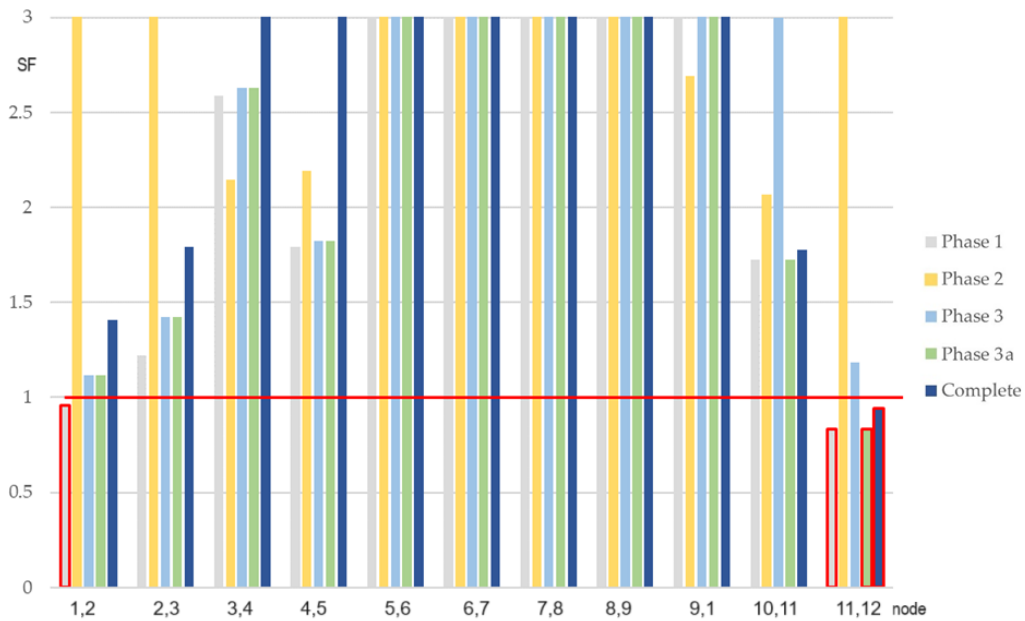
For the case 1 only the nodes 1, 2 and 11, 12 are characterized by SF values less than 1. In fact, node 1, 2 presents a SF = 0.96 in correspondence to the phase 1 while node 11, 12 is characterized by SF values equal to 0.83, 0.83 and 0.94 during phase 1, phase 3a and once construction of the bridge is completed, respectively. Fig. 11 reports a synthesis of the above-commented results.

Figure 11: SF values of the shear friction check, case 1.

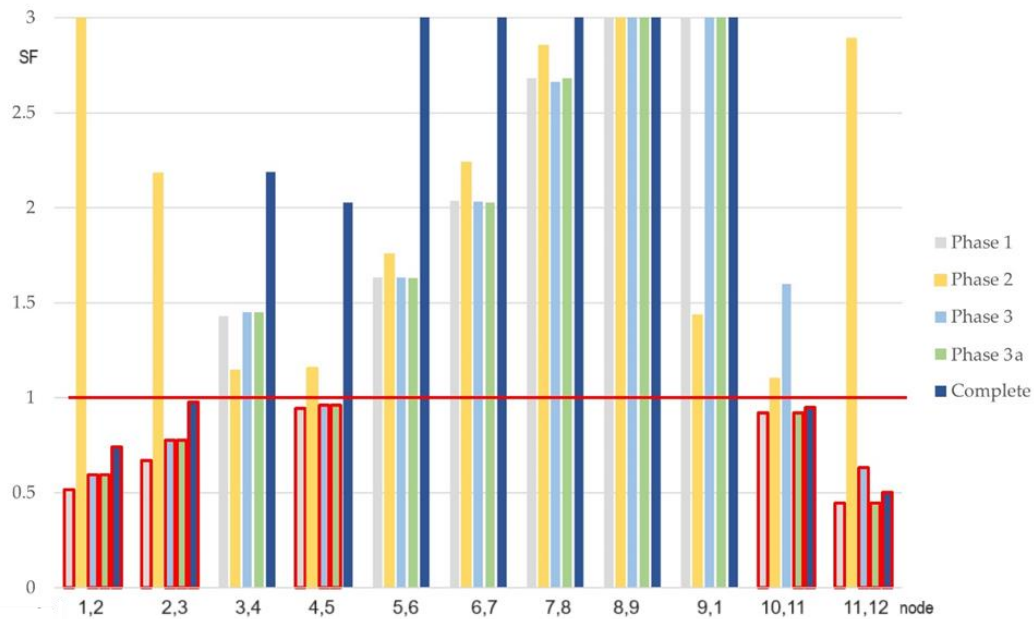
On the contrary, analysing the results obtained for the case 2, several nodes are characterized by SF values less than 1 as it is possible to see in Table 9 and Fig. 12. Also in this case, the most critical node is the 11,12 which presents the lowest values of the SF.

Figure 12: SF values of the shear friction check, case 2.

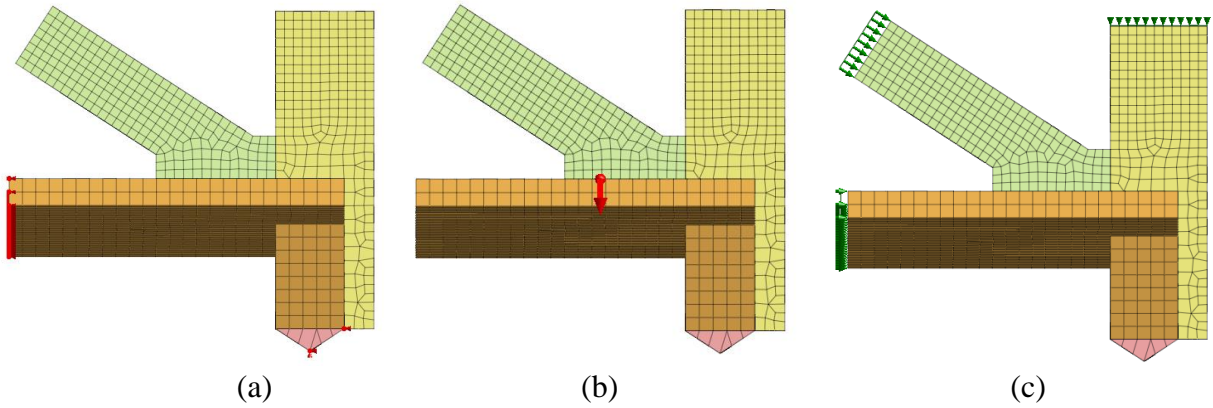
To better understand the initiation of the failure mechanism occurs in node 11, 12 a detailed Finite Element Model has been implemented through MIDAS FEA NX commercial software [32] where the structural elements of the node 11, 12 are modelled using solid elements having maximum mesh size equal to 0.05 m (Fig. 13a). The two post tensioning bars ($2\Phi 45$) have been modelled as embedded trusses within the related structural element (Fig. 13b) as all of the longitudinal rebar and stirrups of the truss and the reinforcement cage of the node (Fig. 13c). Simple pinned beam condition was implemented in order to correctly reproduce the structural behaviour of the analysed node. Furthermore, a pinned connection has been realized under the deck, modelling a triangular prism to guarantee rotations; then on the right end and on the left end of the deck a roller with free vertical translation has been applied (Fig. 14a).

To reproduce the correct load conditions, self-weight (Fig. 14b) and post-tension have been applied using an appropriate function available in MIDAS FEA NX library. Moreover, elements axial force obtained from the previous analysis have been added as pressure load. (Fig. 14c).

Figure 14: (a) Boundary conditions; (b) self-weight; (c) pressure load.

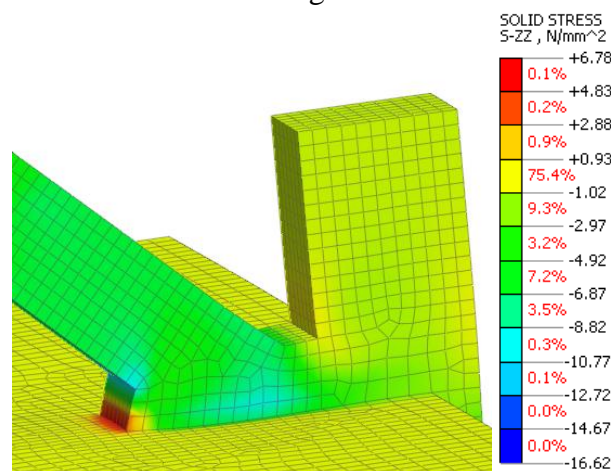
The results show that a value of tensile stress equal to 6.78 MPa, acting in the area in correspondence to the node 11, 12 has been obtained considering the phase 1 (Fig. 15). However, during phase 3, when the element 11 is de-tensioned, the tensile stress lowers down to 5.44 MPa, improving the situation (Fig. 16). Taking into account the results obtained for the phase 3a, when the element 11 is re-tensioned in an eccentric way, the stresses go up to 8.71 MPa (Fig. 17), indicating the cracked concrete. Moreover, it is possible to notice that the position of the exceeded tensile stresses coincides with the cracks that were actually created (Figs. 18, 19).

Figure 15: Results of the phase 1.

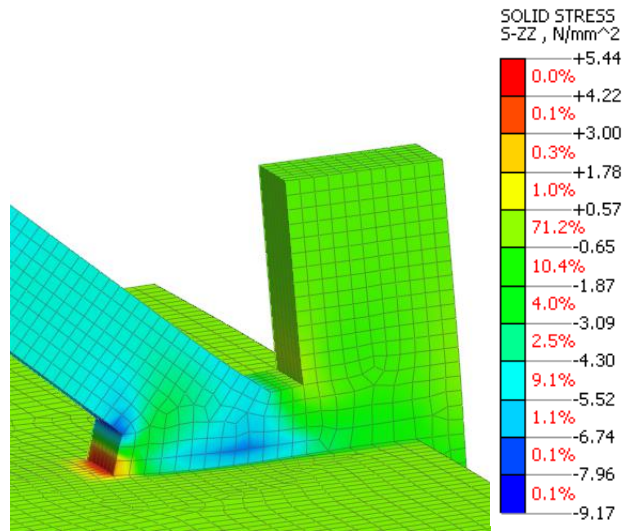
Figure 16: Results of the phase 3.

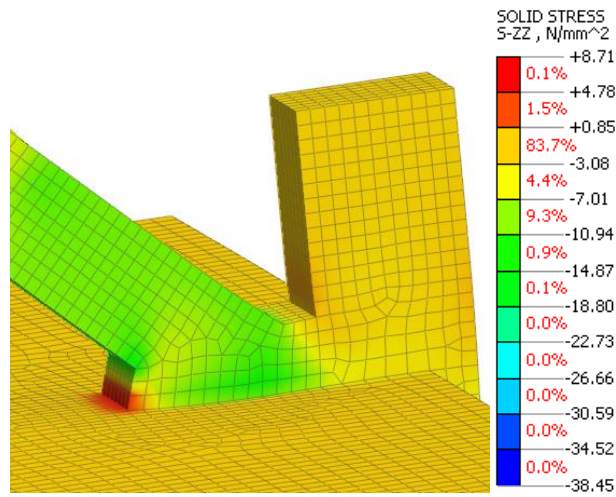
Figure 17: Results of the phase 3a.

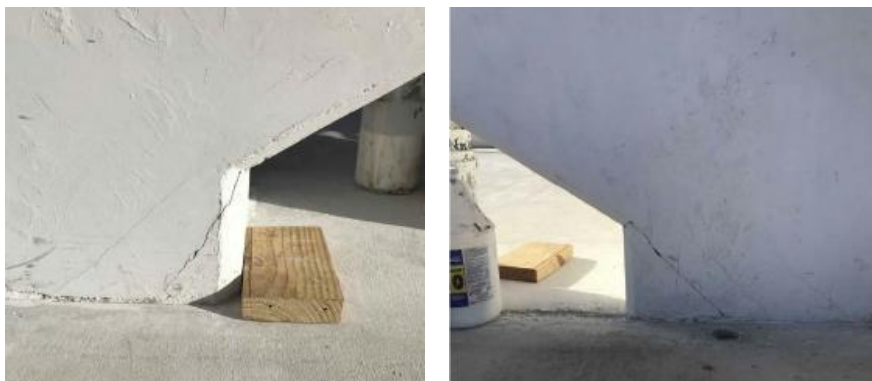
Figure 18: Cracks in node 1, 2 after phase 1 (left) and cracks in node 11, 12 after phase 1 (right).

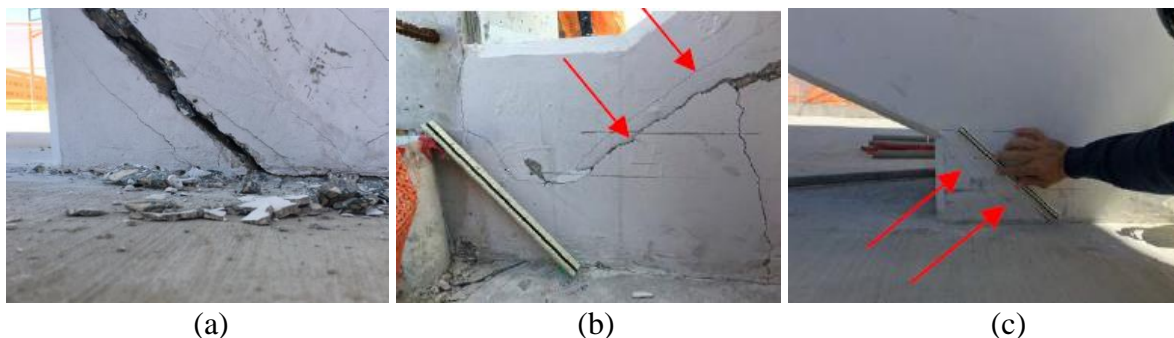
Once again, the conclusion is that the bridge collapsed because of a local problem, the node 11, 12 had a really low amount of rebar and re-tensioning member 11 caused the node to give in.

Figure 19: (a-b) Cracks in node 11, 12 after phase 3 and (c) cracks node 1, 2 after phase 3.
