APPROACHES FOR THE CONSERVATION OF THE NINMAKH TEMPLE IN BABYLON, PRELIMINARY STUDIES AND PROJECT

This paper highlights the methodological approach used for the project of conservation, recovery, and reuse of the temple of Ninmakh in Babylon, a monumental building of significant importance dating back to the Neo-Babylonian period (626-539 BC), in which Babylon was the capital of one of the most powerful empires known at the time.

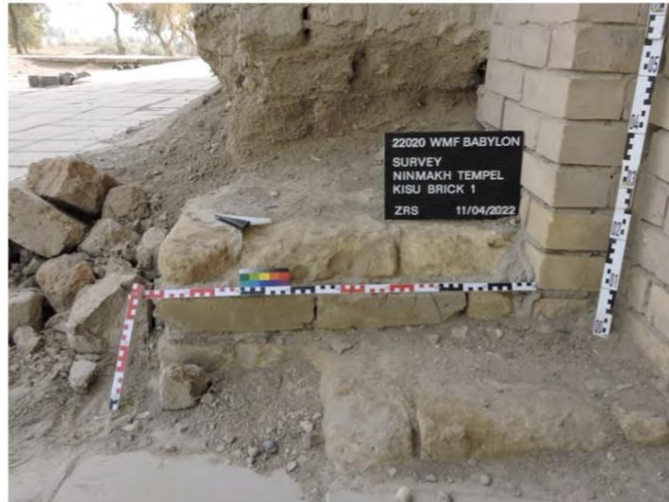
Photo no. ASS-11

Bricks used for the construction of the Kisu (Kisu brick 1), solid brick

Photo 4. Photographic documentation, WMF

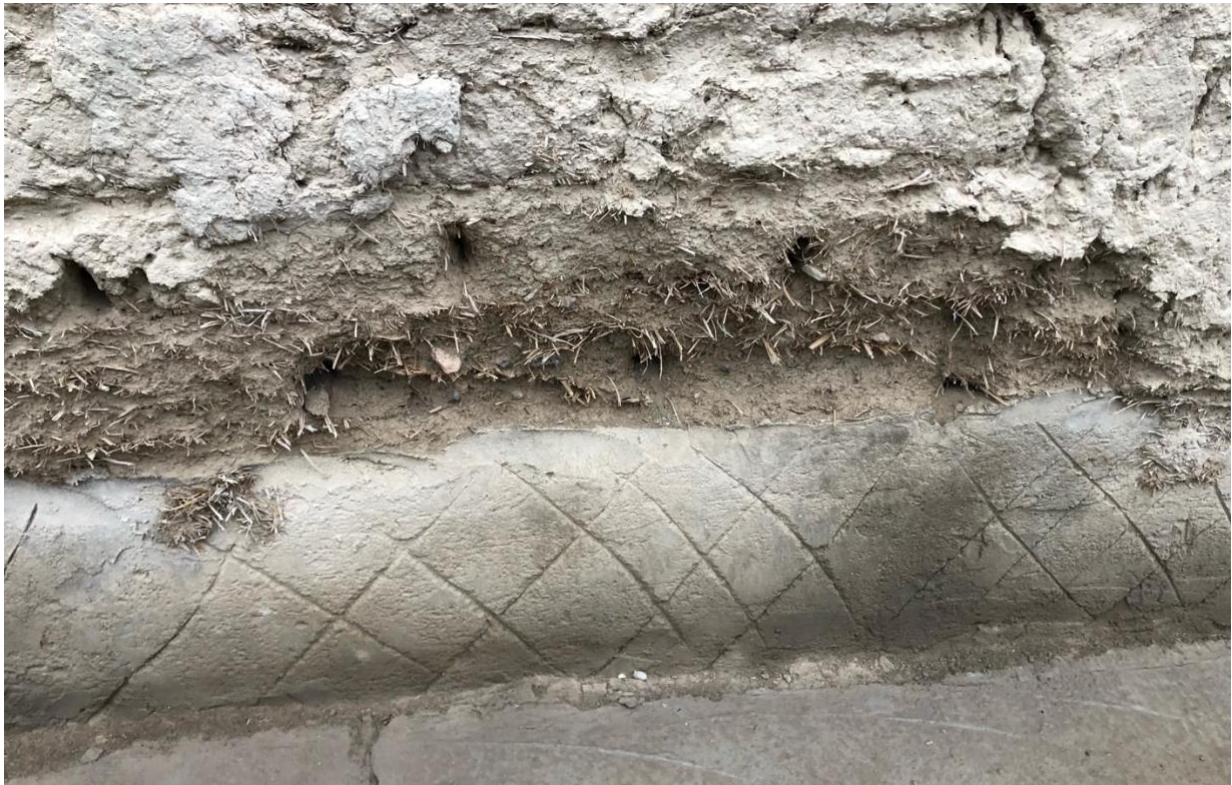
Photo 5. Cement blocks and degradation at the base of the wall. Credits: M. Achenza

The conservation methodology of this intervention focused on overcoming some recurring errors made in past decades concerning the conservation of historical materials. In particular, the concrete blocks positioned at the base of all the walls were almost completely removed to counteract the effects of humidity rise by capillarity. The use of cement for the conservation of earthen archaeology is in fact completely discouraged due to the different physical behavior of the two materials, one elastic and permeable to air and humidity, the other rigid and sealing. The latter factor is the reason why, in the presence of moisture condensation, the weaker material disaggregates. In addition, its subsequent removal without damage to the underlying structure is practically impossible.

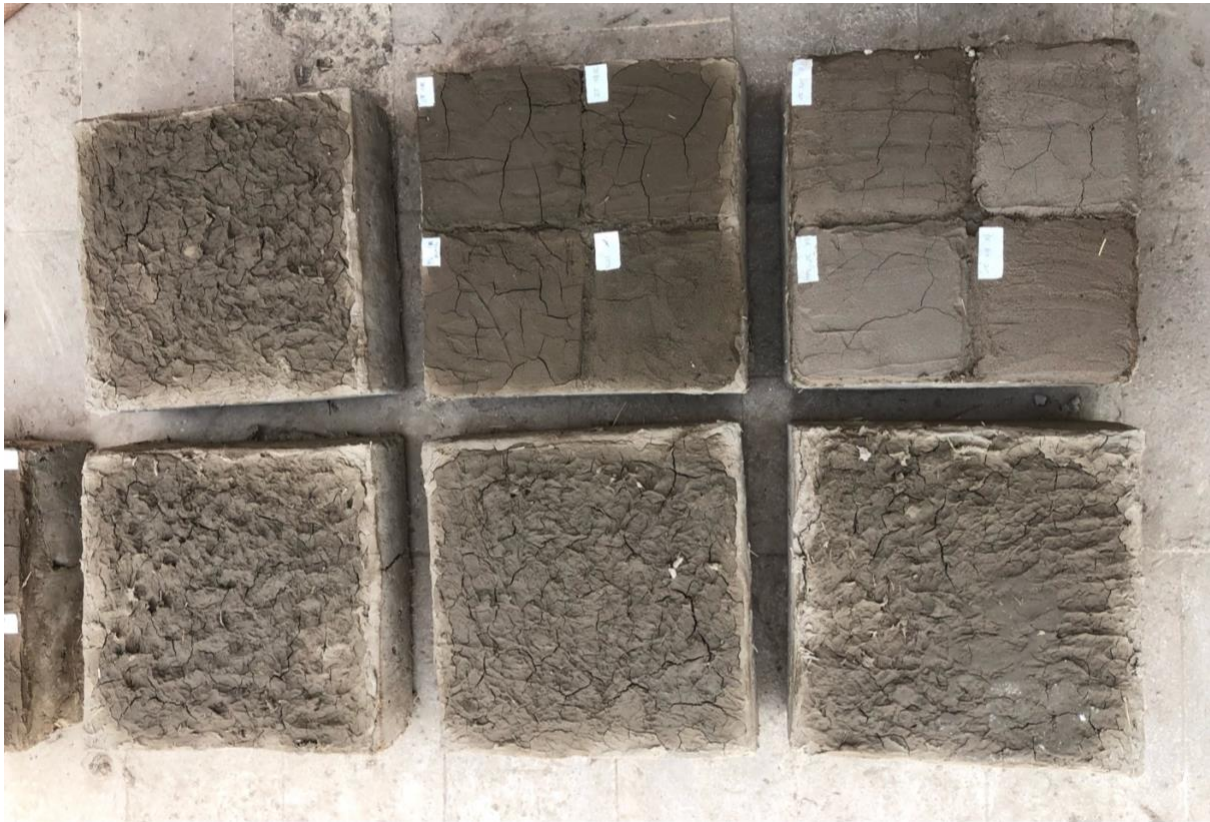
Photo 6. Tests and samples for plasters and mortar. Credits: M. Achenza

Following the same logic, differentiated mortars were developed for the installation of the two different types of blocks (adobe and brick). Only when necessary, have natural additives been added to the mortars, such as lime, to improve their mechanical resistance and ensure good performance against humidity and rainwater.

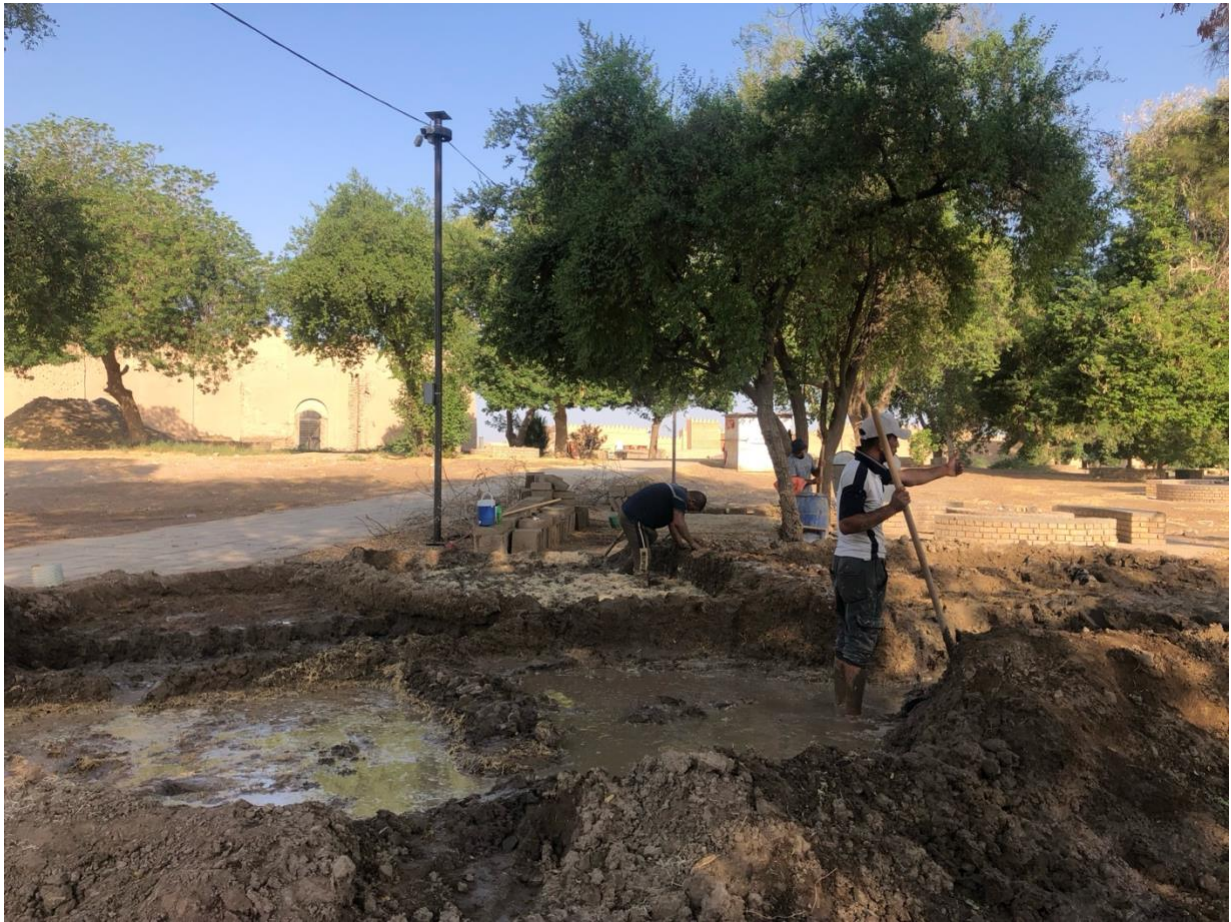
Photo 7. Adobe production outside the temple. Credits: M. Achenza

The soils for the production of adobe and mortars used for the masonry, for the plasters and for the consolidating injections, have been carefully chosen from the soils available in the vicinity. In general, these are soils with a very fine grain size, less than 0.50 mm, very cohesive and difficult to manipulate. For this reason, it was necessary to mix them with percentages of aggregates, also of fine grain size (less than 4 mm). The adobe production process was carried out according to traditional local practices. Inside a pool made of earth, a quantity of material of about 17 cubic meters was hydrated for more than two weeks. Afterwards, the material was further mixed with straw (7 bags per tank, about 28 kg) and repeatedly mixed and "washed" with drinking water to eliminate the large quantities of salts. At the time of the production of the adobe, more straw was added to the mixture (2 bags, about 7 kg) and the material was further worked barefoot. Considered that production took place in the months from May to September, the drying times were very short: two weeks to turn the adobe over on the side and another two for complete drying.

The traditional method, with long hydration times, has proved to be significantly more effective than the systems currently used today. The effective soaking of the organic components contained in the soils seems to give the mixtures much better-quality characteristics and stability. The adobe produced in this way have a very regular appearance, rarely have cracks and, when present, they are of negligible size.

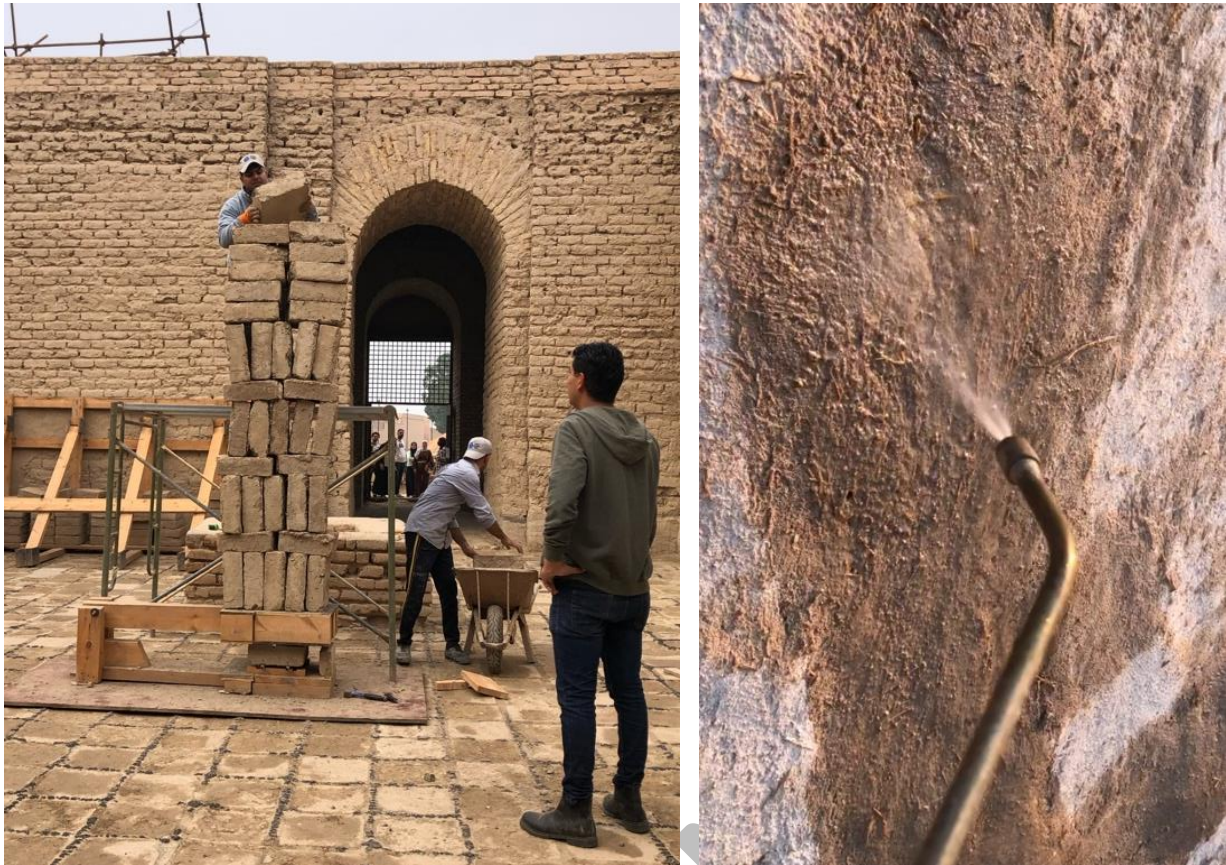
*Photo 8. Compression tests on adobe and water resistance test on earth-lime plasters.
Credits: M. Achenza*

It was not possible to carry out tests in the laboratory, but the numerous compressive strength tests carried out on site during the various stages of production confirmed the good workmanship of the blocks, sometimes excellent.

Water resistance has also been tested with investigations aimed above all at verifying the ability to rise by capillarity. Again, the results proved to be appreciable.

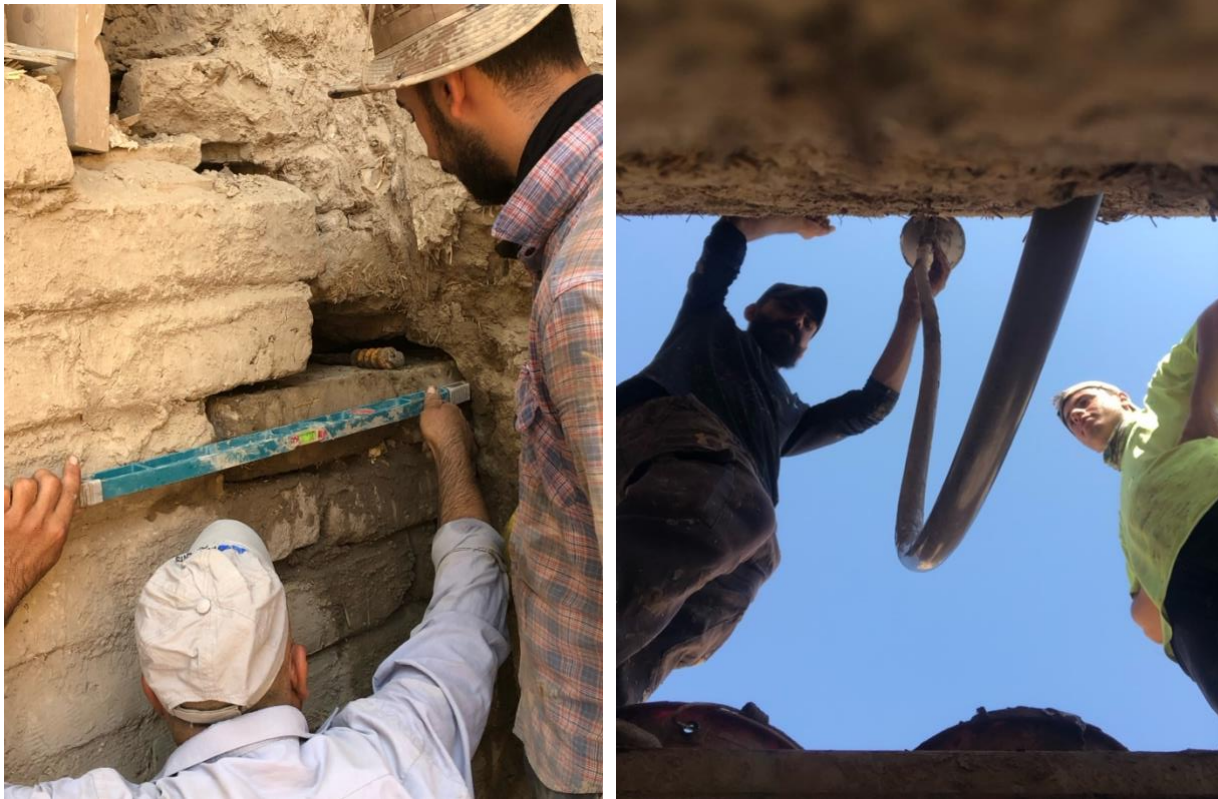
Photo 9. Wall stitching and earth grouting. Credits: M. Achenza

During the works, numerous restoration and wall consolidation interventions were necessary, not initially planned. This is due to the fact that the damage inside the recently built masonry was not always visible. However, the detachment of the ancient structures from the new reconstructions is practically constant, which has made the entire structure very precarious in some places and the superficial lesions of no negligible extent. The interventions concerned almost all walls, both external and internal, which were treated with a stitching system to restore the cracked parts and subsequent filling with a slurry of earth.

Only in very few cases was it necessary to place additional reinforcements with fiberglass bars, fixed with natural hydraulic lime. This system, applied by engineers Christoph Ziegert and Tobias Bieger - ZRS büro Berlin, ensures good stability for the subsequent installation of the roofs.
