7 Stochino, F., Majumder, A., Kanagaraj, B., Sara, N., Serra, A., & Mistretta,
8 F. (2025). Combining experimental and computational approaches for
9 post-fire safety assessment of RC warehouse. *Proceedings of the*
10 *Institution of Civil Engineers-Forensic Engineering*, 178(3), 66-80.

18 Combining Experimental and Computational Approaches for Post-Fire Safety 19 Assessment of RC Warehouse

30 Abstract

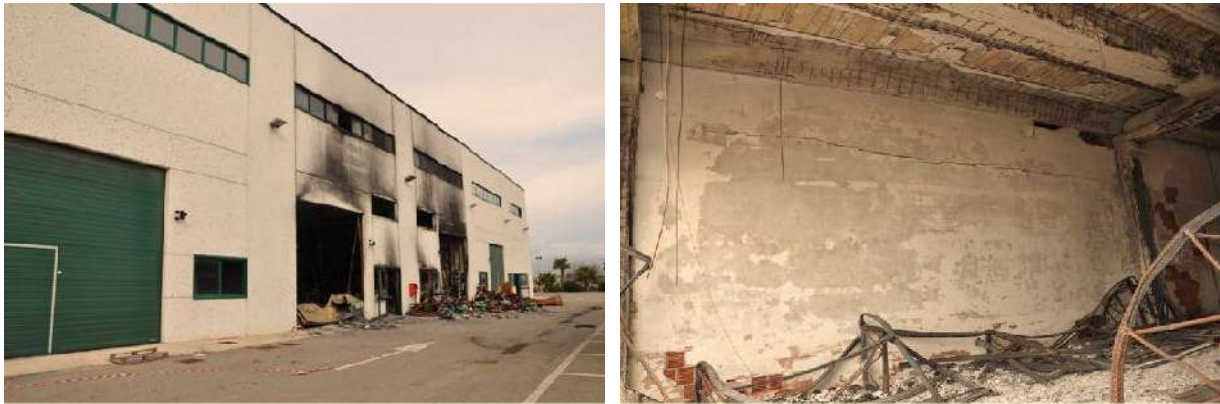
163 On the evening of November 16, 2013, a fire broke out on the ground floor, causing significant
164 structural damage, as shown in *Figure 3*. Notably, the fire was contained to the central area of the
165 ground floor and did not extend to other parts of the building (see *Figure 4*).
166

Figure 3. Warehouse (a) outside view, and (b) inside view.

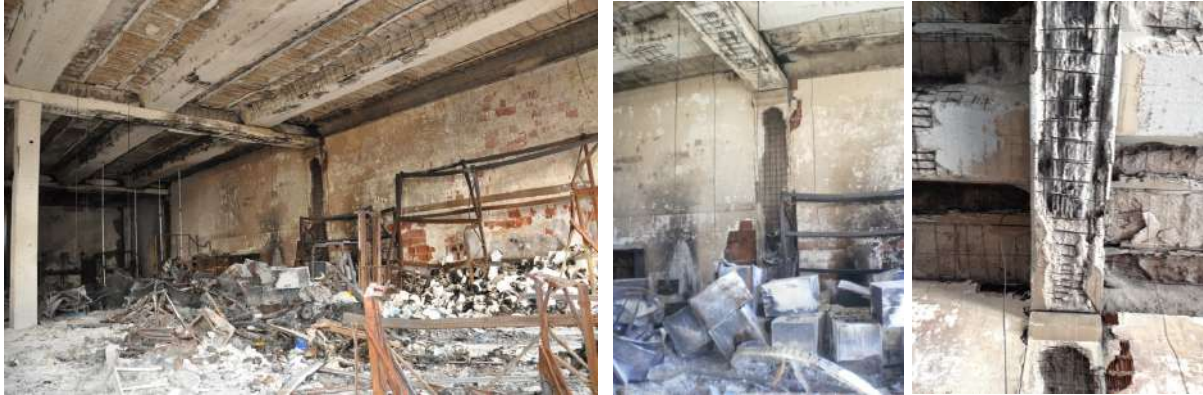
After the fire, a substantial amount of debris was observed across almost the entire floor area. This debris consisted primarily of fragmented concrete, remnants of steel shelving units, charred wooden pallet pieces, and other fire-generated residues (Figure 5). The distribution and quantity of the debris suggest an intense fire that was localized in certain areas, causing widespread disintegration of both non-structural and structural elements, see Figure 5.

(a) (b) (c)
 Figure 5. Damages inside the warehouse: (a) overview, (b) column, (c) beam.

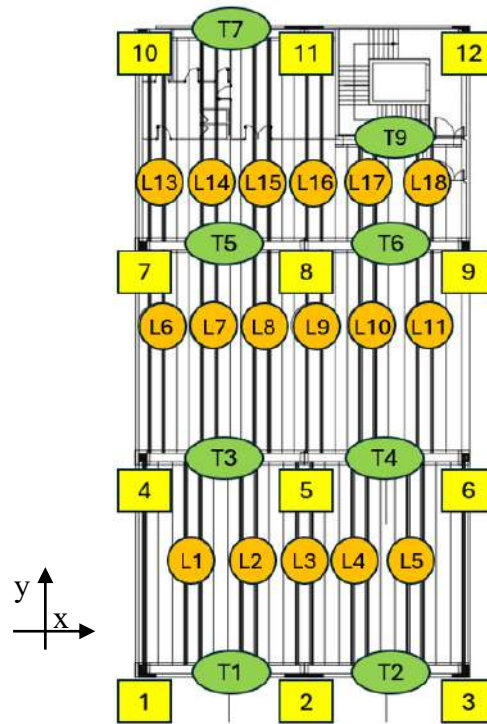
Figure 6. Plan view of the fire zone. T-shaped transversal beam are labelled with “T” while omega-shaped longitudinal beam are labelled with “L”.

A detailed inspection of the structural frame revealed that the lateral columns identified as 4, 6, 7, and 9 (Figure 6) sustained the most extensive damage. Visual examination reveals that these columns were subjected to severe thermal exposure on one side, resulting in progressive material degradation inward toward the core. This pattern of damage suggests asymmetric heating, resulting in hollowing or loss of integrity on the fire-exposed faces (Figure 6).

217 In contrast, the perimeter columns 1, 2, 3, 10, 11, and 12 were located far from the central fire
218 zone, therefore experienced considerably lower thermal exposure. Notably, their physical
219 condition remains relatively intact, with no immediate signs of critical structural compromise.
220 The central columns, particularly columns 5 and 8, display surface characteristics indicative of
221 high-temperature exposure. Their exteriors show significant roughness and a distinctive greyish-
222 white coloration, a typical sign of surface dehydration and chemical changes in concrete under
223 intense heat (Figure 6).
224 Regarding the horizontal structural elements, only the lower portions of the beams were directly
225 exposed to the fire. The upper parts remained shielded by the concrete slab, which provided some
226 level of thermal protection. However, in several beams, specifically T3, T4, T5, T6, L4, L5, L8,

227 and L9 severe damage has been identified (Figure 6). These include substantial spalling of the
228 concrete cover and partial debonding or exposure of the prestressing tendons, both of which can
229 significantly compromise the load-bearing capacity and long-term durability of the beams.
230 These findings underscore the necessity for a comprehensive structural integrity assessment,
231 potentially necessitating extensive repair or replacement of the most heavily affected components.

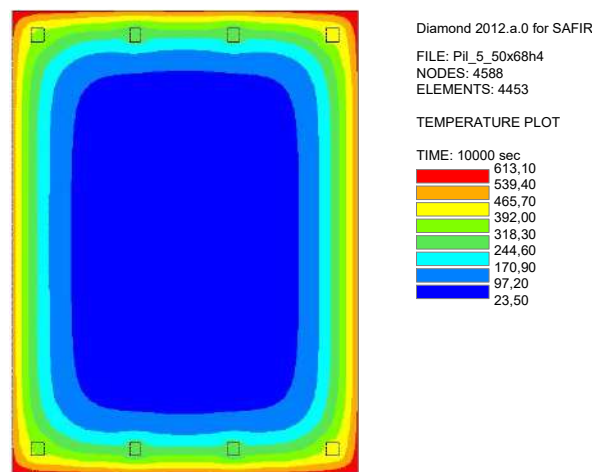
350 For example, for Column 5 which was exposed to fire on all sides the maximum temperature
351 distribution obtained from the FE thermal simulation was compared with estimates derived from
352 the post-fire in-situ investigation (see Tables 2 and 4). The field tests made it possible to estimate
353 the maximum temperatures reached at various depths from the column’s external surface.

354 Figure 11 illustrates finite element temperature distribution across the cross-section of Column 5
355 at a height of 4.45 m, compared with the estimated maximum in-situ temperature. It shows that
356 the surface temperature of Column 5 reached approximately 600 °C, while at a depth of 4 cm from
357 the surface, the maximum temperature was around 300 °C. The variations in temperature across
358 different sides of the column can be attributed to the temperature time-history produced by the
359 CFD (Computational Fluid Dynamics) fire simulation. Since the fire scenario was not
360 symmetrical, the resulting temperature distribution is inherently non-uniform.

362 *Figure 11. Finite element temperature distribution in the cross-section of Column 5.*

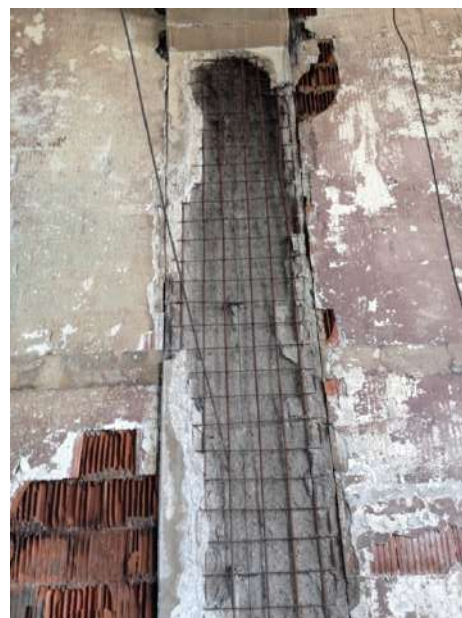
374 Specific attention is necessary for the lateral column 6. This rectangular column (90x60 cm) is
375 characterized by the presence of an internal rainwater downpipe that channels roof runoff to the
376 sewer system. The water contained within the downpipe likely underwent significant thermal
377 expansion due to the fire, contributing to the spalling of a large portion of the concrete within the
378 fire-exposed region of the column, see Figure 13.

379
380 *Figure 13. Column 6 damages.*

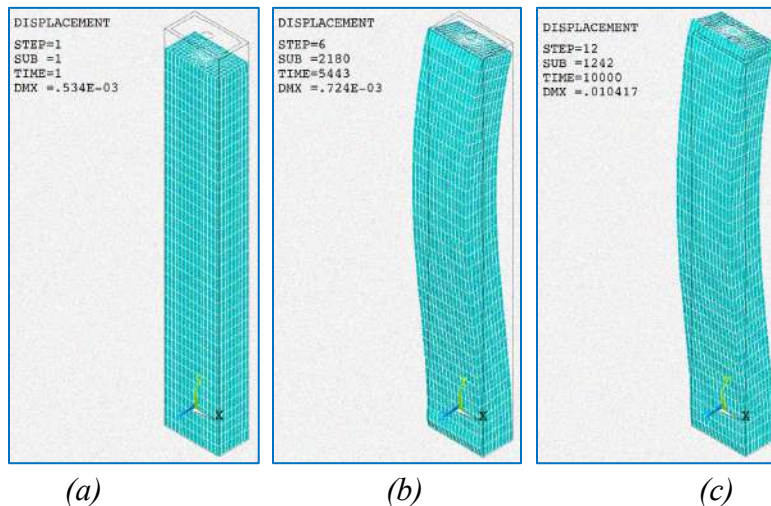
392 From Figure 15, it is possible to observe how the column deforms in response to the applied
 393 thermal and structural loads. Initially, the deformation of the column is due solely to the structural
 394 load. As the temperature increases, thermal stress becomes more significant, leading to a noticeable
 395 change in the deformed shape.

397 *Figure 15. Deformation at (a) $t = 1s$, (b) $t = 5443s$, and (c) $t = 10000s$.*

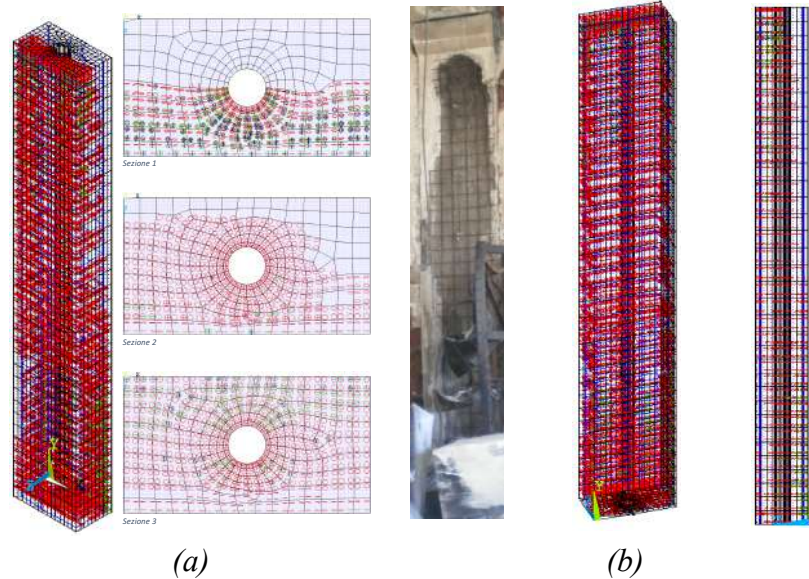
431
432 Figure 21(a) illustrates the damage state at 6880 seconds; at this moment, the entire surface
433 affected by the fire exhibits the highest temperatures. Figure 21(b) shows a comparison between
434 the real image of the damaged column and the results obtained through computational mechanics.

Figure 21. (a) Damage at 6880 sec, and (b) Comparison of the damage.
