An Evaluation of the Structural Behaviour of Historic Buildings Under Seismic Action: A Multidisciplinary Approach Using Two Case Studies

Abstract: The evaluation of the structural behaviour of iconic historic buildings represents one of the most current structural engineering research topics. However, despite the various research works carried out during recent decades, several issues still remain open. One of the most important aspects is related to the correct reconstruction of the complex geometries that characterise this type of construction and that influence structural behaviour, especially in the presence of the horizontal loads caused by seismic action. For these reasons, different techniques have been proposed based on the use of laser scanners, Unmanned Aerial Vehicles (UAVs), and terrestrial photogrammetry. At the same time, several analysis methods have been developed that include the use of linear and non-linear approaches. In this present paper, the seismic performance of the Santa Maria Novella basilica and Santa Maria di Collemaggio basilica (before the partial collapse due to the 2009 L'Aquila earthquake) were investigated in detail by means of several numerical

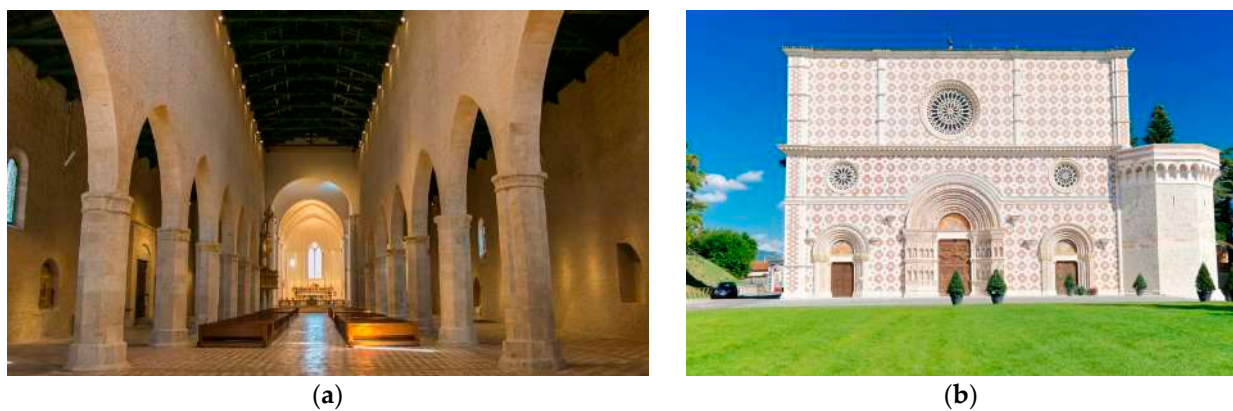
Figure 4. Basilica of Santa Maria di Collemaggio. (a) Central nave; and (b) façade.

The basilica of Santa Maria di Collemaggio represents one of the most significant Italian historical monuments and, as a result, has been the subject of extensive research in recent years [21,22]. The church was built in the late 13th century by Pope Celestino V and originally exhibited the characteristics of Romanesque architecture. However, over the centuries, the construction process of the basilica has undergone various interventions, primarily due to the consequences of earthquake damage. The church is characterised by the presence of three naves, delineated by two columns of octagonal cross sections (Figure 4a).

One of the most important features of the basilica is its imposing two-tone façade (Figure 4b), as well as the tower, located on the right side of the façade, with an octagonal cross section. The church presents a cross-shaped plan with a length of 93.64 m, having a maximum transversal size equal to 34.26 m in correspondence to the transept (Figure 5).
