# Experimental tensile testing of the lap joint composite laminates supported with the acoustic emission and machine learning techniques

This paper investigates tensile behavior of through thickness reinforced carbon/epoxy lap joint composite laminates, reinforced with steel z-pins and staples, arranged in two rows parallel to the overlapping edges, via experimental testing. Acoustic emission (AE) monitoring is employed during the displacement-controlled tensile tests to monitor damage propagation during loading using the Vallen AMSY-5 measurement system, with two piezoelectric sensors being mounted at the laminate surface. Furthermore, machine learning algorithms are integrated to process AE data, enabling the recognition and prediction of failure mechanisms. Fractographic analyses were performed to observe the nature of damage post-failure. The experimental research was enriched with capturing high-resolution pictures of total crack propagation length growth using a high-resolution photocopier. The performed empirical tests demonstrated that the unstable propagation of a crack along the bonding interface has led to an eventual breakdown of both unreinforced and reinforced joints

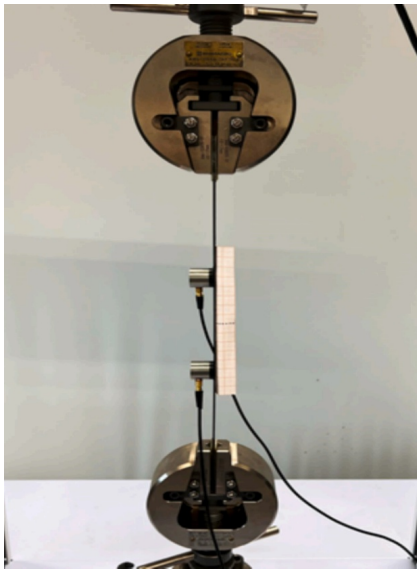
Fig. 2. Experimental test setup for the pinned composite tensile specimens.

Experimental tensile tests (Fig. 2) were carried out on Shimadzu ASG-X tensile testing machine equipped with 10 kN load cell. Prior to experiments, tabs were fastened on both sides to the composites at a length of 40 mm. To ensure quasi-static loading conditions, all tests were conducted with constant crosshead velocity equal to 1 mm/min. Prior to experiments, a millimeter paper was glued to samples in order to increase precise measurement of developing cracks that were recorded with a Nikon D500 4 K photo camera (Nikon, Tokyo, Japan).

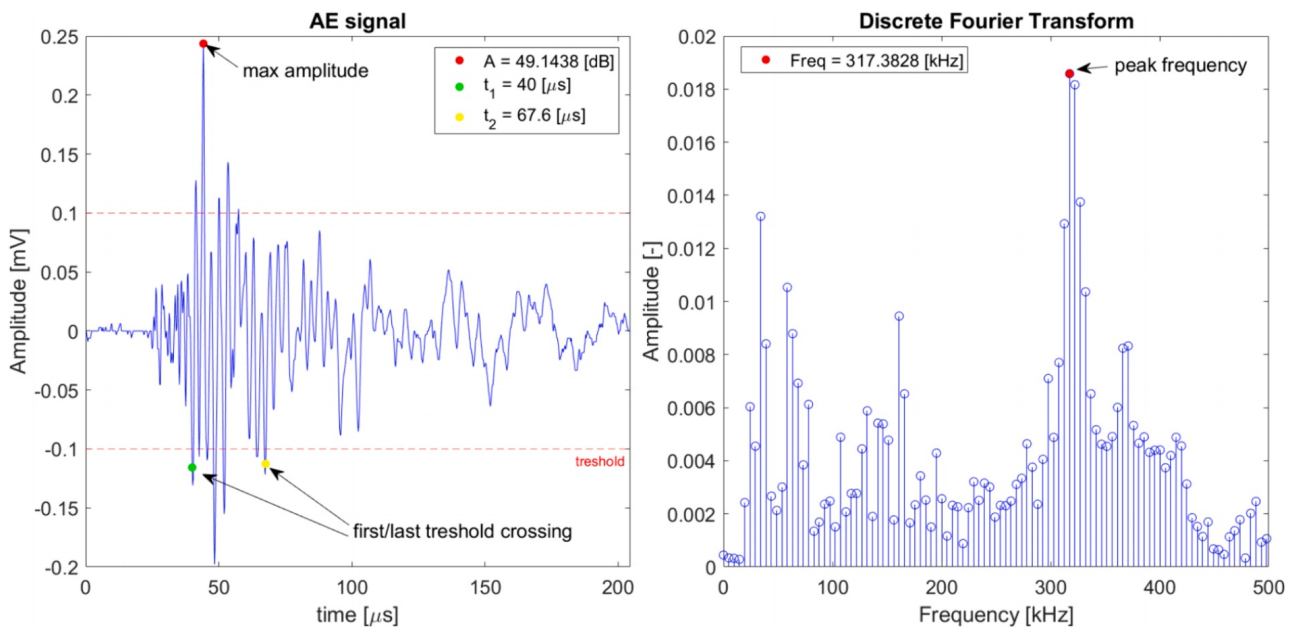
Fig. 5. Typical AE signal registered during tensile test and its spectral representation.

into three groups representing the most expected damage modes occurring during tensile tests of lap-joint laminates: delamination, matrix cracking and other failure mechanism related with deformation and damage of steel pins, as well as regions around it. For the last case, to better recognition of possible failure modes, a scanning electron microscopy observation should be performed, which is not the object of this paper. After clustering procedure, the partitioned acoustic emission signal features were referred to comparative values (resulted from literature review) obtained by other researchers. This allowed to predict and assign specific clusters to characteristic composite damage modes. The general procedure of signal registration and analysis was divided into three steps: collection of the AE data, preprocessing and converting the data into a usable form and sorting into groups called class. In the case of unsupervised pattern recognition, it is a process by which AE waveform features were classified in general group according to their similarity. With regard to the first step, the acoustic emission transient waves propagated into loaded lap-joint laminates were registered by using piezoelectric transducers attached to the specimen's top surface in the form of voltage versus time responses. All signals were registered by using the Vallen AMSY-5 acoustic emission system and were stored in two databases containing primary features and transient data. The registered signals were preliminary filtered to remove measurement noise. The weakest AE transient elastic waves for which the number of threshold crossing was less or equal to three were not taken into account for further considerations. Subsequently, six waveform features were extracted from each of the registered AE signals, namely: amplitude  $A$  [dB], rise time  $R$  [ $\mu$ s], energy  $E$  [aJ] (atto-Joule), duration  $D$  [ $\mu$ s], number of threshold crossing  $C$  (number of counts), and maximum frequency  $f$  [kHz] obtained by application of the FFT transform to raw signal. One of the acoustic emission signals registered during the experiment with typical waveform features is presented in Fig. 5.

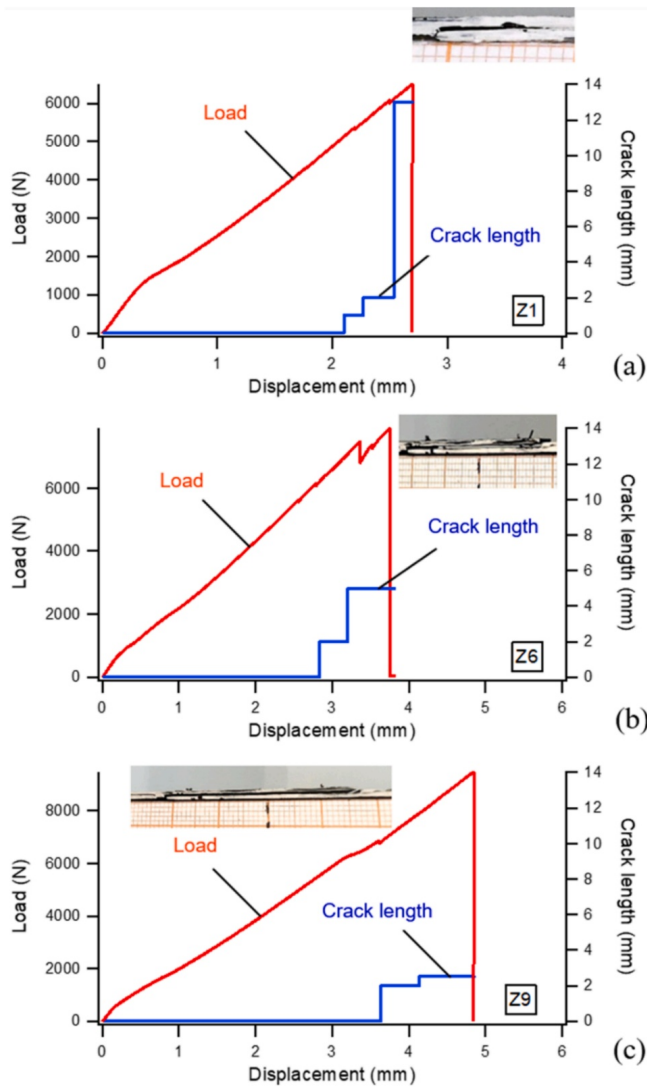
Fig. 7. Typical growth of total crack length: (a) Unpinned, (b) z-pinned, and (c) Staple pinned.

The typical growth of total crack which is the total length from the two edges of unpinned, z-pinned, and staple-pinned joints is illustrated in Fig. 7. The growth of crack length curve for unpinned joint in Fig. 7a was very fast and the crack length immediately before final failure is very large. The rapid rise indicated almost instantaneous crack propagation. While Fig. 7b depicting the z-pinned joint, showed a similar trend of increasing crack length, albeit at a somewhat slower rate

compared to the unpinned specimens and with almost half the crack length at failure, which means that pins restrained the growth of cracks. However, despite the presence of z-pins, there were still instances of sudden jumps in crack length. In contrast, Fig. 7c for staple-pinned specimens demonstrated a distinct behavior. The crack length started to increase at a later stage compared to the other configurations and the rate of crack growth is significantly slower. The efficacy of staples in limiting crack length propagation has been shown by the delayed increase in crack length. The intimate contact promoted by the clamping action of staples leads to a reduction in overall crack length prior to failure, indicating superior crack restraint compared to both the unpinned and z-pinned configurations. The comparison is demonstrated in Fig. 8. For these three configurations, it appears that while both z-pins and staples contributed to restraining crack growth, staples emerged as the more effective solution. Their gripping action promoted intimate contact between layers, significantly minimized the rate of crack propagation and eventually led to an inferior crack length at failure compared to the other configurations.

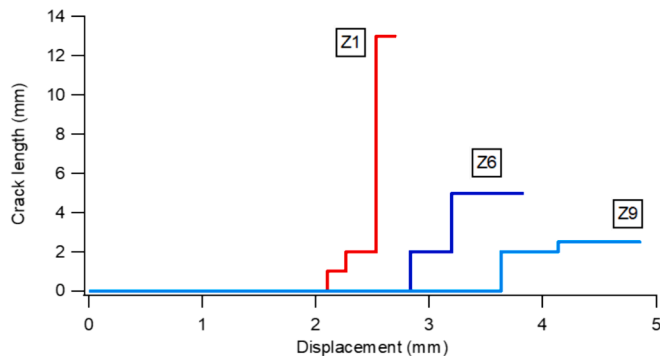
Fig. 8. Comparison of total crack length growth of the different configurations.

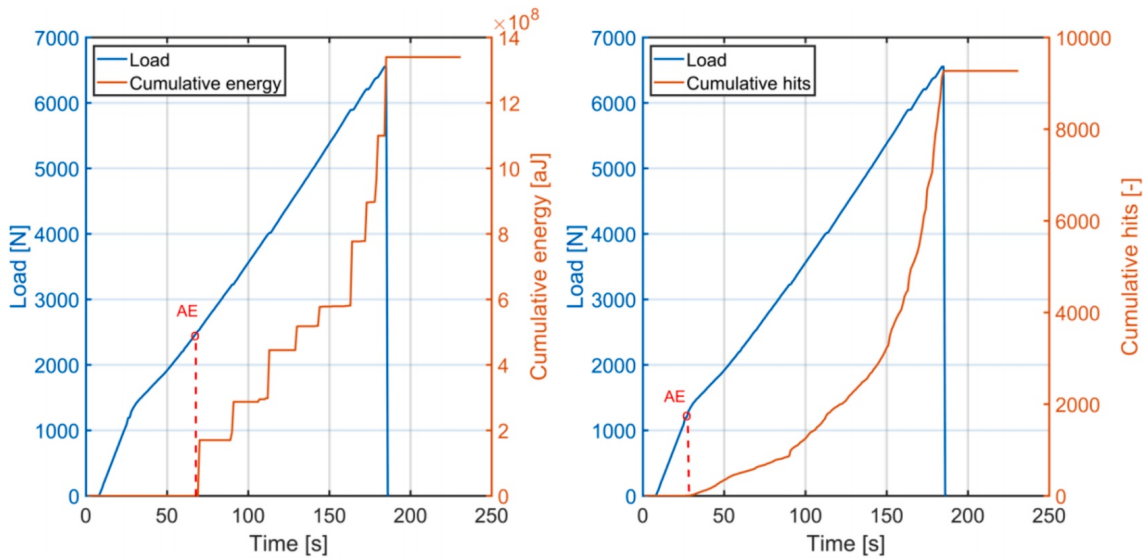
Fig. 9. Load-time plots versus: a) cumulative energy, b) cumulative hits, obtained for Z1 laminate subjected to tensile test.

One of the goal of this paper was precise detection of damage initiation in lap-joint composite laminates by using the acoustic emission technique. The main advantage of this method is high sensitivity to detect material degradation at an early stage. It should be mentioned that this technique was previously successfully utilized by the authors of this article to detect initiation of delamination in elastically coupled DCB and ENF composite laminates [68–70]. In this case, the registered AE features were combined with load values registered during mechanical tests in real time. In order to detect damage onset, two different initiation criteria were used, namely: the cumulative energy and the cumulative hits. With regard to the above, the moment of damage initiation is considered when the first pronounced increase of those cumulative plots is observed. In Figs. 9–11 the load-time versus cumulative hits and cumulative energy curves obtained during tensile tests conducted on composite lap-joint laminates are presented. The AE points marked on the plots represent moments in which sudden increase in the gradients of cumulative values were observed. Hence, the aforementioned criteria were fulfilled. For those points, specific values of time and corresponding load were precisely determined. In the case of Z1 laminate significant increase for cumulated acoustic energy was observed at  $t = 69$  s of the test duration, corresponding to a load of 2516 N. In the case of laminate Z6 increase was observed at 124 s of the test, corresponding to a load of 4310 N. For the Z9 laminate respective values of time and load for significant increase were 81 s and 2348 N. These AE points represent moments in which crack propagation started. On the other hand, the increased rise in the cumulative number of hits indicates much faster propagation of delamination. The AE points for cumulated hits were as follows Z1:  $t = 29$  s,  $F = 1335$  N, Z6:  $t = 52$  s,  $F = 1854$  N, Z9:  $t = 21$  s,  $F = 697$  N. It is also worth emphasizing that higher levels of cumulated acoustic energy activity were observed before the maximum load and before visually observed crack growth. In Fig. 10 at a load of 7461 N energy activity suddenly drops and no energy is released that can be correlated with visually noticed crack length increase (Fig. 7) and is it possible that pins stopped further crack growth. During loading Z9 sample it is also noticeable that a slight drop of load occurred with simultaneous high increase of energy release. Crack increased during that loading, but there was no further decrease in load value, which may be to the staples carrying the load. For all samples, sudden increases in cumulative energy and cumulative hits occurred just before the final failure.

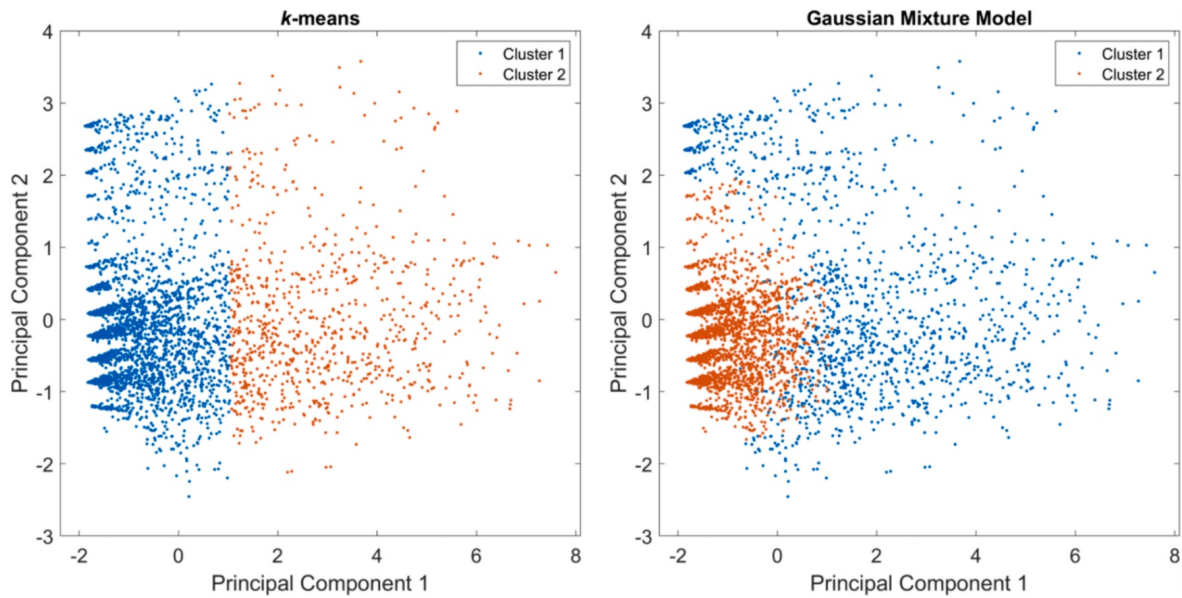
Fig. 13. Scatter plots of clustered waveform features extracted from the AE signals registered during tensile test of Z1 unpinned composite laminate.

characteristic groups of signals that represent two failure mechanisms could be observed. They were as follows: cluster 1 corresponds to delamination (28 %) and cluster 2 corresponds to matrix cracking (72 %). For the Z6 (pinned) joint and Z9 (stapled) joint the collected AE data were divided into three characteristic clusters. For the Z6 laminate, damage phenomena caused by delamination (30 %), matrix cracking (53 %) and other failure mechanism (18 %) can be distinguished. The last failure group can be correlated with steel pins failure or laminate damage in the region around pin. Similar situation can be noticed for the Z9 stapled specimen. Here, the delamination group corresponded to 33 % of total AE signals, matrix cracking to 55 % and other failure mechanisms to 15 %. To sum up, the matrix cracking was found to be the most dominant mode of failure for all three groups of lap joint laminates (Z1, Z6, Z9) subjected to tensile loading. Delamination and other failure mechanisms were grouped in smaller clusters. Based on obtained outcomes, characteristic ranges of the AE waveform features with regard to predicted damage mechanisms can be established and they were as

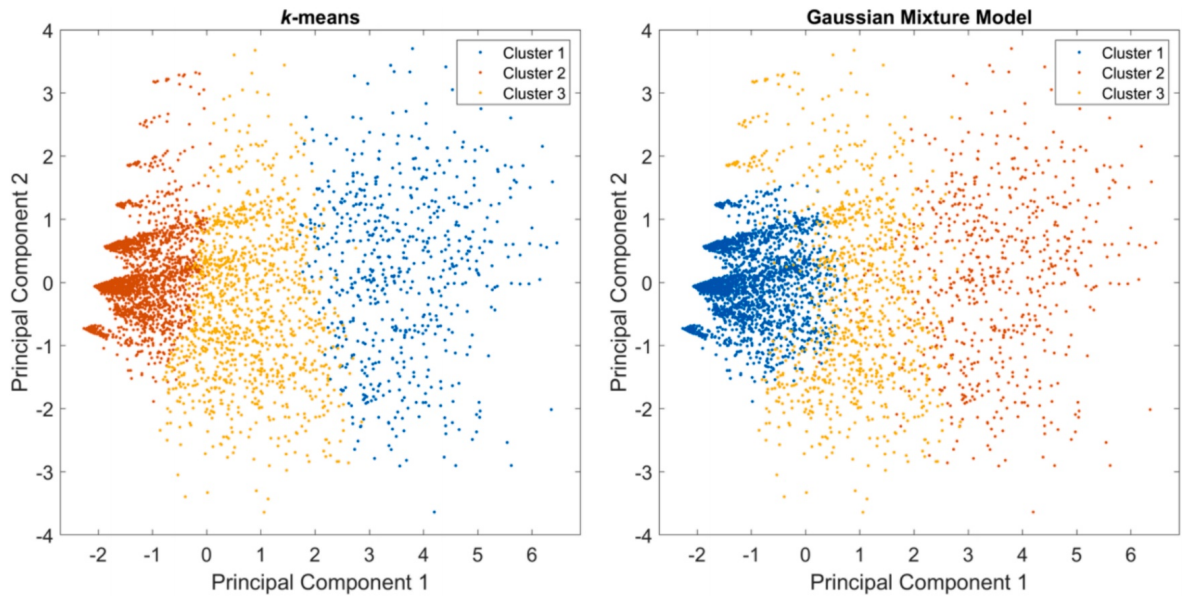
Fig. 14. Scatter plots of clustered waveform features extracted from the AE signals registered during tensile test of Z6 pinned composite laminate.

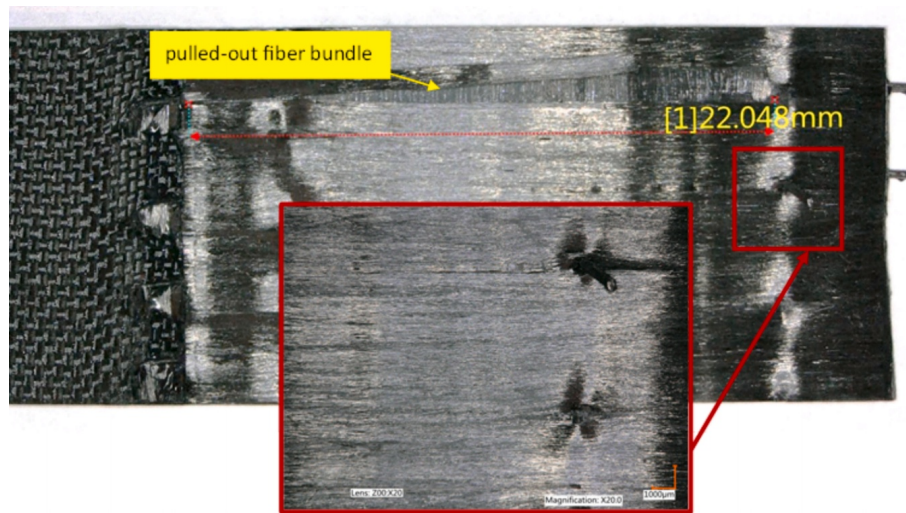
Fig. 19. Micrograph of Z9 staple pinned specimen.

Fig. 19 represents the failure surface of a staple pinned joint, where broken pins are visible within the red square, together with pulled fiber bundles. spanning a total length of 22.048 mm, a cluster of carbon fibers detached from the matrix material upon rupture of the reinforcement. Such damages are significant and may indicate a weak point in the applied reinforcement staple pinned leading to the mass detachment of fibers from the material.
