**Nile's Earth 2023 International Conference: study and conservation of earthen archaeological sites in ancient Egypt and Sudan, 4-5-6 July 2023. Proceedings**

# Construction details against moisture in ancient Babylon and its surroundings

## THEME 3 - Conservation, Valorisation and Management

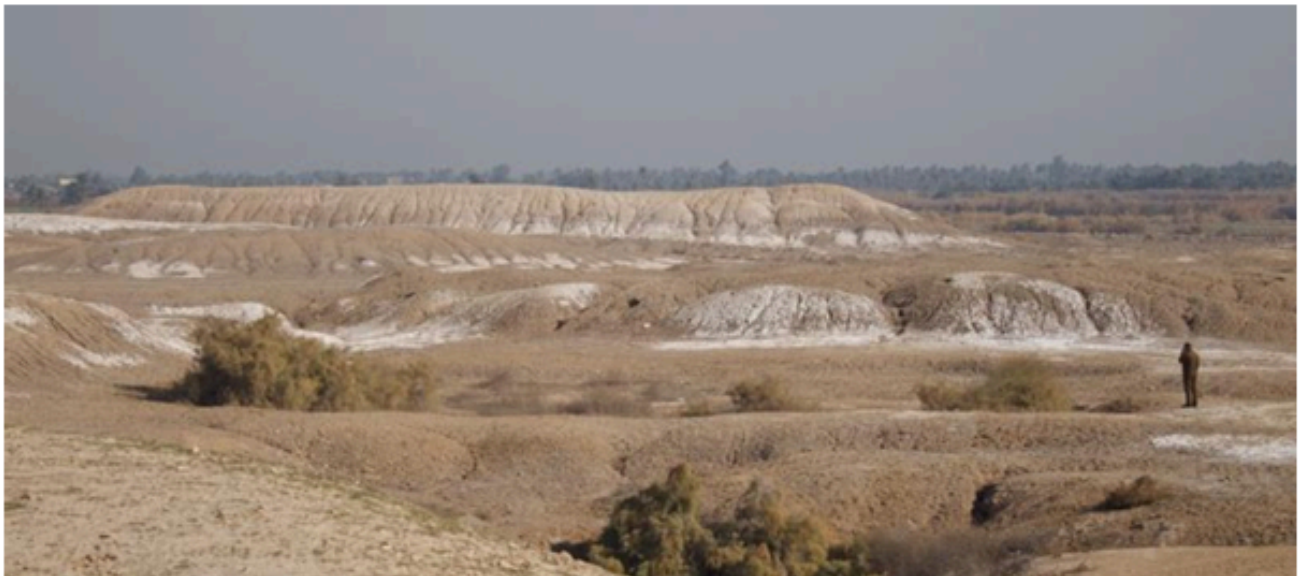
The plain is also collecting groundwater from all surrounding areas. Heavy evaporation of the near-surface saline groundwater leads to salt accumulation on the surface, producing sometimes impressive effects on the landscape (Fig. 1).

*Figure 1. Tell Bander, Kish archaeological site. Credits: Maddalena Achenza*

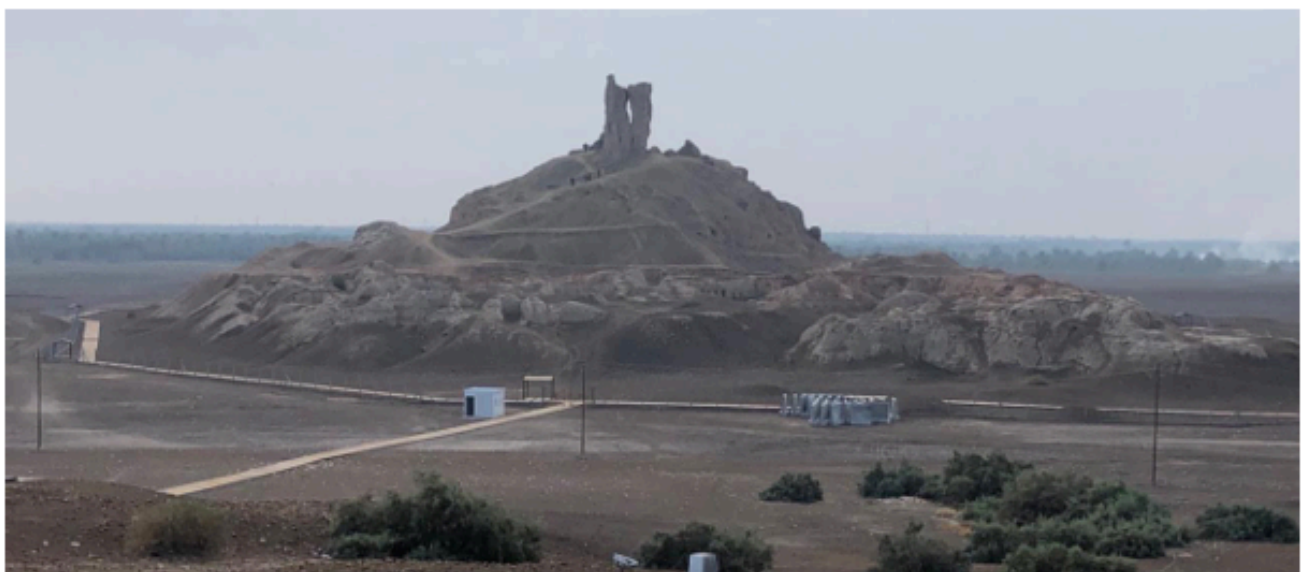
Commonly, as it happens to witness in settlements of any age and everywhere in the world, earth buildings are positioned in areas that are some meters higher than their surroundings. In Mesopotamia, too, iconic and representative buildings such as the ziggurat in Kish and Borsippa (Fig. 2), are located on barely perceived hills, well visible even from far. Though these sites are not yet fully excavated, we can still assume by logic that they were chosen to dominate the landscape. Experience from other similar sites informs us that this is a very common strategy to slow the capillary rise of humidity and keep sites safe from floods.

*Figure 2. Borsippa. Credits: Maddalena Achenza*

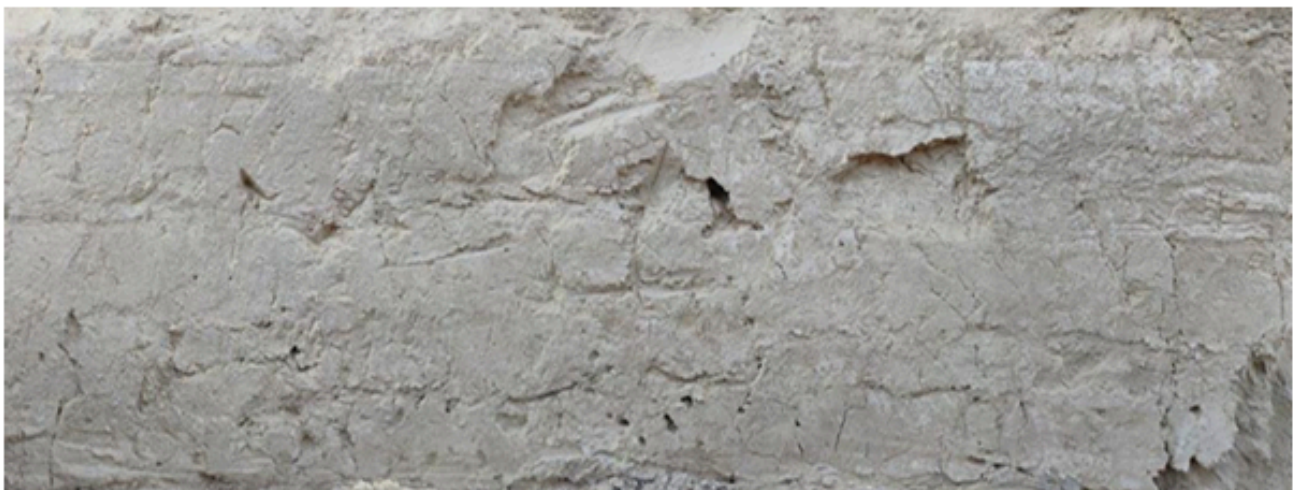
In the temple, lime plasters were found, according to Pedersén during an interview with the authors, on the external façade next to the north entrance, on the walls of the courtyard, and in the *cella*. In February 2023, during reparation works, traces of this type of plaster were found also at the base of the external eastern wall (Fig. 3).

Figure 3. Babylon Ninmakh temple. Lime plaster. Credits: Ammar Al Taei

In January 2023, at Ishtar Gate, part of a squared masonry pillar was unearthed during the construction works of the new staircase accessing the site. The pillar is part of the entrance gate to town from the processional way. The fired brick pillar is covered with the same type of lime plaster found at Ninmakh Temple on earthen bricks.

At a preliminary analysis, the plaster, very similar in both cases, appears mixed just with soil and with no pigment added. The result is a pale coating, 1 cm thick in average.

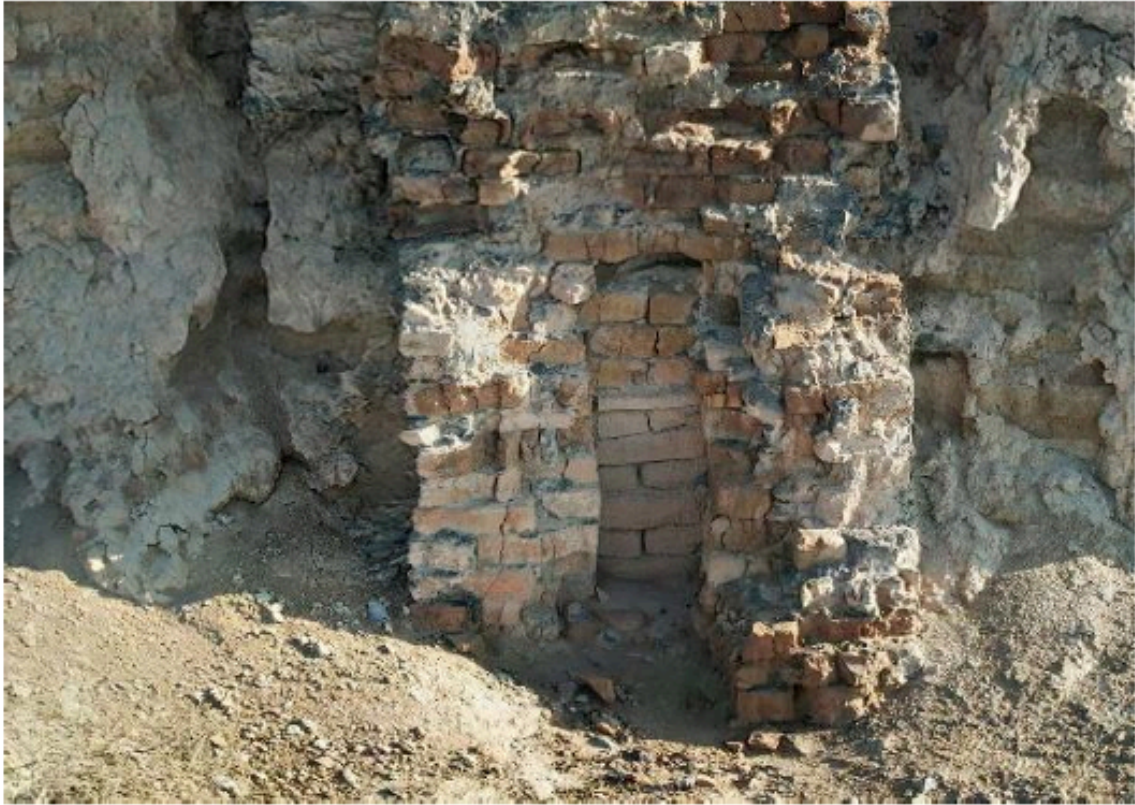
Bitumen was also used as waterproof barrier in between bricks for the construction of rainwater drainage channels, as observed in the Ezida Temple in Borsippa, rebuilt during the new Babylonian era. Although the temple is mostly built with mud bricks, waterways were built with fired bricks laid with a bitumen/soil mix in the form of vertical channels, extending from the top of the roof to the base of the walls (Fig. 5).

*Figure 4. Water drainage in the Ezida Temple. Credits: Ammar Al Taei*

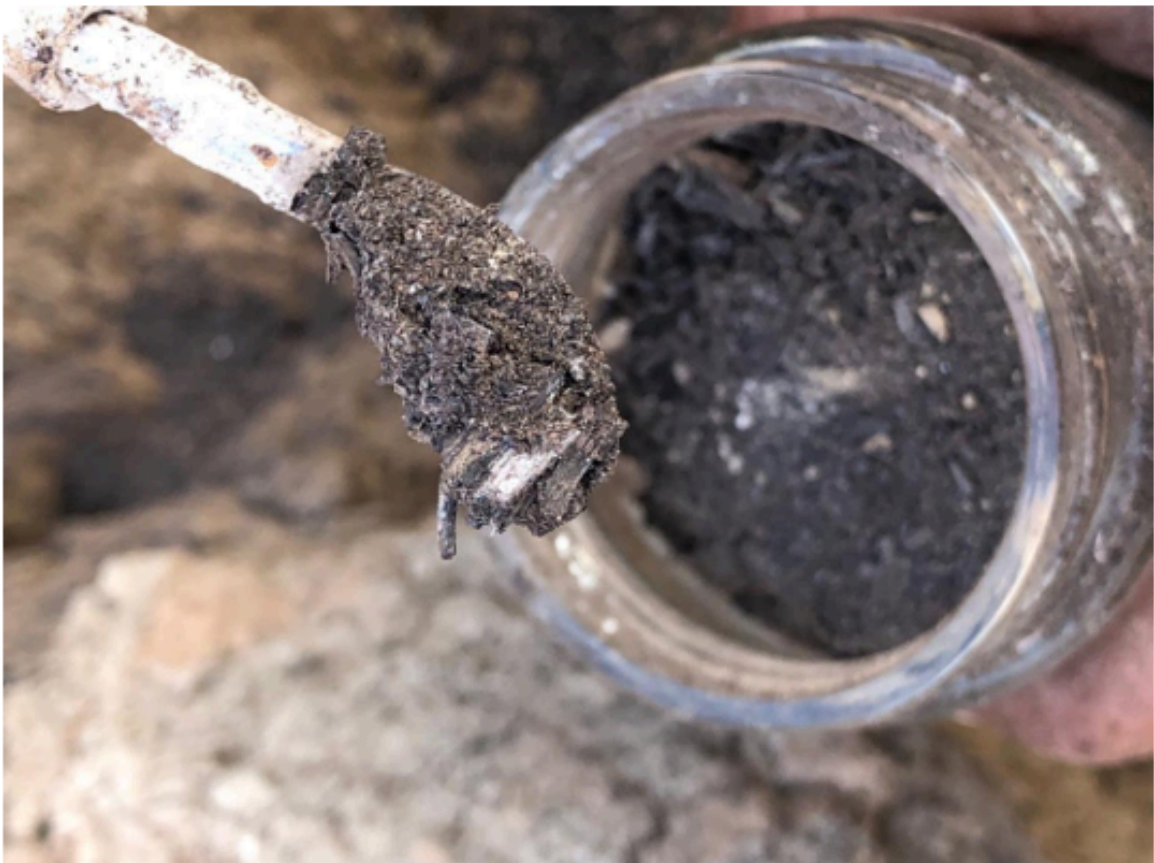
*Figure 5. Bitumen mix found in Ezida Temple. Credits: Maddalena Achenza*

Other materials such as lime and soil were sometimes added to bitumen to reduce its fluidity, as found in some ziggurats masonry such as Dorcoricalzo from the middle Babylonian era (c. 1595 – c. 1155 BC), and Borsippa. This type of mix has been used for the construction of walls made both with raw earth and fired bricks.<sup>8</sup> In Borsippa, layers of bitumen mixed with earth or sand have been found in many walls of the ziggurat (Fig. 6). Bitumen layers recur on walls every 5-7 bricks. The bitumen is easily recognizable because of the smell, still very strong and well identifiable. At Ninmakh Temple there are perfectly preserved layers of pure bitumen in between earthen bricks. The better-preserved ones are at the lower part of the wall facing the north entrance (Fig. 7). Here, at a height of 16 cm from the floor, two layers of bitumen about 2 cm thick are placed between earthen bricks. Many other walls built with earthen and fired bricks have been laid with bitumen in Babylon, confirming how common this practice has been through time.

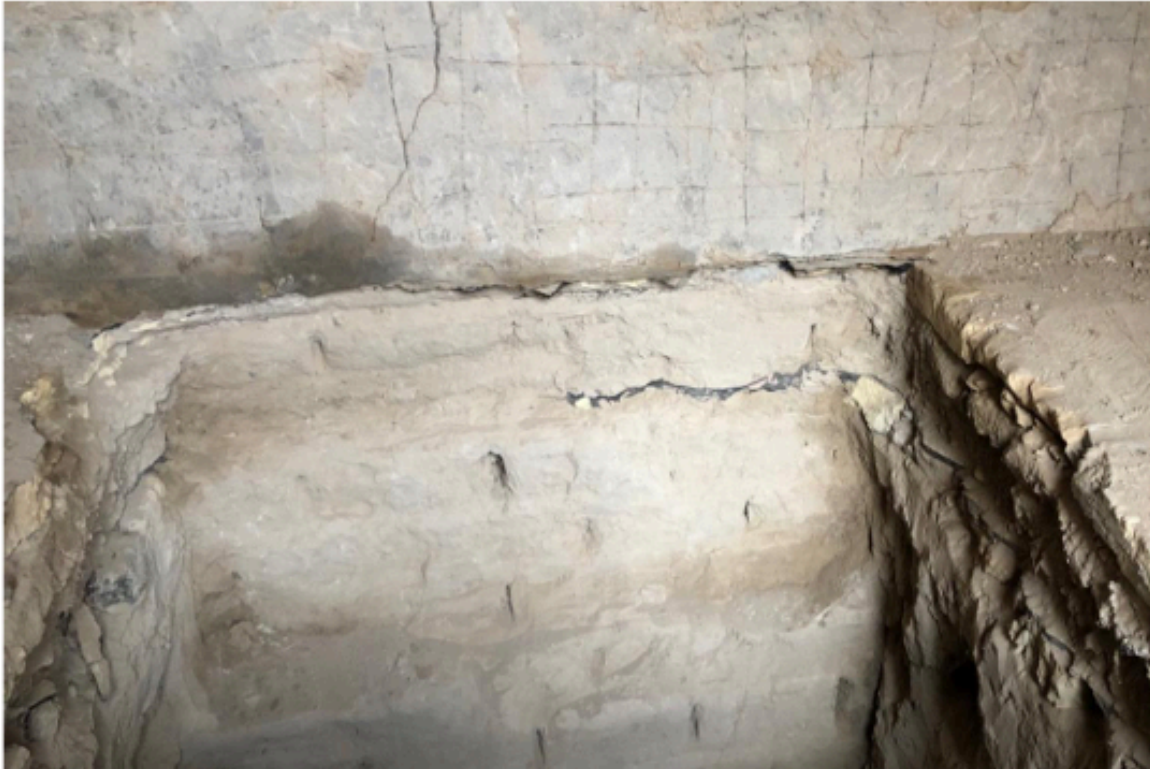
Figure 6. Layers of bitumen in earth masonry at the Ninmakh Temple in Babylon. Credits: M. Achenza

Sometimes fluid bitumen was applied on reed mats. Reed mats, as better explained in the following paragraph, were laid at regular intervals in the earthen masonry. Supposedly, bitumen served as further protection to a system that was evidently used as a barrier for moisture.

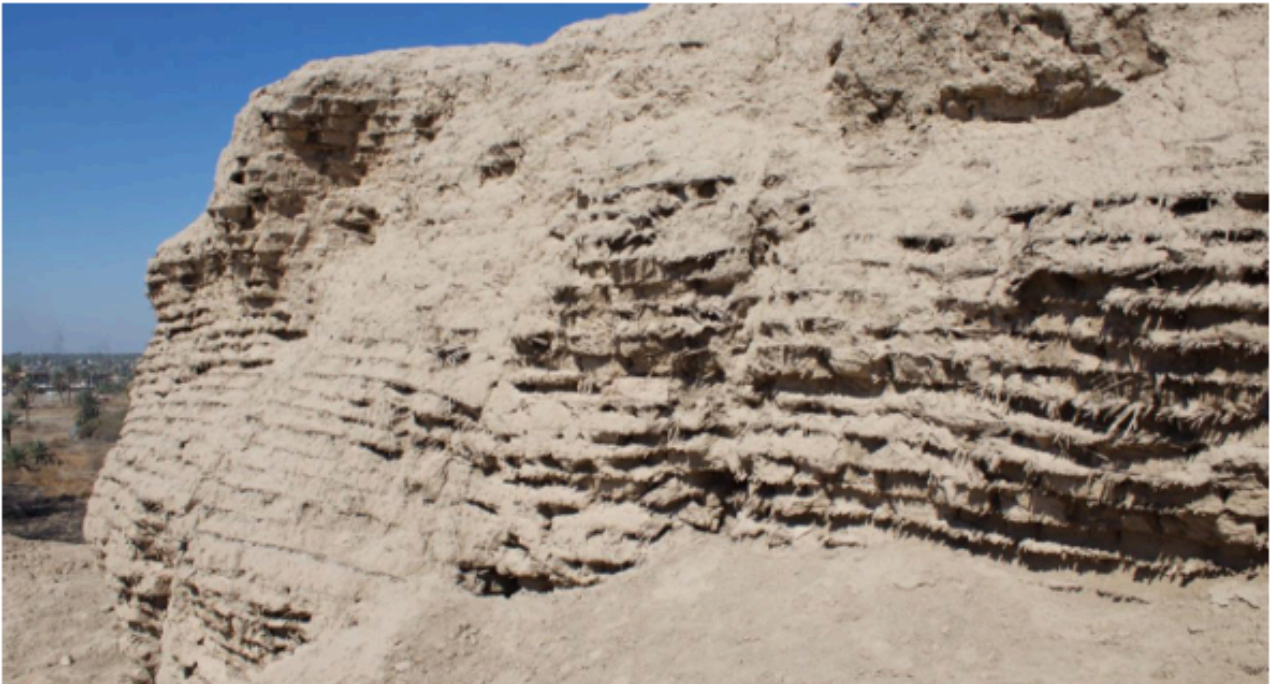
Mats were interposed in between earth-brick courses, in one or, most probably depending on the quantity of moisture present. They were interposed at 7-9 bricklayers or even more, as can still be observed at the Summer Palace in Babylon: *"on the north and south-west remains of walls of very considerable height are still standing, with courses of mud brick held together by layers of well-preserved reed stems. They date from a later period and may have belonged to a fort which was erected in Sassanide or Arabic times on the already ruined Babylonian building"*<sup>12</sup> (Fig. 8-9).

Figure 8. Summer Palace in Babylon. Credits: Maddalena Achenza

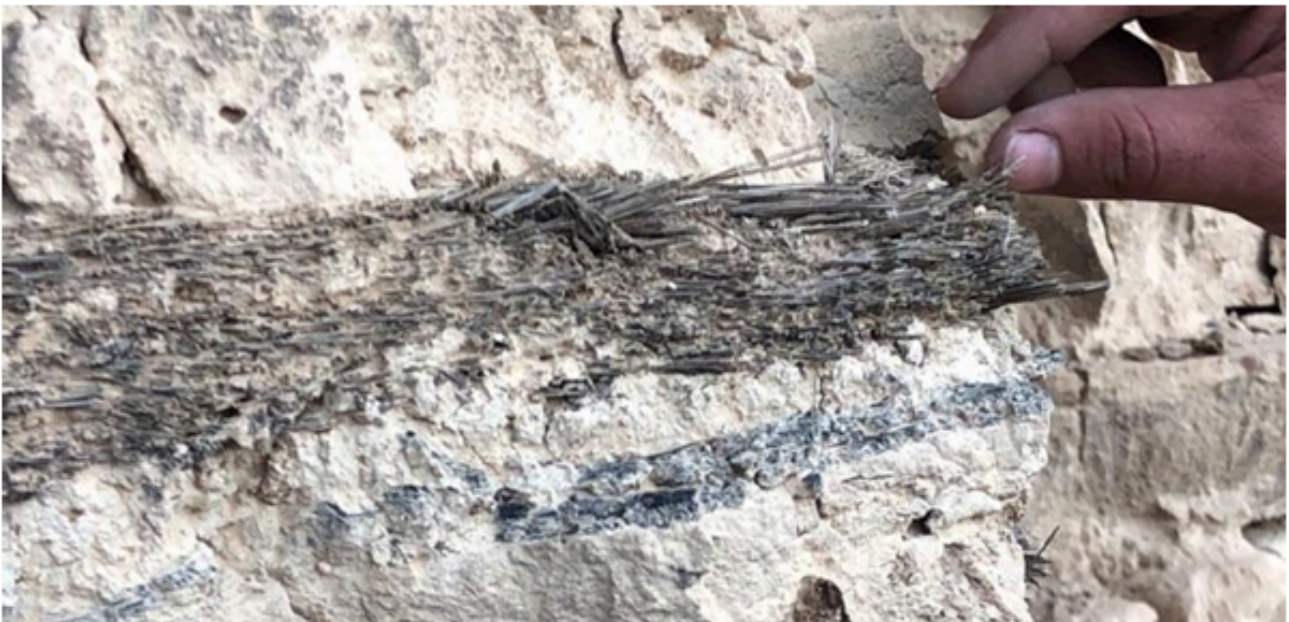
Figure 9. Borsippa: reed mats and bitumen layers in brick masonry. Credits: Ammar Al Taei

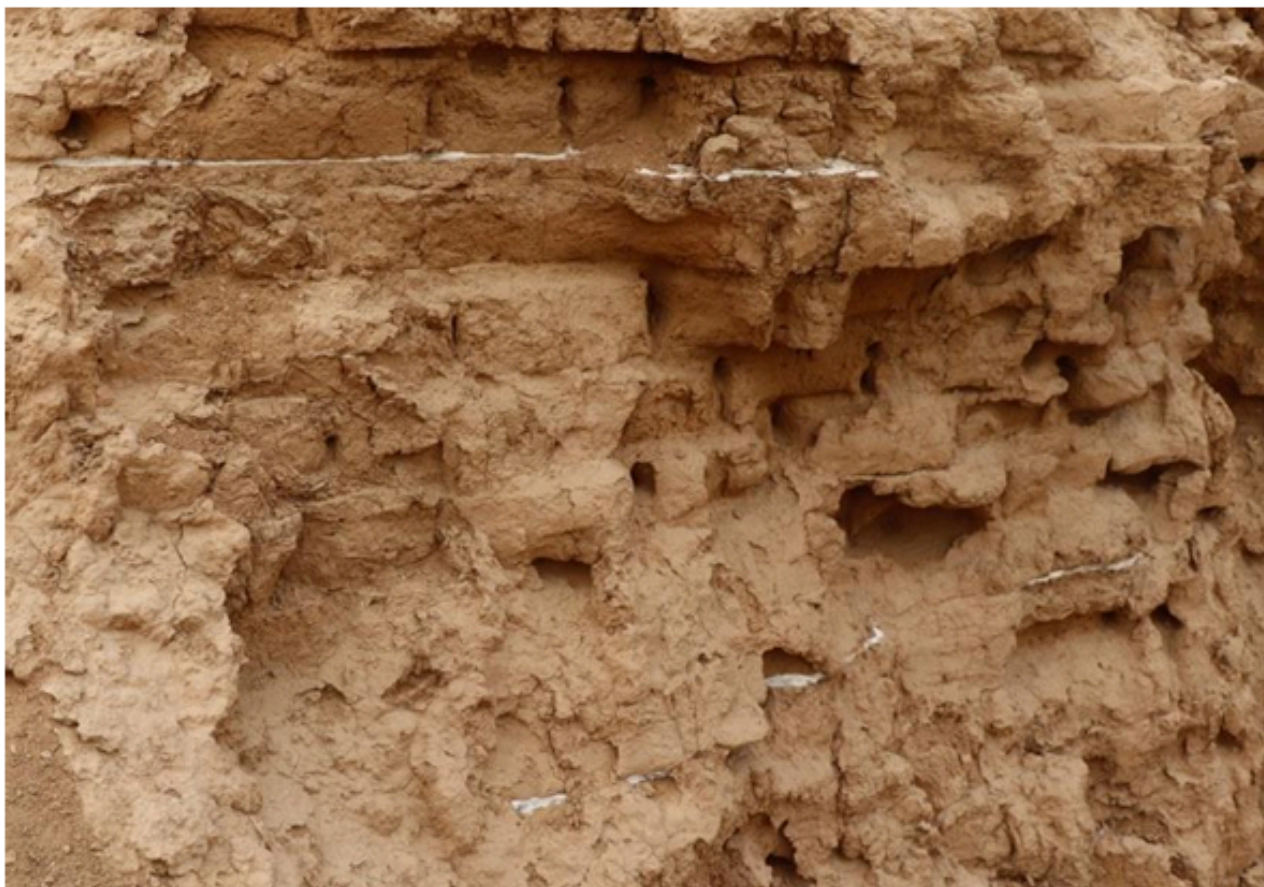
Transformed through time, these layers appear now often as a bright white layer. Their presence was reported already by Koldewey in his early excavations: "After every 9 or 10 layers, a cane or reed mat is inserted into the clay joint to protect the wall from vertical splitting. These inlays of mat, which have deteriorated to a white ash over time, are noticeable throughout the exterior of the walls as white horizontal lines" (Fig. 10).<sup>13</sup>

Figure 10. Borsippa: reed mats in earth masonry. Credits: Ammar Al Taeer

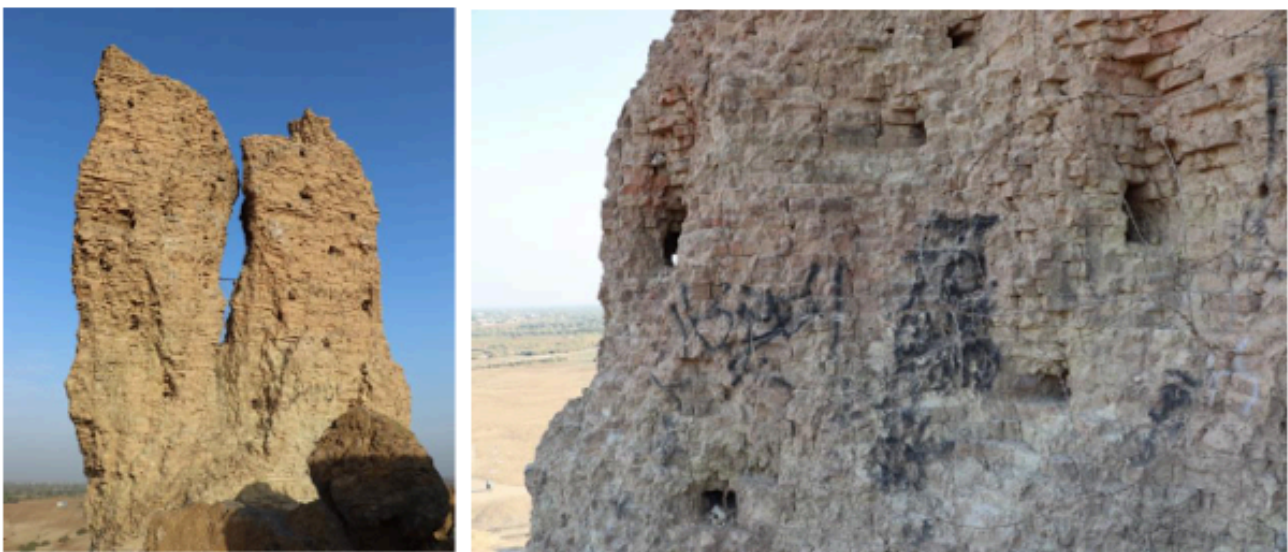
The remains of the ziggurat in Borsippa show an interesting system of conduits built in the masonry that looks like a well-thought arrangement to provide ventilation and thus, dryness to walls. The whole section of the walls is crossed by 18 X 18 cm straight conduits obtained through a specific bonding pattern. These conduits are positioned at a distance of about 2 m one from each other (Fig. 11).

These conduits are visible in all types of masonry used for the fabrication of the monument, made both with half-baked- and fired bricks, and are not coated on their sides. The direction of the conduits is crossed perpendicularly on the different heights of the walls and goes from one surface to the opposite one across the whole thickness of the walls, in a way that it is easily possible to look through.

Figure 11. Ventilation channels in brick masonry. Credits: Ammar Al Tae

W. Allinger Csollich<sup>14</sup> reports a quite detailed description of the fabric of this system, accompanying the design of each layer unearthed. He proposes many hypotheses for the function of these conduits, not coming to a definitive conclusion. Among these hypotheses is the possibility that they could have served as a mean to help the structure dry faster during construction, and to ventilate the core of the building. Something similar was also observed in the ziggurat of Ur where conduits with a similar pattern were also considered as ventilator ducts.

Even though little literature was found by the authors on this subject, and apparently no in-depth investigation has been undertaken recently on this topic so far, it remains difficult to attribute to these conduits a different function than ventilation, given that the ziggurat is a massively built object, with no rooms or empty spaces inside.

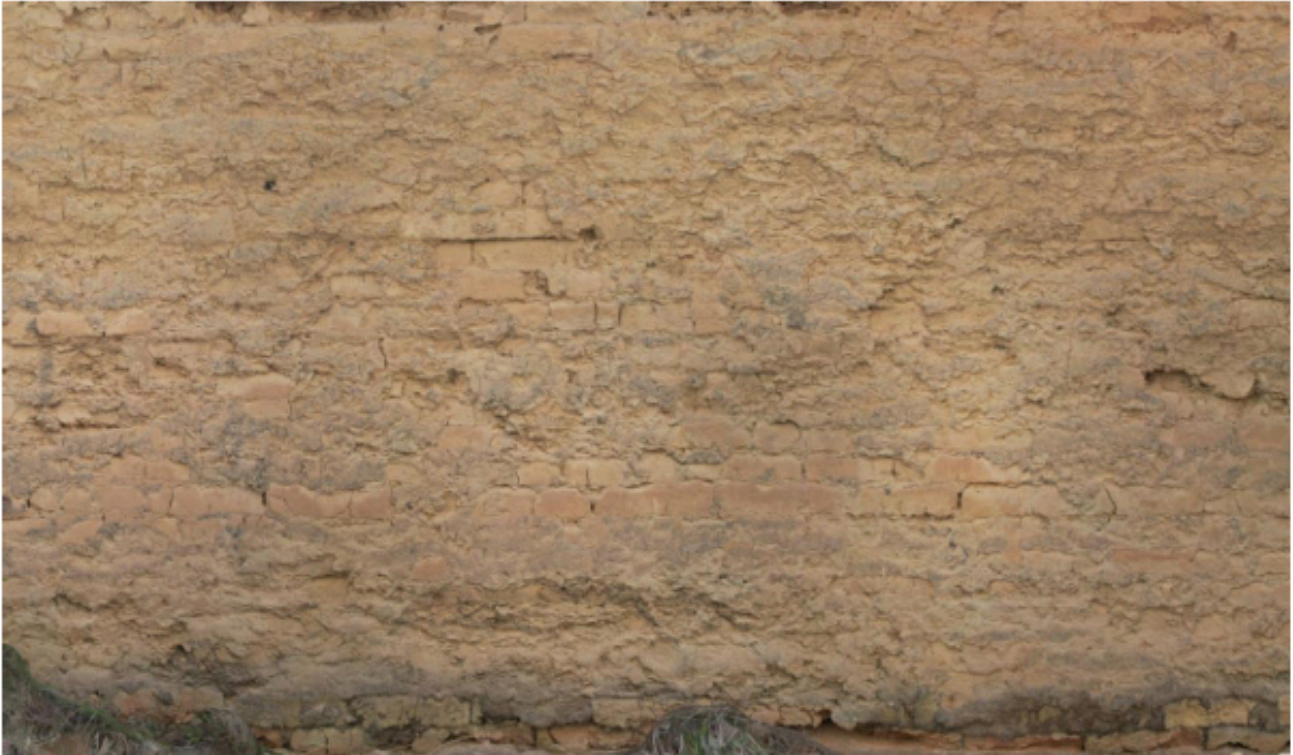
Fired brick walls were sometimes waterproofed with bitumen if exposed to weathering, as in open courtyards, or if in direct contact with water, such as for gutter canals<sup>15</sup>. Some bitumen plasters are still visible in many buildings, such as is the North Palace in Babylon. Here, a layer of this building material is observed, 1-2 cm thick.

Figure 7. Babylon, bitumen plaster on the South Palace. Credits: Ammar Al Taei
