**ATINER's Conference Paper Series
ARC2015-1848**

**Time and Material. Interdisciplinary Study
for Dating St. Francesco Convent in Cagliari
(XIII-XXI Century)**

**Caterina Giannattasio
Associate Professor
University of Cagliari
Italy**

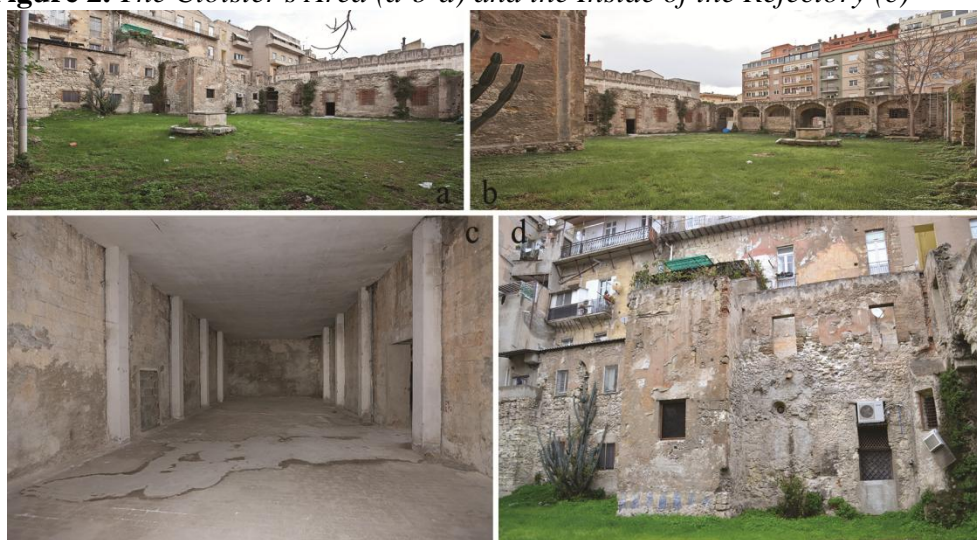
Figure 2. *The Cloister's Area (a-b-d) and the Inside of the Refectory (c)*

As we said before, because of the succession of many events, it is now in an advanced state of decay. It only retains the ground floors of the eastern, southern and western parts which define the cloister area (Figures 2a-b), and the west side, which originally housed the refectory (Figure 2c). The northern part is the only one that has kept its upper level (Figure 2d), although completely embedded in the newer buildings built in the late 19th century, consequent to the demolition of the church and the urban renewal of the area. Also, the southern part of the cloister is compromised, having been partially demolished in order to open a new street in the middle of the 20th century.

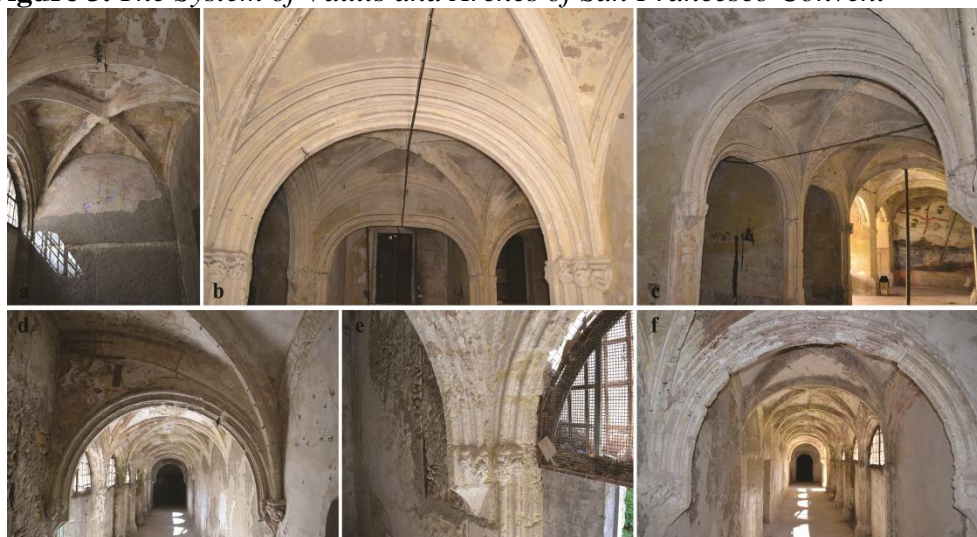
Figure 3. *The System of Vaults and Arches of San Francesco Convent*

The buildings that delimit the cloister on the north, south and west sides are characterized by a very simple decoration, with arches between the spans and crossed vaults with pendula (Figure 3a). The west side is connected with the former refectory.

The east side presents numerous anomalies in comparison with other sides, consisting of a double row of crossed vaults, with different characteristics in size and form. The two parts are connected by arches of different typologies (Figure 3b).

The buildings facing the cloister show a floor plan articulated in square modules (Figure 3c), with crossed vaults held up by finely decorated pillars and capitals (Figure 3d), with some variants, caused by the subsequent stratifications which clearly compromised the original homogeneity of the architectural complex.

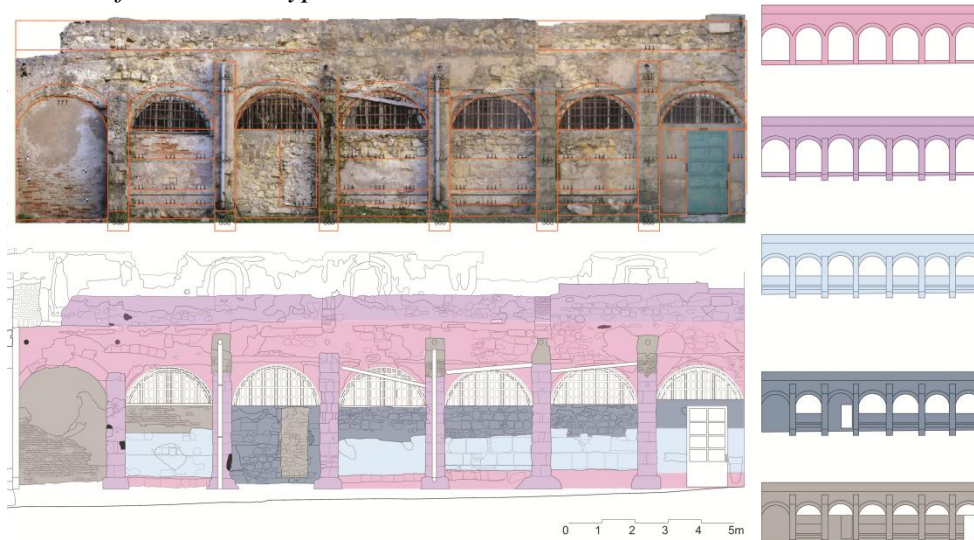
Figure 4. *The West Facade: Stratigraphic Analysis of the Structures, Dating and Transformations Hypothesis*

In detail, the stratigraphic method (Beltramo, S. 2009) was divided into three main phases: a) identification of stratigraphic units (masonry stratigraphic units - msu; surface stratigraphic units - ssu; negative stratigraphic units - nsu); b) definition of connections between the stratigraphic units in order to establish diachronic or synchronic relationships between the parts; c) construction of a relative chronology between the same units (Figures 4-5).

To the first phase, around the 15th-16th century, can be ascribed the external module of the eastern side of the cloister, and in particular the six quadrangular spans with crossed vaults and the rectangular space to the north and to the south. This hypothesis is supported by the fact that the spatial and stylistic features of the complex are similar to those found in the Dominican convent situated in the Villanova historic quarter of Cagliari. That was dated, on the basis of unpublished archive documents, at the same period. Also, the area used as a refectory seems to belong to this time, as confirmed by the wall typologies identified in its longer sides.

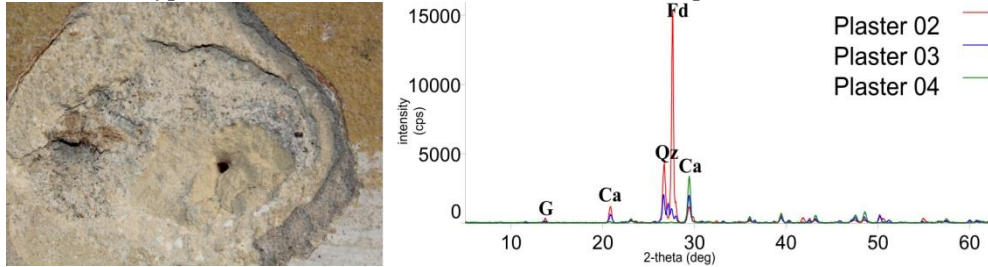
Figure 7. Sampling of the Different Types of Plaster Found in the East Side, Indoor. G: Gypsum; Ca: Calcite; Qz: Quartz; F: Feldspar

The optical study of the aggregates and binder composition shows two types of plaster (1:pl_02-03 and 2:pl_04). Both of them consist of sandy aggregates made with a few fossil and lithic calcareous fragments with single crystal quartz grains and feldspars (Figure 7). This composition, together with the granulometric and the morphometric characteristic of the aggregate grains is similar to those of the marine beach sand of the old city. The lime binder consists of micrite carbonates and sometimes shows a non-homogeneous texture due to the presence of lumps. A rim of reaction with formation of cryptocrystalline carbonate and gypsum is often present around aggregate grains.
