STRATIGRAPHY AND ANALYSIS OF INTERFACES FOR THE PRESERVATION OF ARCHITECTURAL HERITAGE

D.R. FIORINO

Department of Civil Environmental Engineering and Architecture (DICAAR), University of Cagliari, Italy.

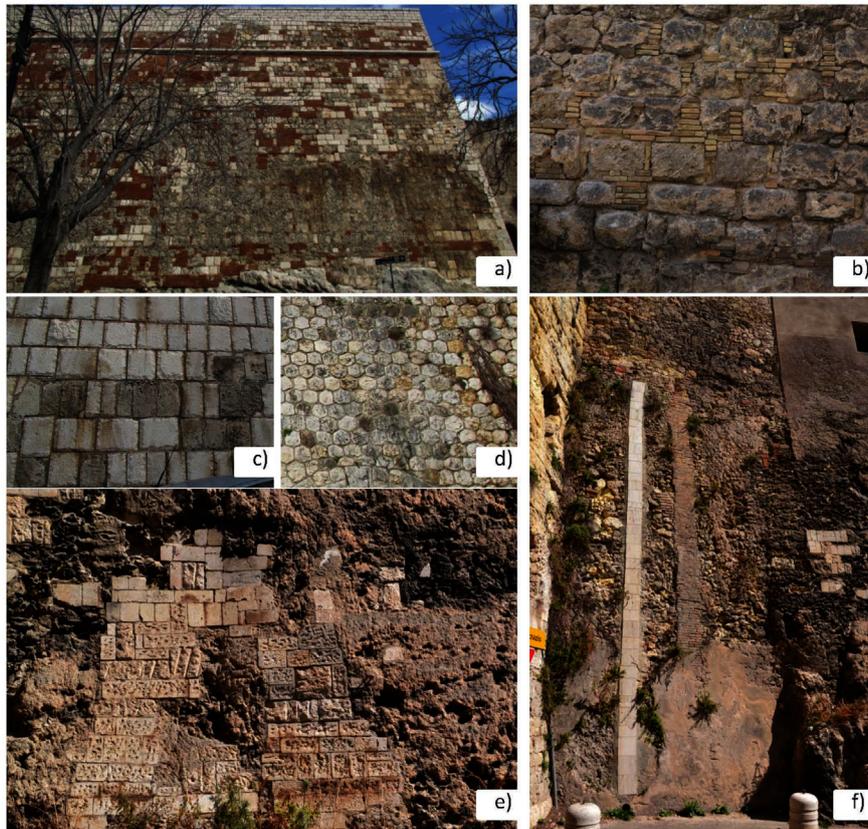
Figure 1: Different modes of integration of erosion gaps by using clay bricks as in picture (a) and (b), or by stone elements with different shapes as in picture (c) and (d), or with different surface treatments as in case (e), or with stones moulded as tiles as in case (f).

In the course of time, other solutions have been attempted, such as the introduction of other stone elements with similar geological properties, but with different surface treatments. The aim was that of making the additions distinguishable from the antique stones, but some solutions has strong impact of the perception of the old curtains, as it happens for the reparations made with stones moulded as tiles. Some samples are in Fig. 1.

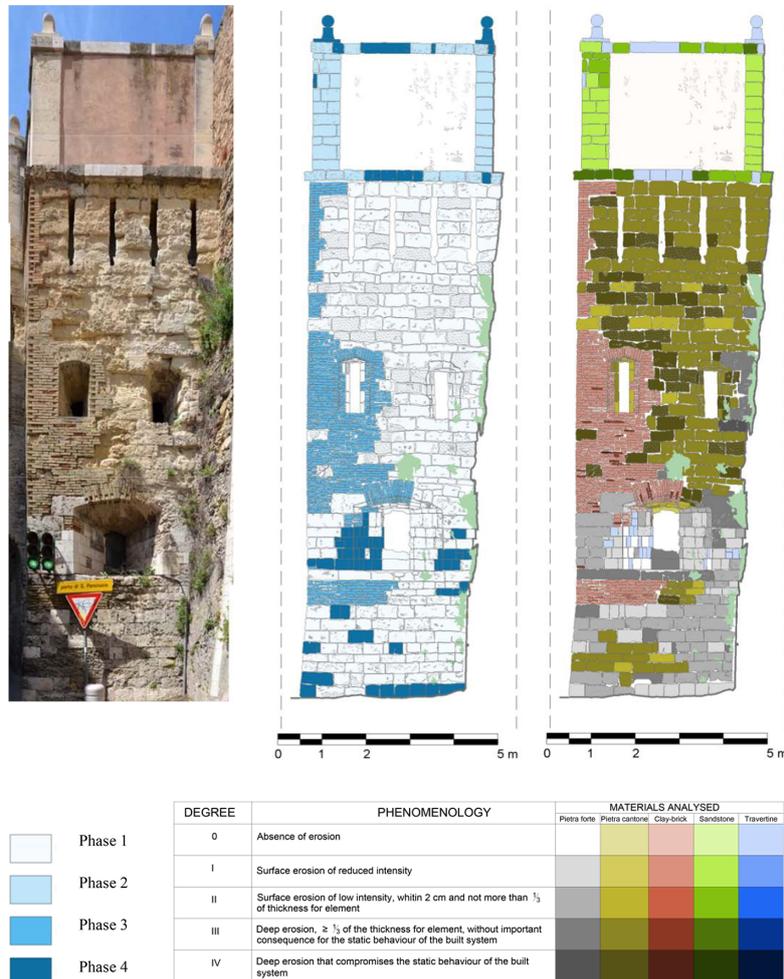
Figure 2: Cagliari, urban door called D'Altamira, study of the stratification and interfaces of integration owing to the erosion and definition of the current levels of erosion, preparatory to the restoration plan (drawing produced in the Integrated Course of Restoration and Building technology, Master Degree in Architecture, University of Cagliari, AA. 2012/2013, students A. Manca, D. Orrù, F. Farci and F. Savona).

However, the most significant analysis carried out on the monument was the definition of a scale for the evaluation of the erosion degrees; this scale has been tested on the different materials of the gate, as shown in Fig. 2.

This useful scale of values is able to classify the gaps created by the erosion accordingly to the depth of the lack and to the general state of risk brought about by it. In fact, the parameter designed by this research considers not only the level of erosion reached by each constructive element, analysed stone by stone, but also takes into account the possibility of a structural collapse of the outer layer due to the reduction of the bearing section of the wall, which this element belongs to.

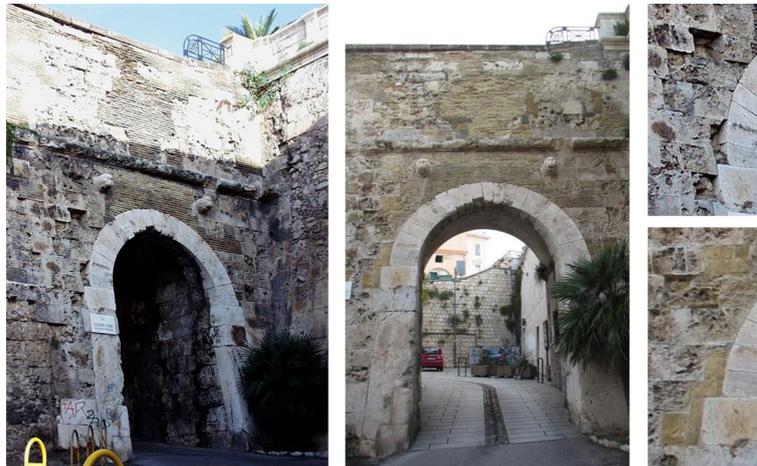
Figure 3: Cagliari, the Lion Gate before and after its restoration in 2007. The images show an interesting careful conservation of the stratifications and of the interfaces maintain the sequence of constructive events and the phases of restoration works clear even in the future. The integration in the areas of the greatest erosion was made by wedges in limestone from Segariu (CA).

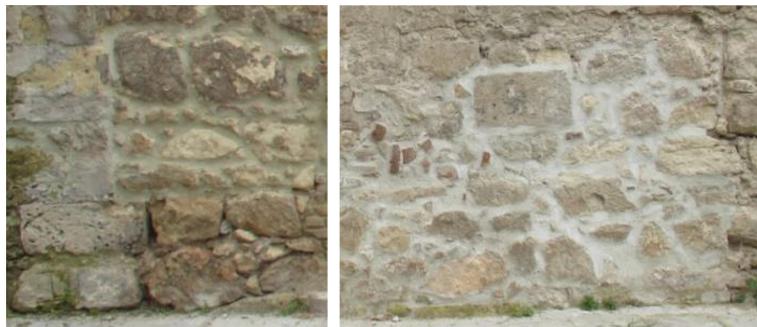
Figure 4: Integration of the gaps due to the erosion of the joints of mortar through the use of the same material but with a different colour.

The first thought regards the sealing of the joints. The use of the technique of the 'undercut' does not guarantee in itself an optimal result. Figure 4 shows, for example, how the choice of the colour of the mortar used for the joint sealing can notably modify the formal result of the integration.

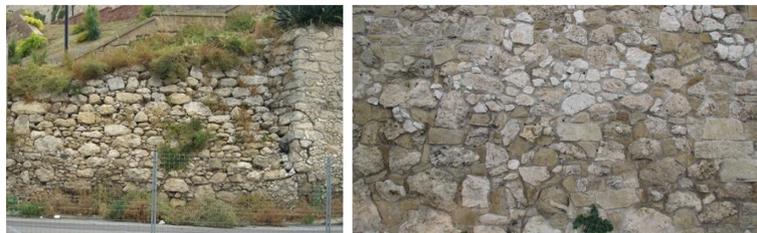
Figure 5: Cagliari, Cammino Nuovo bastions, the masonry before and after the integration of the gaps due to the erosion of the joints of mortar through the use of stones and wedges in limestone from Segariu (CA).

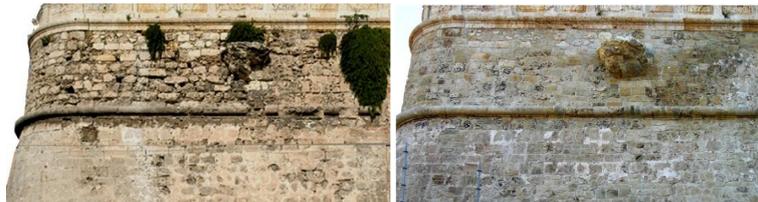
Figure 6: Cagliari, Bastione dello Sperone, the masonry before and after the integration of the gaps due to the erosion of the joints of mortar and the completion of the cornice through stones of different colour to assure the distinction of the new elements with respect to the old ones.

A good sample of respectful integration is illustrated in Fig. 6.

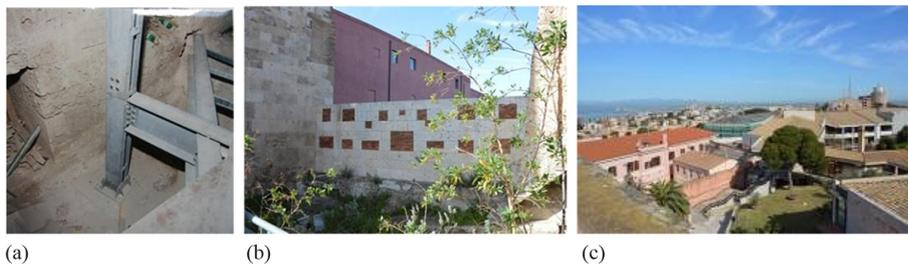
Figure 7: Technical, architectural and urban stratigraphic unit of integration added during the restoration works for the reuse of San Pancrazio site in Cagliari: (a) Dusay's stronghold, support of new structures in steel at the antique rocky basement by means of a slab (G. Tola); (b) San Pancrazio courtyard, new wall dressed with recognizable decorative element inspired in the integrative phase with bricks adopted to the rest of the antique wall portions (D. Scano); (c) Citadel of Museums as contemporary integration (P. Gazzola, L. Cecchini) about the area of the antique tenaille of San Pancrazio.

When the gap obtains architectural dimensions, as showed in Fig. 7, or when entire structures must be inserted, serious attention must be paid to the design of the integrated element, which must be recognizable as a contemporary stratification unit, as well as to the borders that rule the relationship between the new element and the antique material. Such attention must be placed both in the project phase with the executive definition of the interfaces, as well as in the construction phase, where precise operative regulations must be punctually be defined by the director of the worksite. Also demolitions, when necessary, must be treated as negative stratigraphic units, well described in documents, but also recognizable in the building.
