Seismic Reinforcement of a R.C. School Structure with Strength Irregularities throughout External Bracing Walls

Abstract: The effect of irregularities due to the non-uniform distribution of material properties on structural elements of a significant real case is here investigated. Mechanical tests performed on a typical Italian reinforced concrete (r.c.) school building built in the 1960s showed irregularity in the distribution of compression strength in columns, even though the construction is featured by substantially symmetric distribution of the frames. Extreme scenarios in the distribution of irregularities in compression strength of concrete columns are analyzed, with the hypothesis of rigid or deformable slabs. The seismic analysis showed the influence of the response due to the irregular distributions of concrete strength. A proposal of equivalent “material eccentricity” is shown to account for the mentioned irregularity. Furthermore, the practical solution of reinforcement to mitigate the effects of irregularities is also described. It consists of couple of external r.c. walls stiffened by r.c. buttresses added to the building, connected by transverse slabs. An extensive

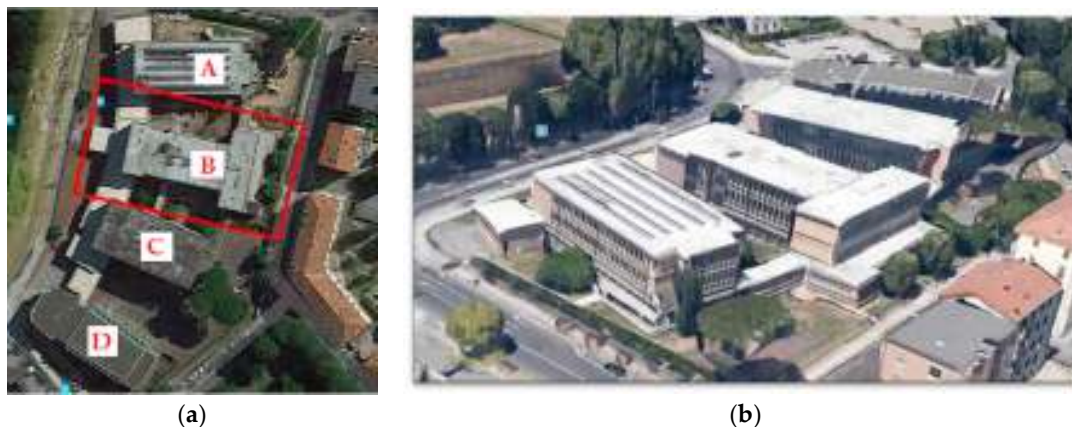
Figure 1. Plan (a) and aerial view (b) of the School Complex I.T.C. F. Carrara (Lucca–Italy).

An example based on an existing r.c. building is illustrated. The school building “I.T.C. Carrara” is a complex from the early 1960s, located in Lucca (Italy) (Figures 1–3). It consists of four isolated buildings labeled A, B, C, and D, weakly joined to a one-floor structure. The pavilion B (Figure 2) is formed by three levels and a basement on an extension of about 1000 m²/level. A large number of thin r.c. columns, together with a set of short columns at the top of the ground floor (Figure 3) are seismically vulnerable. Original drawings are available (Figures 4–6). Poor quality of the concrete is another relevant and emblematic aspect of seismic vulnerability of the building. In this sense, the considered example represents a typical situation of r.c. constructions that must be urgently enforced.

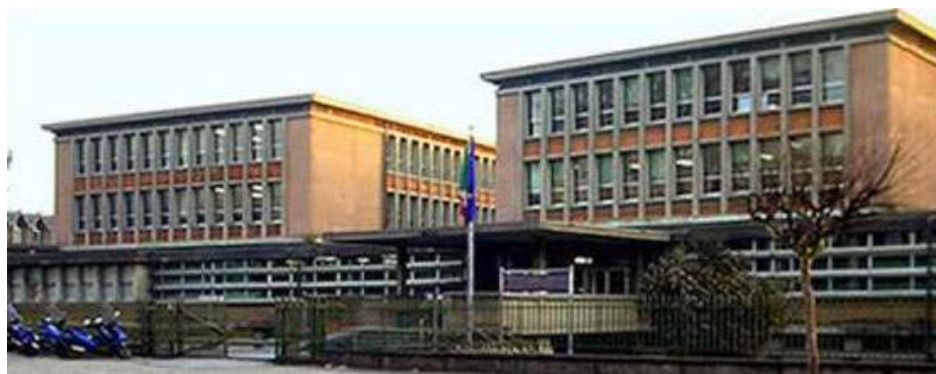
Figure 2. View of the B pavilion (right) and C pavilion (left).

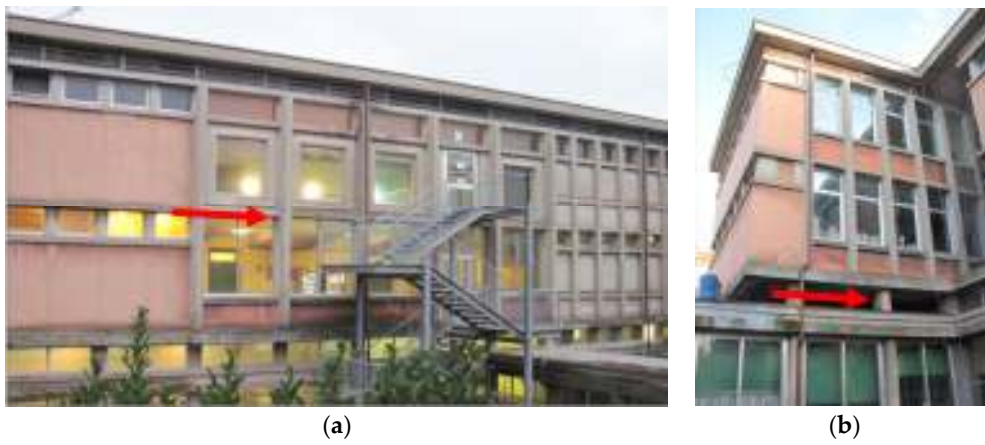
Figure 3. Details of seismic vulnerability: (a) slender columns close to a double height spacing; (b) squat element (brittle shear force) in r.c. columns.

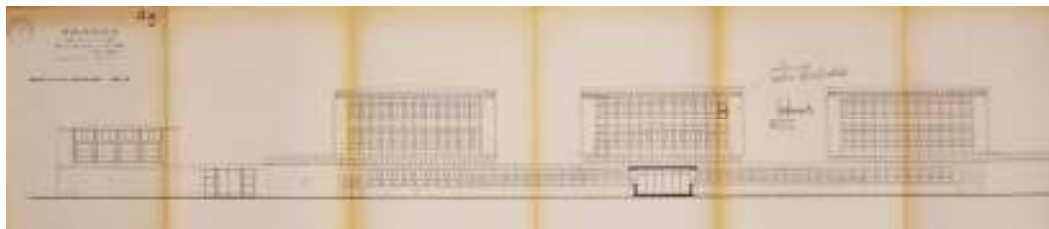
Figure 4. Original drawing of the complex—Frontal view.

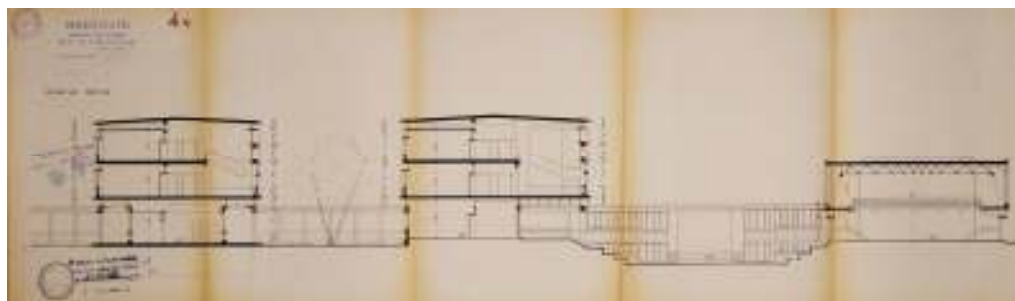
Figure 5. Original drawing of the complex: vertical section.

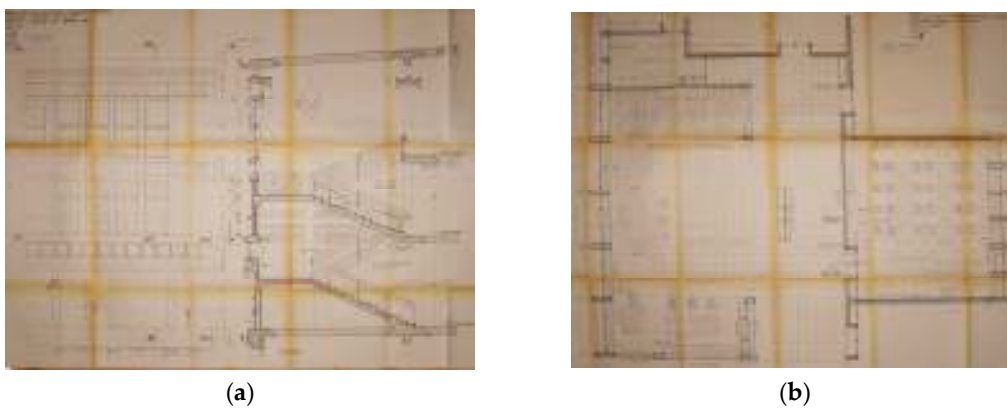
Figure 6. Original drawing of the B pavilion: (a) vertical section; (b) plan view.

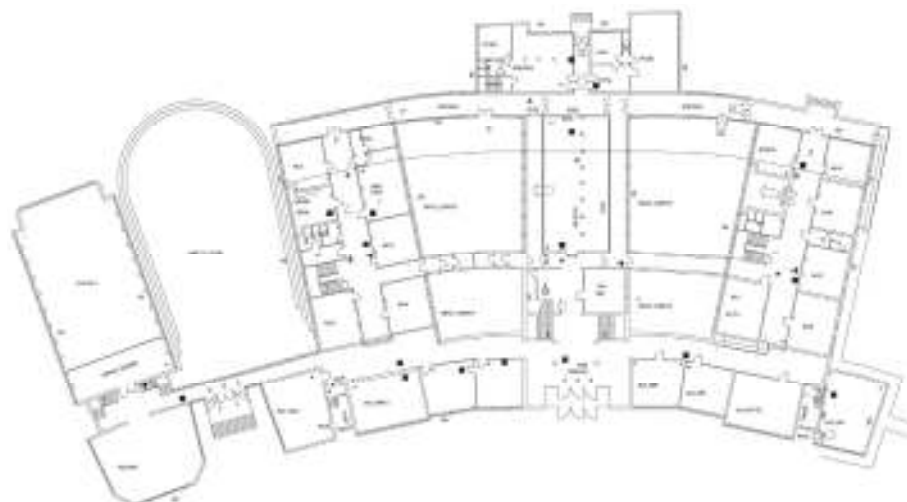
Figure 8. Ground floorplan of the complex.

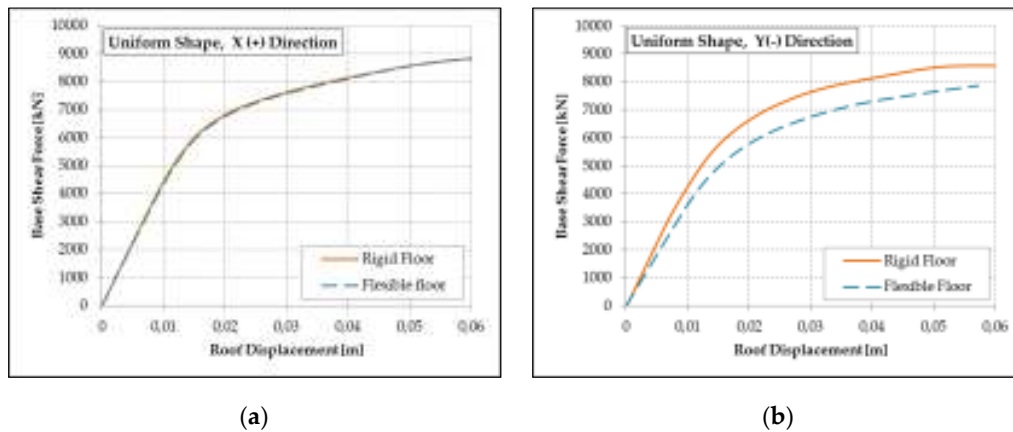
Figure 9. Pushover capacity curves in X (a) and Y (b) direction, with “uniform” pattern load distribution.

From the capacity curve obtained by push-over analysis (Figure 9), the frames appeared sensible to the floor flexibility, particularly along the Y direction.

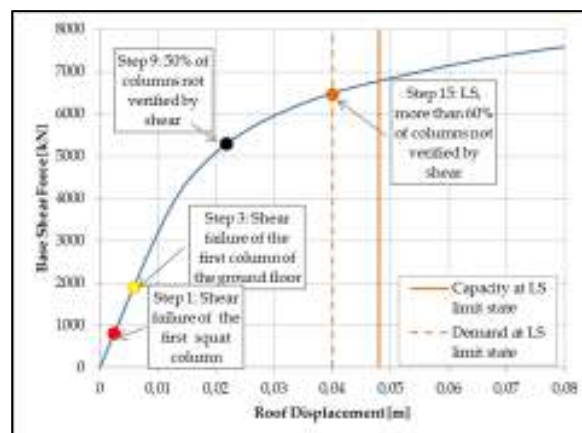
Figure 10. Capacity curve X direction from “modal” pattern of load distribution—rigid slab.

As expected, the brittle mechanisms were more dangerous than the ductile ones, taking place for lower displacements (Figure 10). More in detail, the collapse of the structure started with a shear failure of the squat columns along the building perimeter between first and second floor, followed by a shear failure of the ground floor columns.

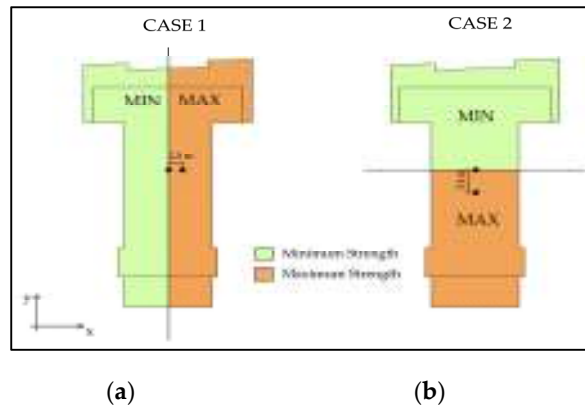
Figure 11. Extreme distributions of material irregularity: (a) CASE 1 (X direction); (b) CASE 2 (Y direction).

Values of maximum and minimum concrete compression strength, as defined before, were assigned to the structural elements (beams and columns) with two extreme distributions in plan

(Figure 11), considering both models (rigid and flexible slabs). The capacity curves—given by push-over analysis in both X and Y directions—showed the structure as more sensitive to the variation of the concrete strength in the model with flexible floors—particularly in the Y direction (Figures 12 and 13). The mode shape distributions of the equivalent seismic transverse loads systematically furnished a more severe result with respect to the uniformly shaped ones. To compare the different cases, the compression-bending strength of the ground floor pillars was chosen as collapse mechanism.

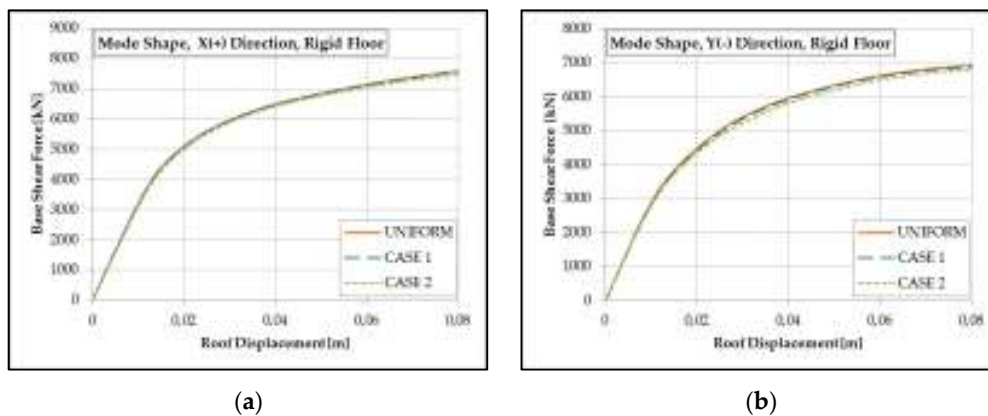
Figure 12. Capacity curves: (a) X direction; (b) Y direction with “mode shape” load—rigid floor.

The assumption of rigid slab has made unessential any material asymmetry assumed (Figure 12). It can be noticed that in this case, the displacement of the control point is related to the average value of the assigned concrete strength. The average concrete strength does not differ significantly from the average value assumed for uniform distribution assumed in non-linear static analysis. The capacity curves of Figure 12 are emblematic in this sense. On the contrary, in the model with flexible slabs (Figure 13) sensible differences occurred, mainly for irregular distributions along the Y direction. It was also testified by the higher number of columns allowing the failure limit, compared with the uniform distribution of strength, as in the histograms of Figure 14.

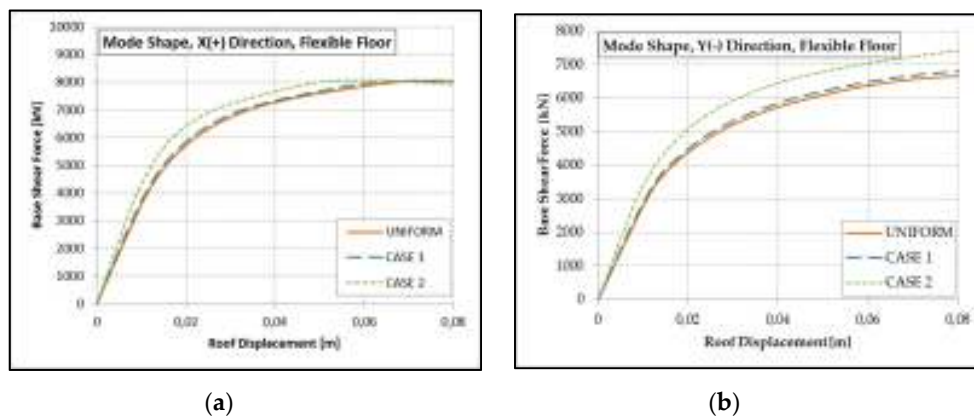
Figure 13. Capacity curves: (a) X direction; (b) Y direction with “mode shape” load—flexible floor.

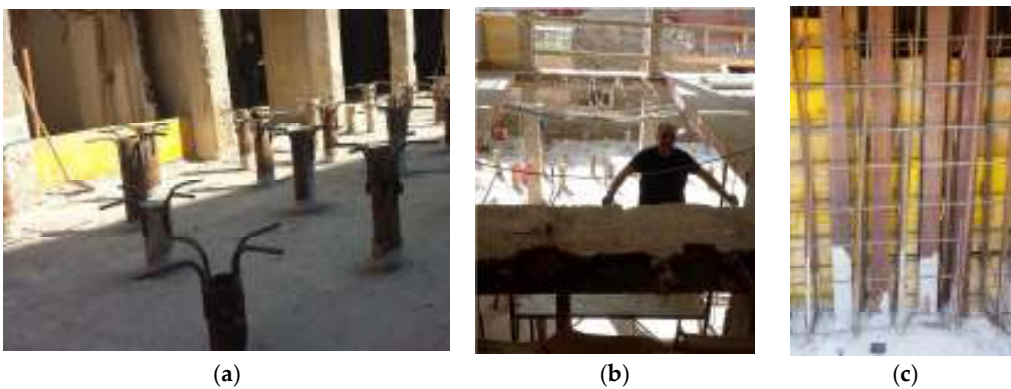
Figure 17. Phases of the intervention in A pavilion: (a) Micropiles anchoring, before casting of the concrete foundation; (b) Demolition of the slab to ensure the connectivity of the opposing bracing walls; (c) Insertion of the steel reinforcing with profiles HEB100.

The pavilions in this study are under seismic reinforcement. The images provided are of the A pavilion. The intervention consists of the insertion of couple of symmetrical opposed r.c. bracing walls, stiffened by transverse r.c. buttresses, able to absorb the majority (more than 85%) of the design seismic action. Their positions correspond to the inner stairs and the toilets, with the aim of minimizing the impact on classrooms. These bracing systems are appropriately connected to the building: each portion of slab between the opposed walls is demolished and reconstructed through new r.c. plates well connected to walls. The r.c. bracing walls are also supported by a series of micropiles (Figures 16 and 17). The bracings are calculated to absorb the entire amount of the design seismic actions (Figure 18), achieving after retrofitting an index of seismic risk (IR) greater than one. The r.c. walls are also able to perform a stiffness more than ten times the global stiffness of the existing r.c. frames. The quality and uniformity of the concrete used on the new r.c. walls are strongly controlled. In this sense, the effect of material irregularity is then neglected. The geometrical disposition of the bracing system is based on centering of the center of strength, decreasing the eccentricity due to the dispersion of the concrete strength. The architectural effect of the refurbishment is in Figure 19, where the r.c. bracing walls are also aesthetically harmonized with the new façades.

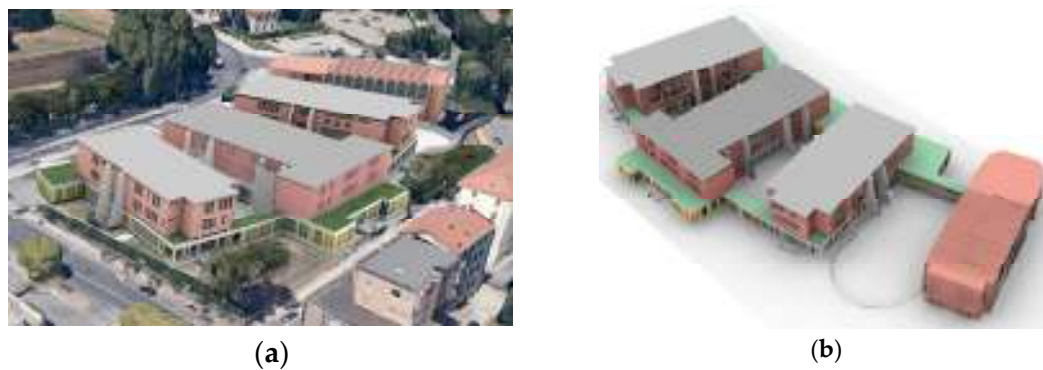
Figure 19. Rendering views of the school from (a) south-east; (b) north-west.
