Sealing of paving stone joints

Mauro Coni*, Silvia Portas, Francesca Maltinti, Francesco Pinna

DICAAR, Department of Civil Engineering, Environment and Architecture, Faculty of Engineering, University of Cagliari, Via Marengo 2, 09123 Cagliari, Italy

Abstract

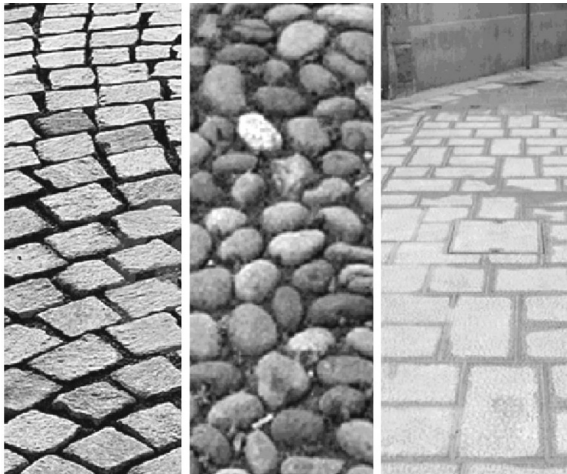
Fig. 1. Different types of stone pavements: sett, cobblestone, flagstones.

Different types of stone pavements are widespread in historic areas, and there are increasing amounts of new construction and requalification (Fig. 1). Paving blocks can be made of a variety of materials to satisfy functional and esthetic quality standards [1–3].

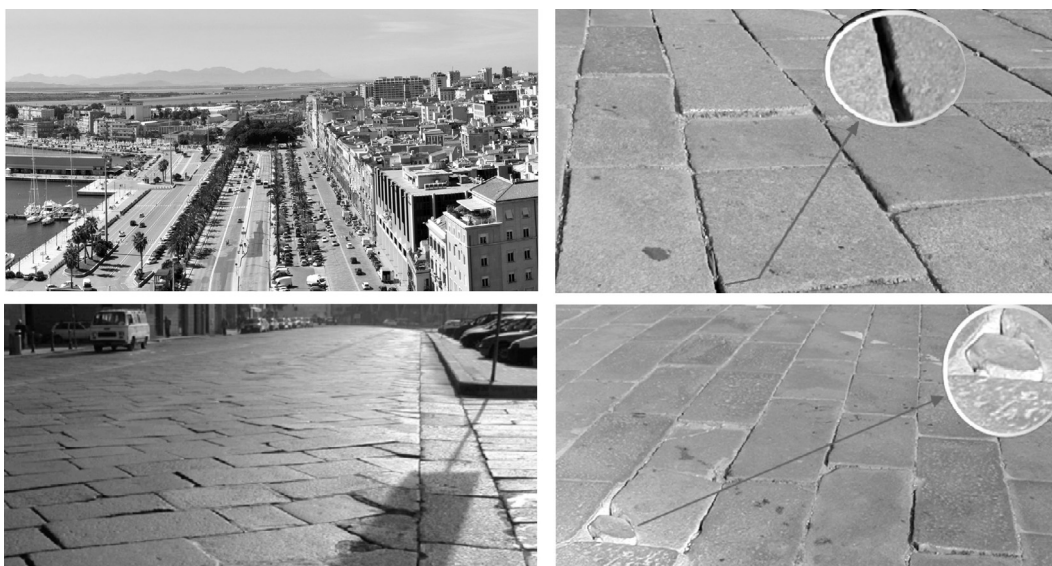
Fig. 2. The flagstone pavement on the Cagliari waterfront and typical distress.

The stone pavement in the historic waterfront of the city of Cagliari is frequently subjected to maintenance to restore disconnections between stones due to joint weakness (Fig. 2). The pavement is composed of blocks of granite squared in irregular prisms with maximum dimensions of $40 \times 80 \times 19$ cm. The elements are set in a herringbone pattern with regular plots and characterize the valuable areas of many historic towns and villages in Italy. A gran-

The flagstone pavement of the Cagliari waterfront (Fig. 2, top left) was built in 1870, and it is currently protected as a monument and landscaped site. The street is one of the primary connections between the western and eastern parts of the metropolitan area, with 1800 vehicles/h in peak hours, 25% of which is heavy vehicles, mainly urban buses. The traffic creates frequent disconnections requiring maintenance activity. A critical event occurred in 2014. The fast passage of a bus dragged some of the

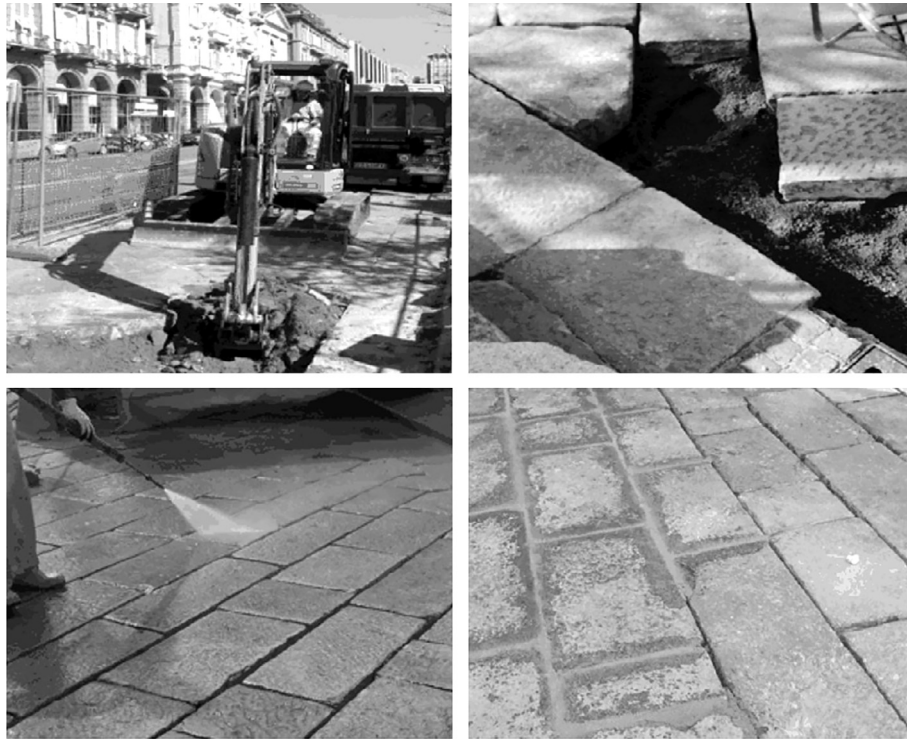
Fig. 5. Removal of the cement-sand deteriorated layer, cleaning, and joint sealing.

The dirty surface of the stone elements can affect adhesion of joint-sealing material. Thus, the flagstones are cleaned first removing mechanically cement-sand attached material and, just before the application, with high-pressure jet water (Fig. 5). A new technique to seal joints using epoxy resins was tested in the right lane (4.50 m width, 500 m length).

A proper bearing capacity value, with average M_d of 102.4 MPa, was found during the survey. Therefore, attention was focused on the underlying material and sealing joints. The implemented technique involved the following steps: (1) catalog and displace the flagstones; (2) remove the cement-sand deteriorated layer; (3) add new sand-cemented material and a metal mesh; (4) reposition the pre-existing flagstones, and (5) seal with the epoxy material (Fig. 5). Historical and Monumental Protection Authority supervised all phases of the pavement restoration.

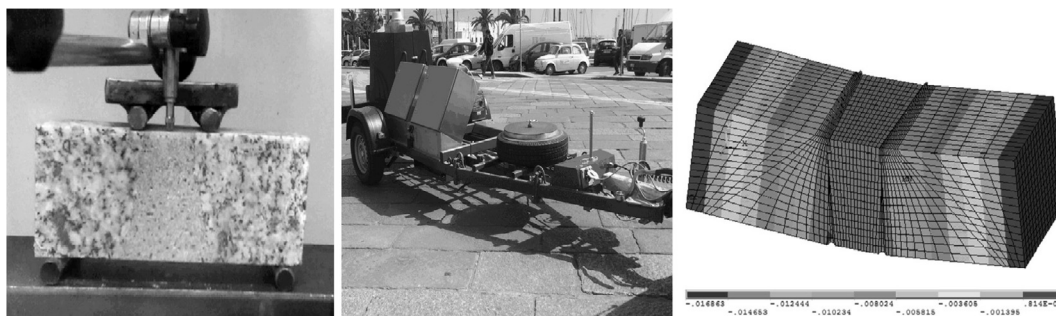
Fig. 7. (a) 4 point bending tests (4PBT); (b) FastFWD tests; (c) FEM simulations.

The study aimed to evaluate the structural capacity of the joints and to estimate the improvements of the stress and strain fields. Eight prismatic specimens at the joint were subjected to repeated cycles of the four-point bending test (4PBT). The new pavement was tested with 42 deflectometric drops performed with the FastFWD at three stress levels to evaluate the ability of a deflection basin with a specific geophonic configuration to return the load transfer efficiency (LTE) between adjacent elements. Finally, a series of FE simulations of the 4PBTs and the 2D pavement section subjected to the FWD dynamic load were conducted (Fig. 7).

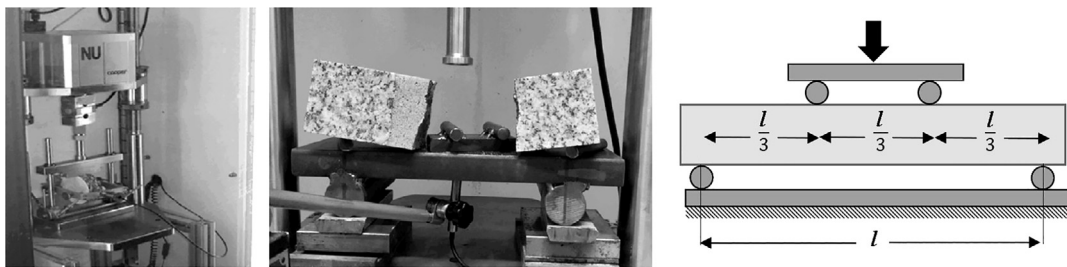
Fig. 8. Adapted NAT equipment, fatigue breakage and 4PBT scheme.

The origin of joint degradation is fatigue phenomena induced by the repetition of loads. Fatigue investigation was conducted via 4PBTs using prismatic specimens (137 × 42 × 42 mm) sawn from two adjacent pavement blocks glued together with epoxy resin. The 4PBT frame was designed to reproduce the beam pattern: two lateral supports and two forces applied symmetrically at L/3 beam length (39 mm). A Nottingham Asphalt Tester (NAT) was used for the fatigue analysis, and a load transfer system and Linear Variable Differential Transformer (LVDT) sensors were used to measure the stress and horizontal and vertical deformation. The NAT is designed for cylindrical specimens of diametrically loaded bituminous conglomerate; thus, to connect the frame to the testing machine, special pieces were manufactured to fit the actuator and reaction plate. Furthermore, a 4PBT rig permits to measure the vertical movement at the neutral axis of the specimen (Fig. 8). The 4PBTs, set in strain control, allow measuring the deflection of the central part of the specimen at a specific strain level, and calculating σ_t and ϵ_t using the following equations:

Fatigue tests were performed on five prismatic specimens with a nominal tensile stress of 1.67 MPa applied to the specimen. Granite flagstone samples were cut, sealed with resin, squared and rectified in the laboratory. The same process was not possible on joints sealed with sand-cement mortar because the cutting and preparation operations destroyed the samples, demonstrating the low adhesive capacity and fragility of joints made with sand-cement mortar.

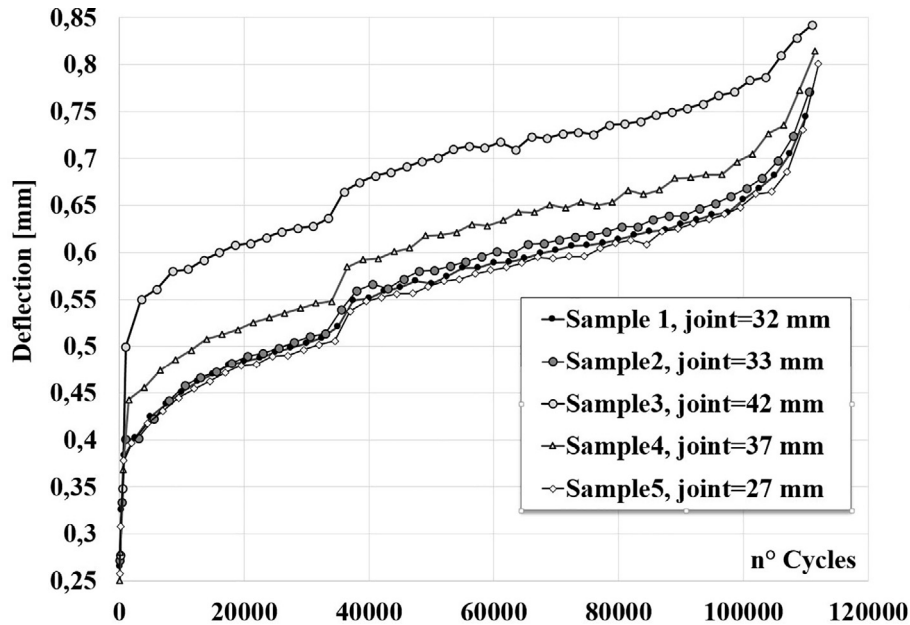
Fig. 9. Results of the four-point bending fatigue tests.

The tests performed on the resin joint specimens showed 3 phases (Fig. 9). After the first linear phase (<5000 cycles), the deflections progressed at a decreasing rate. Afterward, the curves evolved linearly up to 100,000 cycles.

An exponential trend was observed before collapse (approximately 112,000 cycles for all specimens). The specimens have a joint thickness ranging from 27 mm to 42 mm. The imposed stress produced a 0.28 mm maximum deflection, which was stable for the first 100 cycles for all specimens. Narrow joints exhibited smaller permanent deformation ϵ_{up} , which grew as a function of joint thickness and the number of cycles, reaching similar values in all cases at collapse. The number of cycles at collapse was the same for different joint thicknesses, while different behavior appeared starting in the first phase.

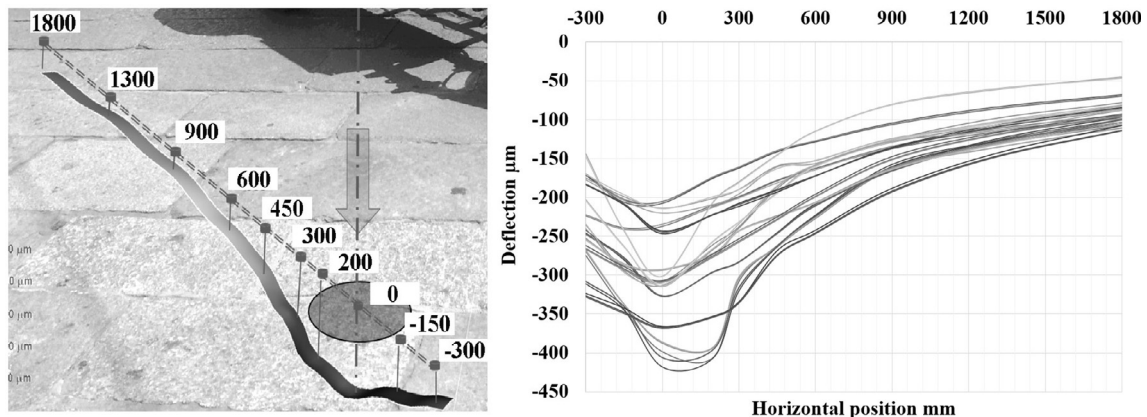
Fig. 10. FWD transducer configuration and deflection basin envelope for the 42 drops.

Direct tests estimated the elastic modulus of the subgrade the elastic modulus of the subgrade on undisturbed samples taken at different depths of up to 8 m. The mean value was 22 MPa. Fig. 10 shows the geophone configura-

tions and the deflection basins. Forty-two FastFWD tests (one every 40 m) were performed.

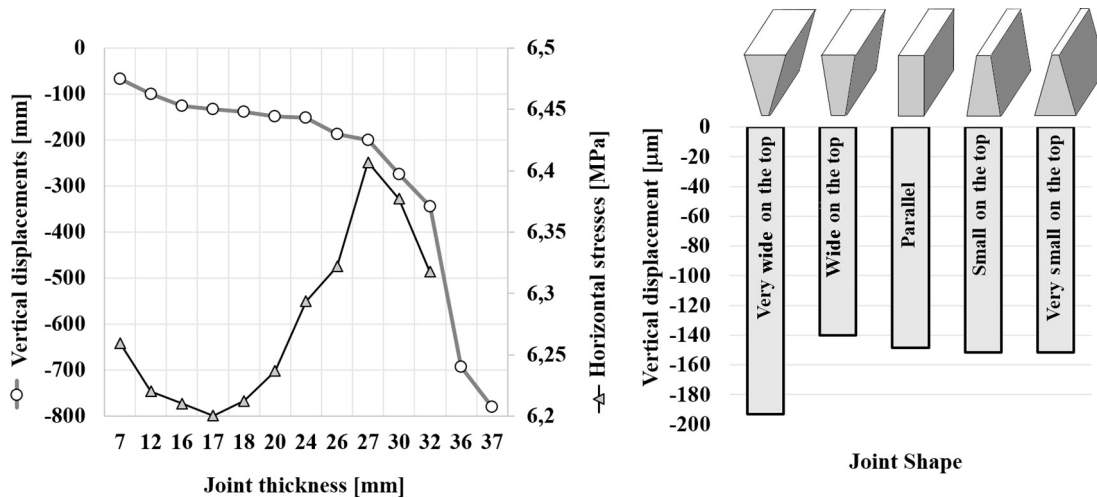
Fig. 13. Vertical deflection and horizontal stress vs. thickness and joint shape.

The 4PBT 3D FE simulations included different joint sizes (7–37 mm) and shapes (wide or narrow on the top, very wide or very narrow on the top, vertical sides). In the vertical and parallel joints, the simulated deflections grew linearly with thickness up to 26 mm and became exponential at higher values, as shown in Fig. 13. The figure also shows the trend of the horizontal stress, which exhibited small changes as the joint thickness increased.

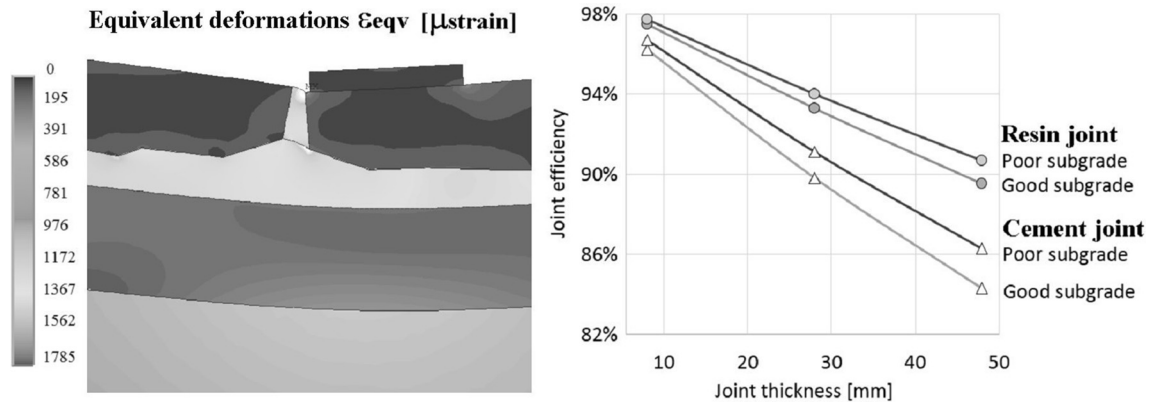
Fig. 16. Equivalent deformation distribution and LTE vs. joint thickness and subgrade stiffness.

the resin joint size was increased from 8 mm to 48 mm. Smaller variation, ranging from 97.7% to 90.7%, resulted in a poor subgrade (Figs. 16 and 17). With sand-cement joint sealing, LTE ranged from 96.2% to 84.3% on a good
