1 **Landslide analysis of historical urban walls:**
2 **the case study of Volterra.**

3 M.L. Puppio⁽¹⁾, E. Vagaggini⁽²⁾, L. Giresini⁽³⁾, M. Sassu⁽⁴⁾

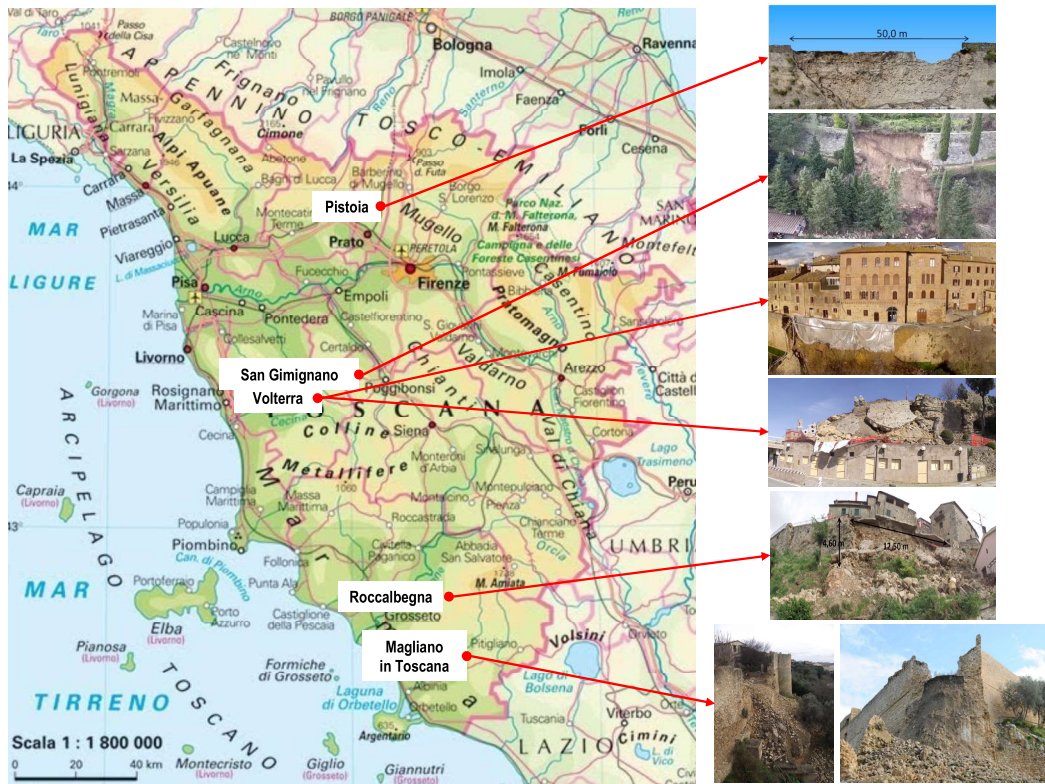
Fig. 1 – Failure cases analysed in Tuscany (adapted from Puppino et al., 2019).

63 Tuscany Region (Italy) was affected in the last ten years by several collapses of historical urban walls:
64 seven examples on five different locations are summarized in Fig.1 and Tab.1.

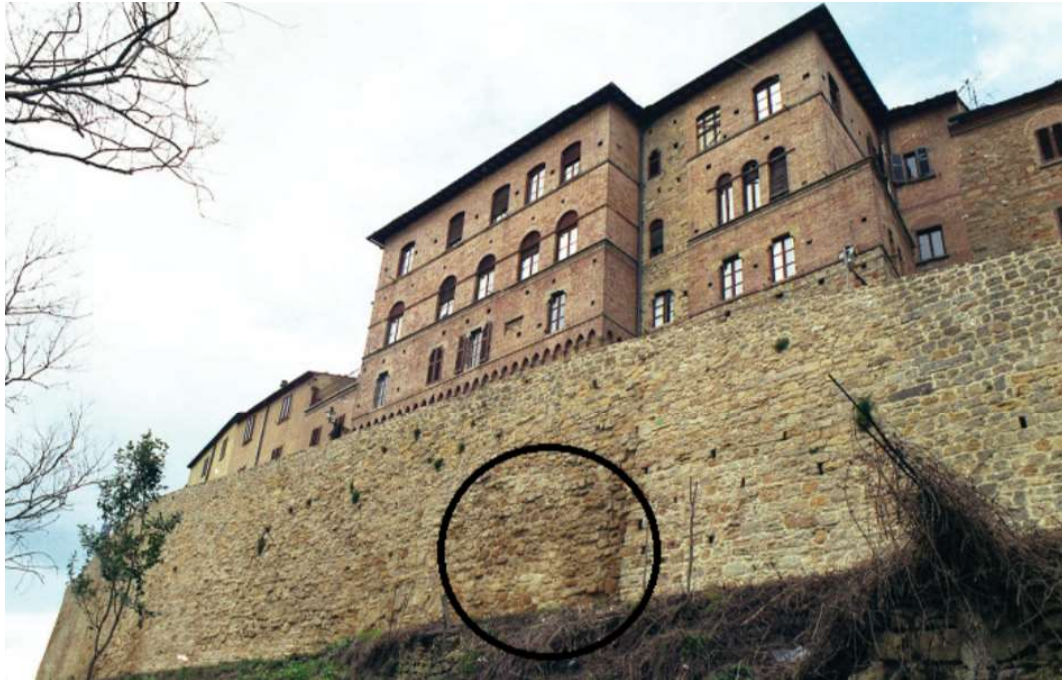
Fig. 4 - Presence of moisture before the collapse of January 2014 of the Urban walls of Volterra.

87 Evidences of the effects of humidity appeared on the external face of the wall (Fig. 4) before the
88 failure. The rainfall that forced the collapse was preceded by water infiltrations with an evident lack of
89 drainage in the walls. The collapse exposed the foundations of adjacent buildings, as well as Palazzo Stella
90 (Fig.5). Non linear analyses taking into account an increasing level of hydraulic thrust were made in (Puppio
91 and Giresini, 2019). In this work, the weakening effect induced by water is instead neglected; the effect of
92 water is solely assumed as an additional thrust. The aging effect on blocks and mortar is also neglected,
93 since the collapsed portions of walls were of good masonry quality, as visible in Fig.6.

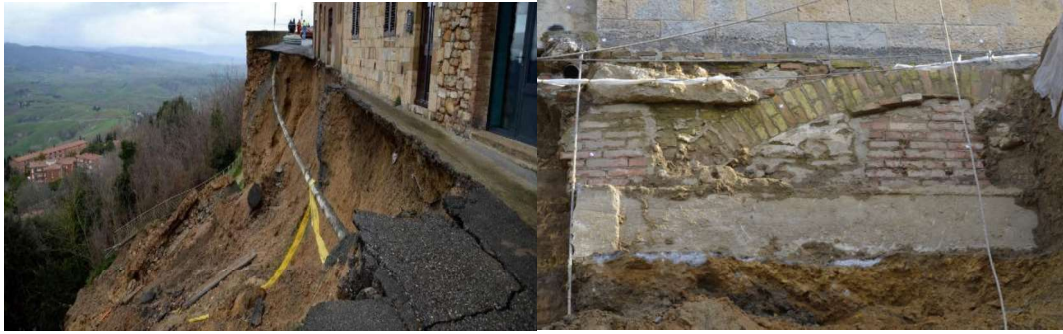
Fig. 5 – Views of the collapsed area: (a) natural gas pipeline under the road, (b) foundation of Palazzo Stella.

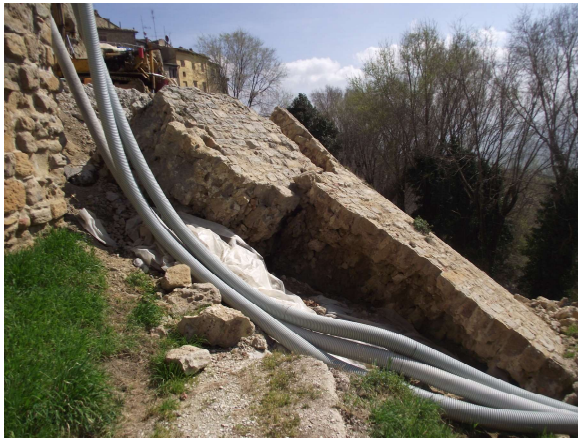
Fig. 6 – (a) Picture of the wall after the collapse - (b) main soil lithotypes and wall layers.

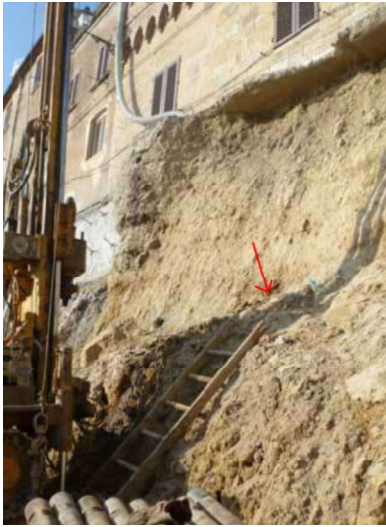
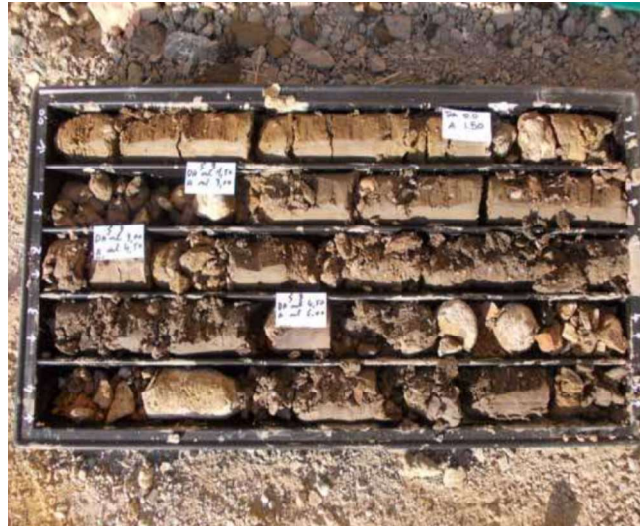
Fig. 7 - Drilling with SPT test: (a) location - (b) coring samples (adapted from Santarecchi, 2014).

94 The main geotechnical and masonry parameters were investigated after the collapse. Two vertical
95 continuous drillings with Standard Penetration Tests (SPT) and three horizontal continuous drillings were
96 performed. The geological description is reported in (Santerecchi, 2014), whilst the geotechnical
97 parameters are recalled in Tab.2. To simplify the soil characterization, two main lithotypes were observed:
98 the Villamagna layer and the lime layer (Fig.7).

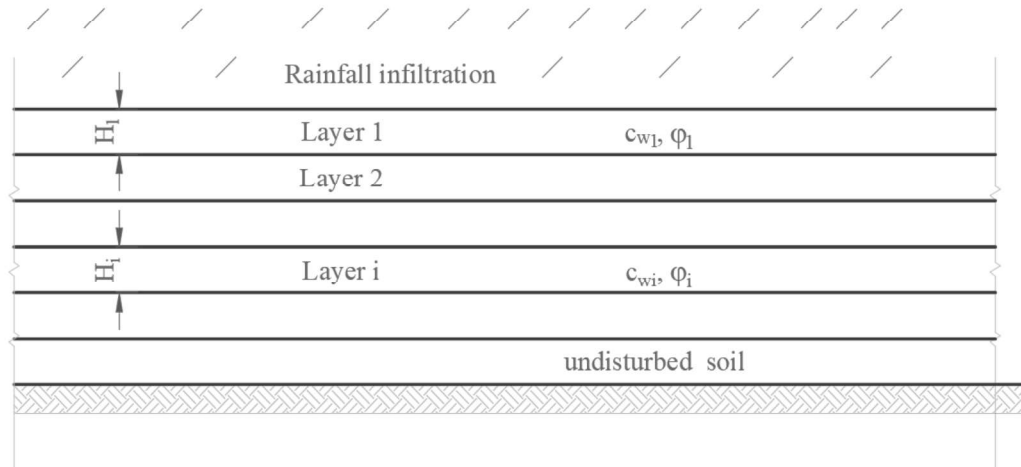
Fig. 13 – Vertical section of the soil with discretization in horizontal layers.

237 The decay of the mechanical properties of the soil due to imbibition in horizontal layers is shown
238 in Tab.4. In Fig.13 the level of imbibition of each stratum is considered.

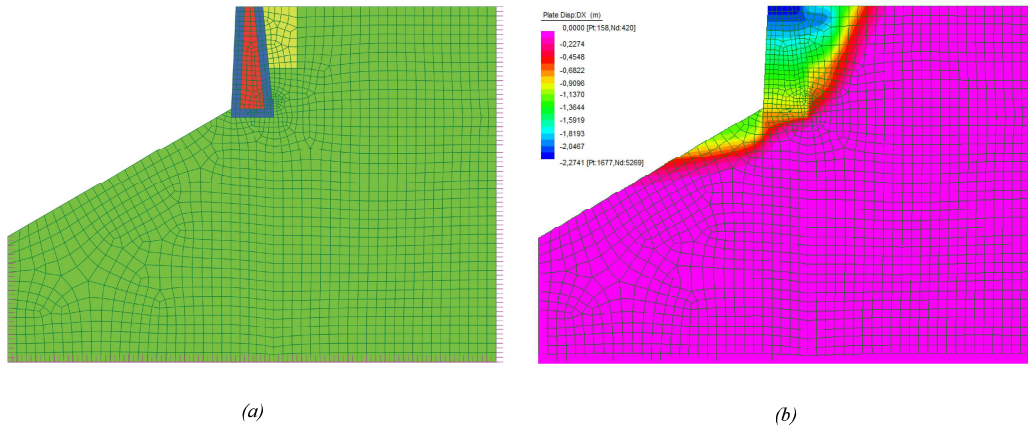
Fig. 16 – FEM Analysis of section (92-93); geometry and mesh (a); horizontal displacements (b).

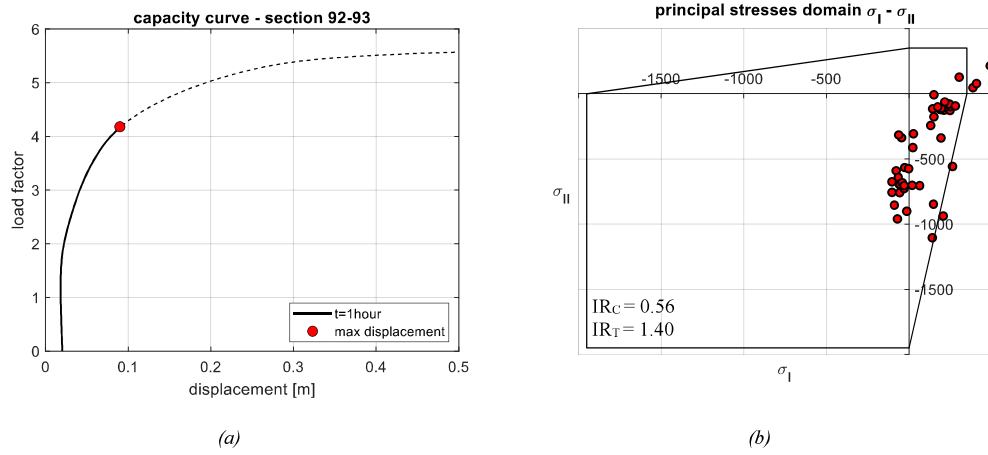
Fig. 17 – Pushover (a) and principal stresses domain (b) for a rain duration of 1 hour.

268 The pushover analysis and principal stresses domain in case of rain duration of one hour
269 and a return period of 175 years is shown in Fig.17. This section, that is the one interested by the
270 collapse of January 2014, reveals the reduced safety factor also in dry condition. In particular the
271 application of the initial soil stresses in the FEM model is not possible for rain durations major
272 than 1 h because of the non-convergence of the models. So, a sensitivity analysis is carried out
273 considering the effective rain duration in the month before the collapse with the LAM model (Fig.
274 15).

288 With the increase of rain duration, the most relevant failure mechanism for all the analysed
289 sections becomes the maximum displacement (d_{SLD}). Through the analysis of Fig.17-19 it was
290 possible to determine the rain duration that corresponds to this:

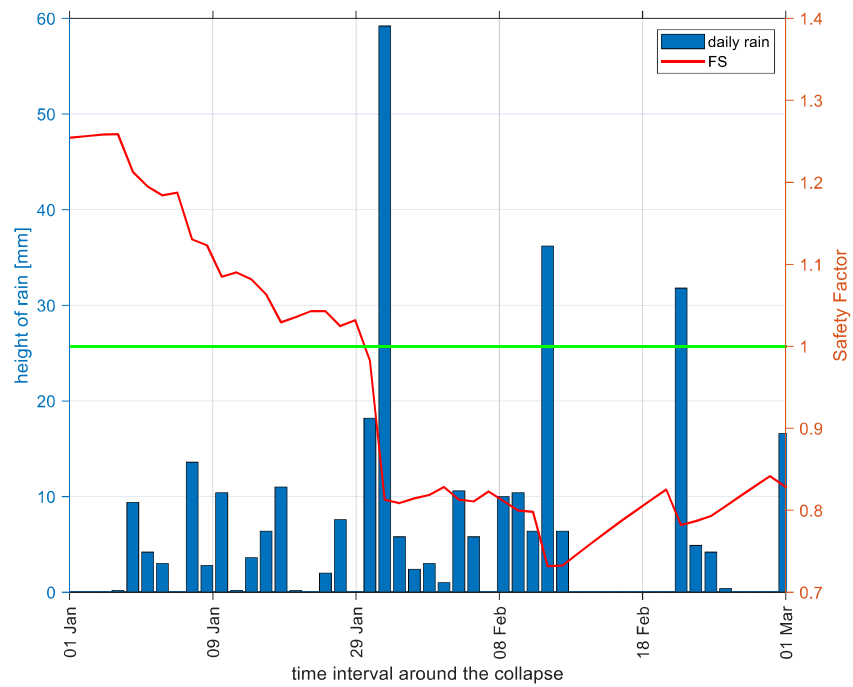
Fig. 18 – Sensitivity analysis of the effect of imbibition with the real rainfalls registered in the days around the collapse (30th January 2014).

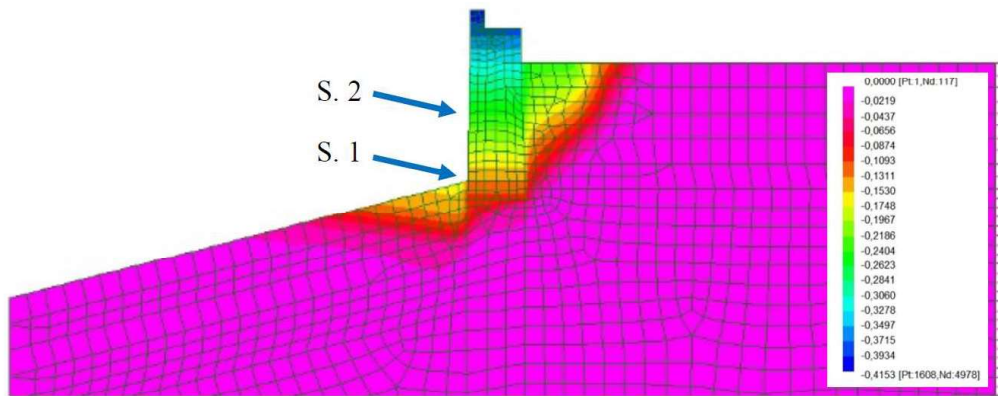
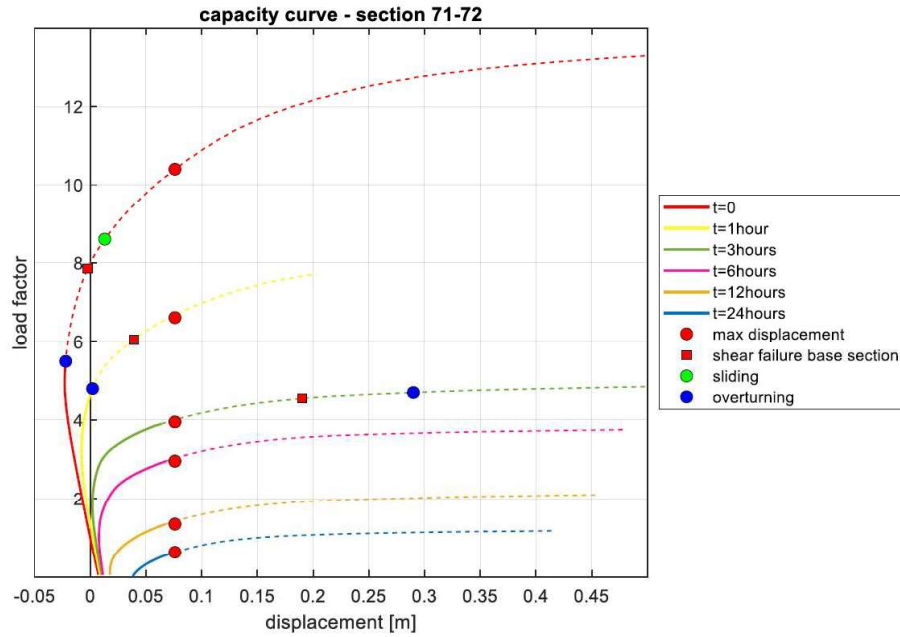
Fig. 19 – Section 32-33, (a) contour of the horizontal displacement [m] of model 5 and (b) results of the pushover curves for all the models.

319 As the graphs of Fig.19-21 show the results are heavily dependent on the grade of imbibition.
320 Different saturation levels affect not only the Intensity Measure that generates a certain LS but
321 also the kind of failure that takes place first. The maximum damage displacement d_{SLD} is the first
322 to happen in case of an high imbibition level. Instead for a reduced grade of imbibition other
323 mechanisms are reached first. This suggests that the monitoring of displacements can provide
324 important information to prevent damage or failure. Intensity of the rain and rain duration are
325 both crucial variables.

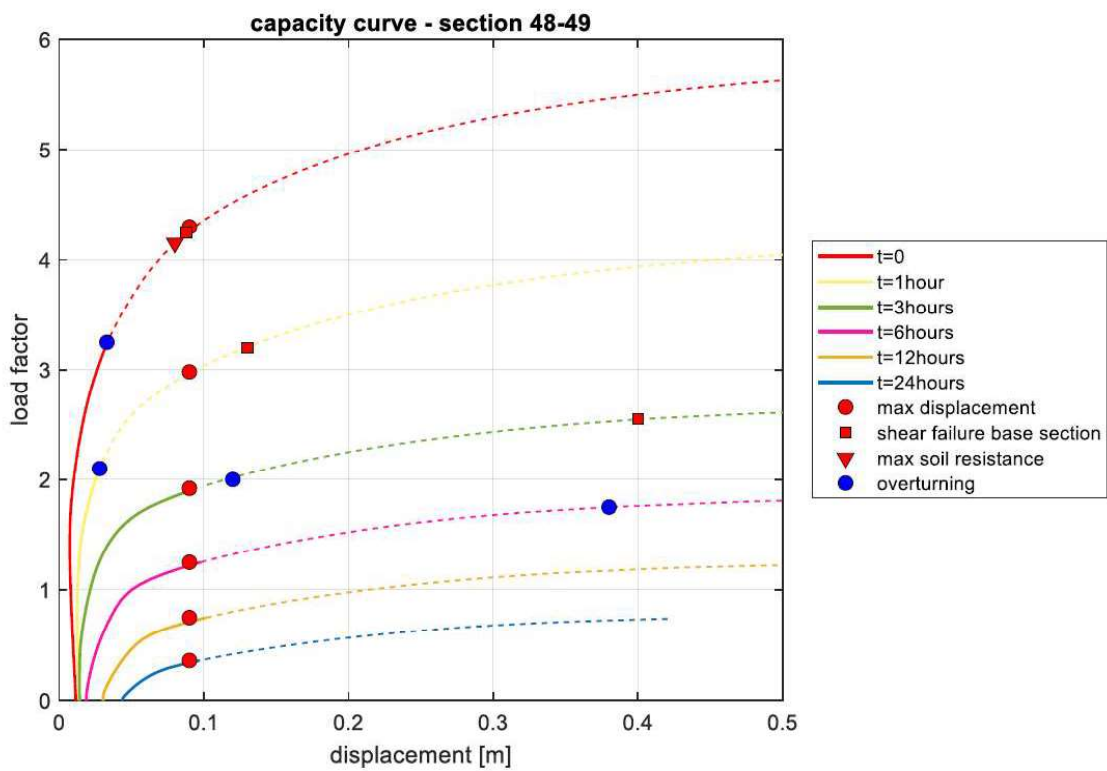
Fig. 20 – Section 48-49, (a) contour of the horizontal displacement [m] of model 5 and (b) results of the pushover curves for all the models.
