Alberto Franchi, Paolo Napoli, Pietro Crespi, Nicola Giordano, Marco Zucca, Unloading and reloading process for the earthquake damage repair of ancient masonry columns: the case of the Basilica di Collemaggio, International Journal of Architectural Heritage, Vol. 16 (11), 2022, pagg. 1683-1698.

# Unloading and reloading process for the earthquake damage repair of ancient masonry columns: the case of the Basilica di Collemaggio

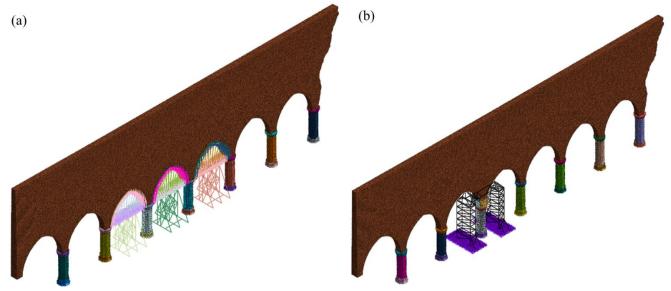
Fig. 5. FE models of the unloading-reloading systems (a) steel-ribs system (b) clamping system.

The two unloading and reloading solutions developed in the project are presented in the following paragraphs. Conceptually, the first solution is based on the use of three steel ribs + frames that directly supports the arches (Fig. 5a). In this scenario, two columns can be unloaded and repaired simultaneously. The second solution acts on the abutments of the arches through a clamping system (Fig. 5b). To assess the feasibility of the unloading-reloading procedure, a nonlinear construction stage analysis reproducing all the phases of the intervention procedure was implemented in Midas FEA (Midas FEA, Analysis Manual 2015). Since the unloading-reloading procedure affects only the nave structures, a partial 3D finite element model of the left nave wall was developed starting from the 3D point-cloud laser scanner geometry coming from the survey (Brumana *et al.* 2018). In this way, the real shape of the wall, with all its irregularities, was considered. The effect of the other parts of the church were accounted with a set of loads and boundary conditions. In particular, one

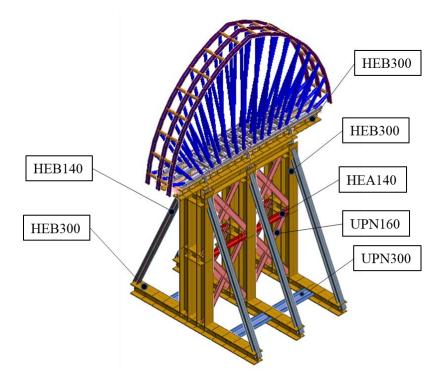
Fig. 8. FE model of the steel frame and ribs of the unloading-reloading system.

The struts-ribs system was designed to unload two internal columns of three adjacent arches (Fig. 5a). The frame, characterized by a height of 9 m and plan dimensions of  $3.3 \text{ m} \times 4 \text{ m}$ , is made of S355 steel profiles (Fig. 8). On top of the frame, a double level of steel ribs and struts is located. The columns are progressively unloaded by applying a distributed vertical-upward pressure on the intrados of the arches. The vertical pressure is generated by six hydraulic jacks that are placed in between the steel frame and the struts-ribs structure. To guarantee a uniform distribution of stresses over the surface of the arches, wooden planks are placed between the masonry and the ribs.

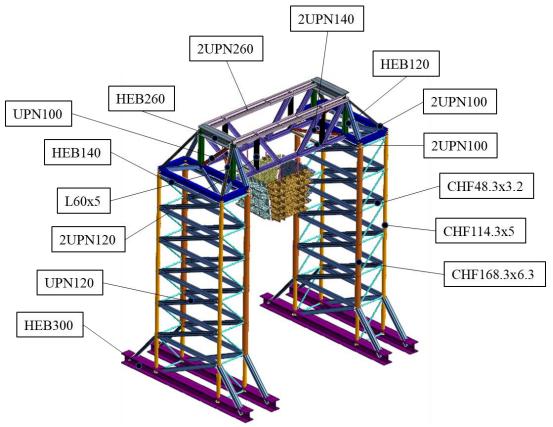
Fig. 9. FE model of the steel frame and clamping system.

With the clamping system, the unloading-reloading procedure works on a single column by supporting the abutment of the two arches insisting on it (Fig. 5b). The abutment of the arches is confined in a steel clamp, placed 10 cm above the column's capital (Fig. 9 and 10). To guarantee a uniform stress distribution on the abutment, the gap between the clamp and the masonry surface is filled with mortar. Then, the clamp is tightened on the abutment through horizontal pre-stressing bars. This activates a horizontal biaxial compression stress field (compatible with the masonry compressive strength) that allows the lifting of the abutment by friction. The clamp is connected to the supporting steel frame with four threaded bars, and the column is progressively unloaded by applying tension loads to the threaded bars through four hydraulic jacks. Particular attention was devoted to the modelling of the steel clamp region. A mesh refinement was implemented in this part of the model (Fig. 10) to increase the geometrical accuracy. In fact, the thickness of the clamp-to-wall mortar filling is about 20 mm while the thickness of the clamp's plates is 14 mm.

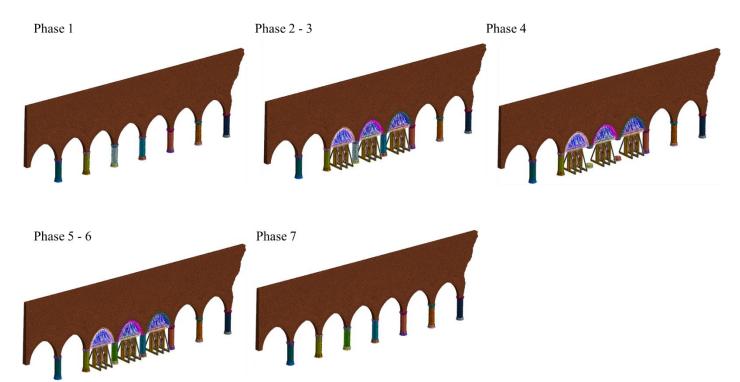
Fig. 11. Construction stage sequence of the struts-ribs solution.

- Phase 3. *Unloading phase*. The vertical load on the column is progressively transferred to the provisional steel frame by means of hydraulic jacks. In the struts-ribs system, the loads are transferred on the top HEB300 couple of horizontal beams. In the clamping solution, the loads are transferred from the vertical threaded bars to the horizontal trussed beam. From a numerical point of view, the unloading condition is reached when the sum of the vertical reactions at the base of the column is equal to the self-weight of the column.

- Phase 6. *Reloading phase*. After the intervention, the column is reloaded by the progressive unloading of the hydraulic jacks.
- Phase 7. *Dismantling of the steel frame*. The last stage consists in removing the temporary supporting frames, together with the clamp and the mortar filling. By comparing the stress and displacement fields of Phase 1 and Phase 7 is then possible to quantify the effect of the construction process on the existing structure.

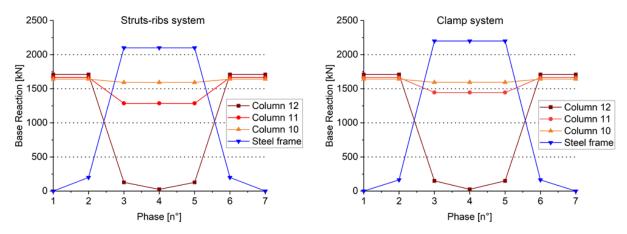
Fig. 14. Base reaction trend for steel frame and columns (P10, P11 and P12) during the unloadingreloading process: (a) struts-ribs system, (b) clamping system.

The results obtained from the nonlinear FE construction stage analyses confirmed the feasibility of the proposed repairing procedures. The vertical base reactions versus construction phases diagrams of the supporting steel frame, together with the unloaded column (P12) and the other two columns beside it (P11, P10), are represented in Fig 14, for both the struts-ribs system and clamping system. Notice that, in Fig. 14a, the curve of the steel frame represents the summation of the reactions of the three steel frames simultaneously present, divided by two in order to have a comparable "per column" value.

It is clear that also the reactions evaluated at the basement of the columns adjacent to the unloaded one decrease, especially using the struts-ribs system. On the contrary, considering columns far away from the column involved in the retrofitting intervention, this phenomenon does not occur.

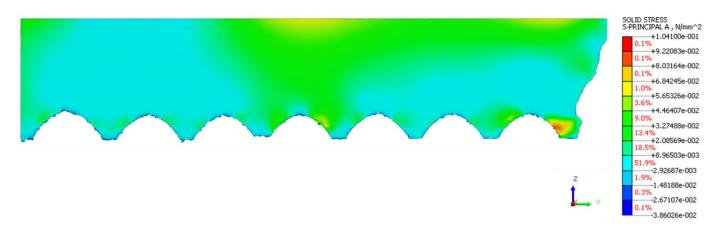
Fig. 15. Struts-ribs system: maximum tensile stresses acting on the wall (phase 3).

Going more in detail, during the whole unloading-reloading process, the stress fields of the masonry elements do not exceed strength limits of the materials, i.e. the model behaved within the elastic range at any step of the construction stage analyses. The maximum tensile stress on the stone masonry material of arches and abutments is about 1.5 MPa for the struts-ribs system and 1.3 MPa for the clamped solution. These values are indeed significantly lower than the tensile splitting strength of the stone blocks, assumed at 10% of the compressive strength (e.g. (JCSS 2011)). In the upper portion of the nave wall, made of rubble masonry, the maximum tensile stress over the entire retrofitting process is 0.1 MPa (Fig. 15) and 0.12 MPa (Fig. 16) for the struts-ribs system and clamped system, respectively. These values are significantly lower than the tensile strength of the material, assumed as 0.2 MPa. The vertical state of stress inside the investigated column (P12) is reported in Fig. 17 (struts-ribs system) and 18 (clamping system), by considering phases 1, 3 and 6. It can be observed that the vertical stress field of the column is not significantly affected by the unloading-reloading process. In addition, the comparison between Phase 1 and Phase 6 shows that a more uniform distribution of the vertical stresses over the cross section of the column can be highlighted at the end of the intervention, thanks to the higher mechanical properties of the new inner core.

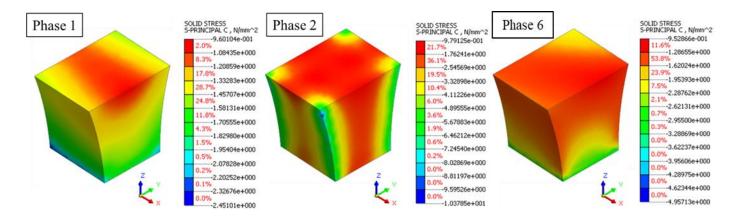
Fig. 19. Clamping system: principal compressive stresses of the masonry abutment (phases 1, 2 and 6).

An additional structural check was carried out for the clamping system to verify the state of stress of the clamped portion of the masonry abutment (Fig. 19). In this case the focus is on phase 2 in order to check the effects of the post-tensioning loads applied to the horizontal ties of the clamp.

As previously mentioned, the bidirectional-horizontal compression self-stresses applied by the clamp should generate an adequate friction capacity in the vertical direction. At the same time, however, they must not damage the masonry abutment by exceeding its compressive strength limits. The maximum compressive stress evaluated during the unloading-reloading process is about 10.38 MPa (Phase 2), which is consistently lower than the average compressive strength of the regular stone masonry elements (66.68 MPa).

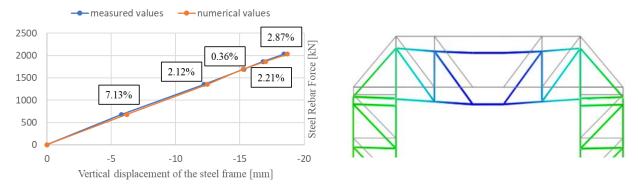
Fig. 20. Numerical vs. experimental comparison of vertical displacement of the steel frame.

As discussed in Section 5, both unloading-reloading systems represent a valid solution to intervene on the historical masonry columns of the church. For construction site and operational reasons related to the Basilica di Collemaggio project, it was eventually decided to adopt the clamping system. On site, the clamping steel frame was instrumented with a set of transducers in order to monitor the real behavior of the system during the various stages of the unloading/reloading process. Thanks to the availability of the acquired data of this set of instruments, a comparison between numerical results and in-situ measurement collected during the unloading process of the considered column was carried out. As an example, the vertical displacement evaluated at the midpoint of the horizontal truss of the steel frame was considered for the comparison. Five load sub-steps were implemented in the numerical model, corresponding to the actual load steps implemented to reach the complete unloading of column P12 through the hydraulic jacks. Fig. 20 clearly shows the good agreement between the results obtained by the numerical model and the onsite measurements, with an average error of about 3%. Moreover, as expected, the trend of the force-displacement curve is almost linear.

Finally, it is observed that the numerically estimated unloading force is 2067 kN while the corresponding in-situ value is about 2000 kN.
