Case Studies in Engineering Failure Analysis

Case study

Collapse of prestressed reinforced concrete jetties: durability and faults analysis

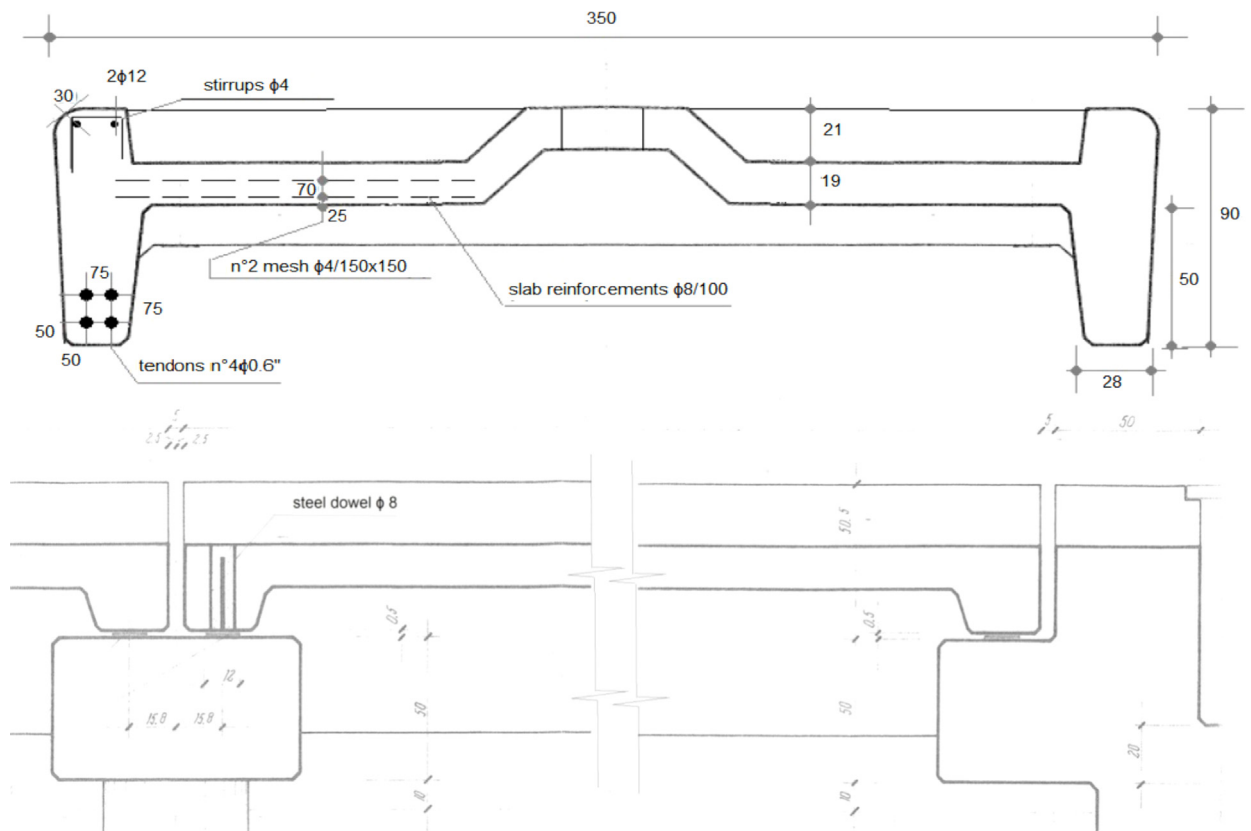
Fig. 1. Cross (top) and longitudinal (bottom) sections of the jetty.

The jetties consist of precast decks and beams supported by R.C. piles. Referring to Fig. 1, the decks have a π -shaped cross-section of prestressed reinforced concrete. It is hinged on one side and simply supported on the other. The geometric characteristics of the cross-section are: 3.5 m width, 0.9 m height. The longitudinal span is 10 m.

Fig. 1 shows also the reinforcements' distribution. In the deck slab, the reinforcement is a double mesh with a step size of 150 mm and there are also bars of 4 mm diameter. The authors found out in the calculation report that there are also rebars of 8 mm diameter.

As regards the two ribs, the only ordinary reinforcements are those in the top part of the section: two 12 mm diameter bars that, indeed, are stirrups support bars. Actually, the tensile reinforcements of this element are the 4×0.6 in. prestressed strands in the bottom part of the cross-section. In other words, the stability of the whole element depends on the pre-tensioning.
