M. Vanzi, G. Mura, *Peculiar failure mechanisms in GaN power transistors* in *Microelectronics Reliability*, Volume 114 (2020), art. 113896.

Peculiar Failure Mechanisms in GaN Power Transistors

M. Vanzi, G. Mura

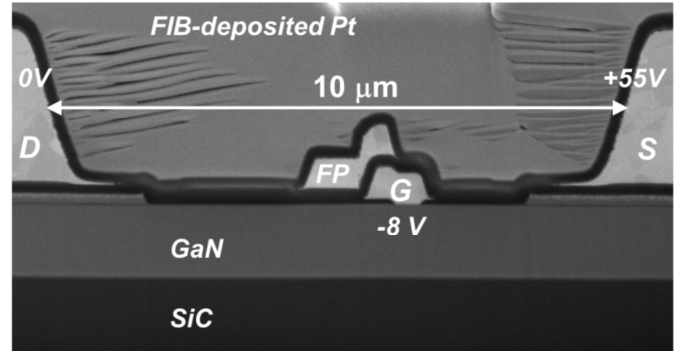
Both tests require DC biasing of the devices, that for the GaN transistors under test corresponds to $V_{DS}=55V$, $V_{GS}=-8V$ (fig.3). In this configuration, the channel is closed, and no current flows across any part of a regularly working device.

Fig.3. Enlarged view of one of the cross-sections in fig.3, with the bias conditions for the HAST and THB tests.

In fig.3, it is worth noticing that the maximum field occurs between Gate and Field Plate and is in the order of 300 kV/cm.
