Protocols of knowledge for the restoration: documents, geomatics, diagnostic. The case of the Beata Vergine Assunta Basilic in Guasila (Sardinia).

Abstract: For several decades, the conservation and maintenance of the historical architectural heritage in Italy have become one of the central problems within the scientific community of architects, restorers, and engineers. In fact, historic buildings represent not only an important symbol of the country's culture but also a significant economic resource linked to tourist flows. Unfortunately, many historic buildings are in a state of neglect or in a dangerous state of conservation. It is therefore important to activate a series of actions to preserve and conserve this built heritage. In this context, a transdisciplinary approach that includes an accurate historical, dimensional, and material knowledge has fundamental importance to allow a correct design for restoration actions and the possible reuse as well as to allow this heritage to be usable and active. This article presents this integrate approach carried out for the specific case of the Basilica of the Beata Vergine Assunta in Guasila (Sardinia) with a particular focus on the

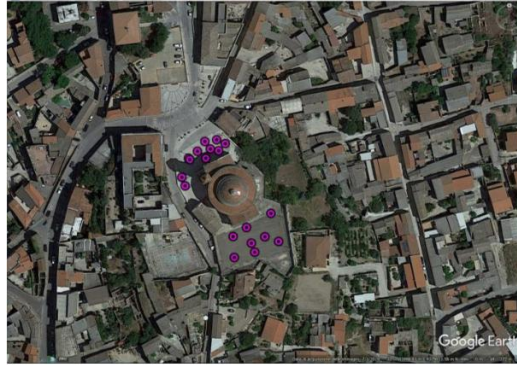
Fig. 6. GCPs position (image from Google Earth)
