An on-site teaching laboratory in a village damaged by the 2009 Abruzzo earthquake

ABSTRACT. This paper illustrates a two-year program of summer internships that involved forty students from the School of Engineering (University of Pisa) in 2010-2011. The activity consisted in a systematic survey of damages occurred in a village after the 2009 Abruzzo earthquake and in the preparation of documents addressed to a reconstruction plan. The historical center of San Pio delle Camere (1000 inhabitants) was fully surveyed, including about 140 hypogeal sites. Each student spent at least one month in these activities, funded by study grants provided by the Tuscany Region. Teams of two-three students performed well-defined work packages, led by a tutor, who established roles and functions. The students discussed the progress made preparing a weekly report. Moreover, preliminary structural analyses were carried out to assess the seismic vulnerability of some relevant buildings, fully available to the students. The main results were published in a book presented in a workshop. Most of the results were used to set up the official reconstruction plan of the village. During this on-site laborato

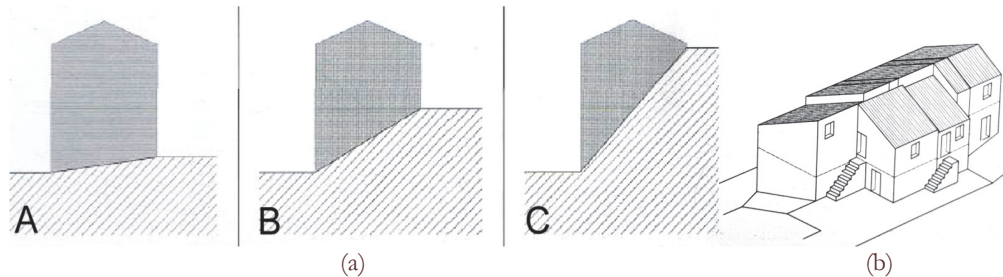
Figure 3: Buildings location in case of ground natural slope [1] (a); “Profferlo” house typical scheme [1](b).

During the night of April 6th, 2009, a main shock rated 5.9 on the Richter scale (M6.3) occurred in the Abruzzo Italian Region. This shock caused devastation, with 286 deaths and 1173 injured. San Pio delle Camere, 25 km far away from the epicenter, was made of 2-3 storey masonry buildings, built according to the schemes B-C of Fig.

3a due to the sloping ground condition. A considerable amount of houses in the city centre were of the so-called “Profferlo” type [1]: an external staircase and a multi-functional house (Fig. 3b). The basement was often used for storage or as farm recovery, while the other floors were used for residential purposes. The newest part of the village, mainly made of r.c. buildings, was not damaged.

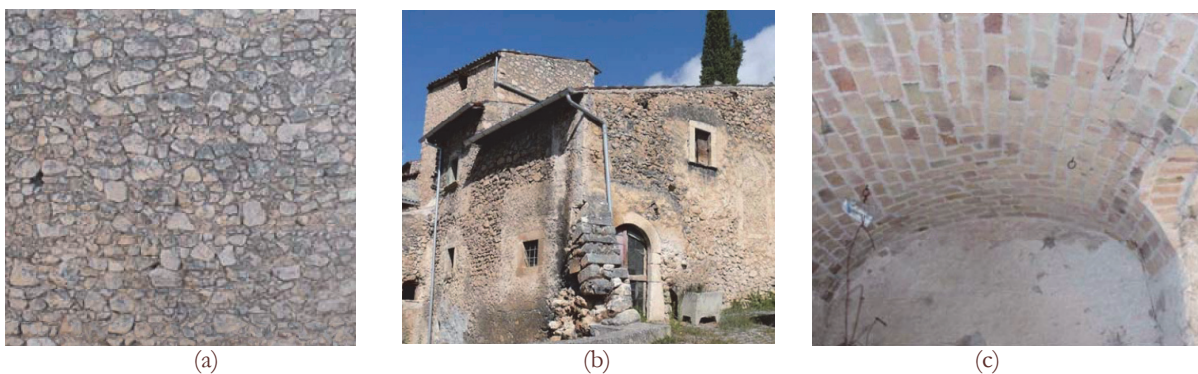
Figure 4: Old masonry texture (a); typical house in the city centre (b); masonry vault (c).

Masonry of poor quality was mainly made of small size stones with irregular shape (Fig. 4a,b), without headers or transverse connections. Local mechanisms of out-of-plane rigid block modes and collapse of external leaves were detected [4]. Other relevant damages influenced heavy roofs in clay and r.c. diaphragms, besides flexible roofs such as vaults (Fig. 4c). More extensive failures were surveyed in some buildings with hypogeal cavities, as illustrated in the next paragraphs. The buildings with masonry made of concrete blocks masonry, good quality mortar, steel ties and light timber roofs were less damaged.

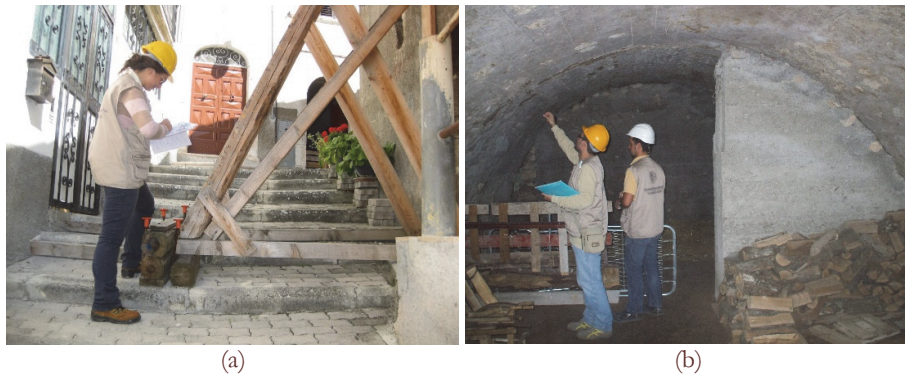
Figure 7: Students surveying structural features and damages of a building (a) and an hypogeal structure (b).

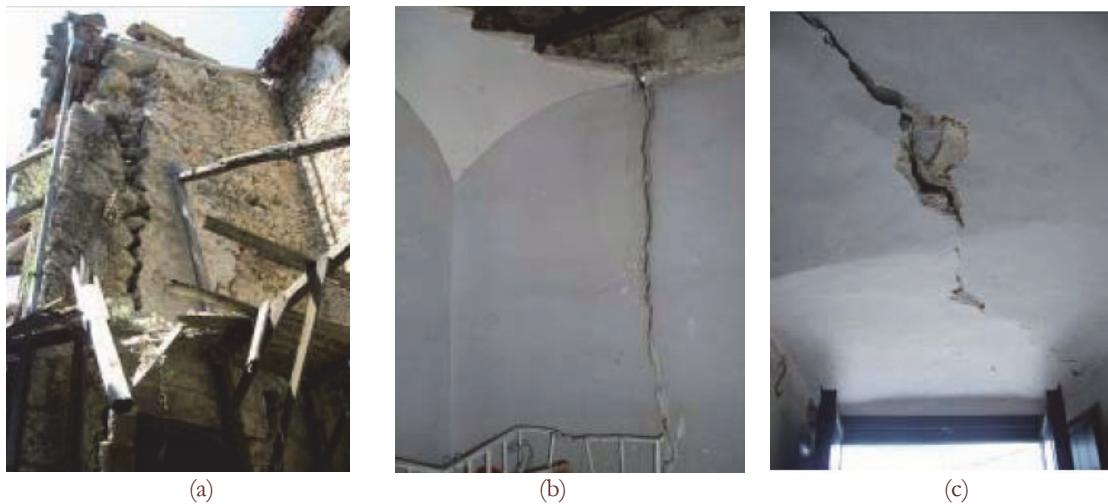
Figure 9: Masonry façade overturning (a); partial vault collapse (b); deep vault crack due to shear action (c).

Some historic buildings, such as the San Pietro Celestino Church, were declared unusable due to the collapse of the bell tower and an incipient overturning of the main façade. Other cases were also declared unusable for the external risk caused by adjacent buildings (Fig. 9).

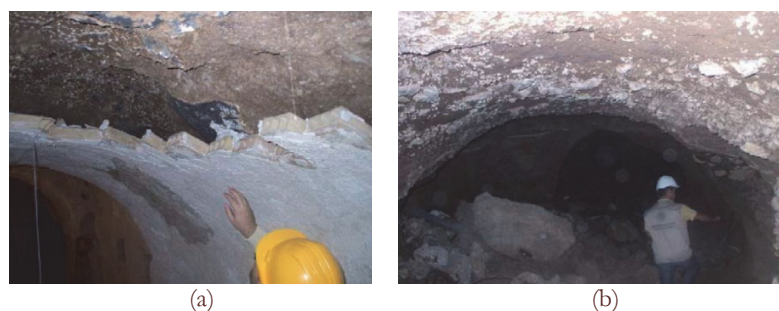
Figure 10: Qualitative survey of the hypogeal structures: assessment of the structural status (a); material and humidity level (b).

The first team analysed the main structural characteristics of these chambers, such as the soil type and the humidity level (Fig. 10a, b). Clay alluvium of red colour was mainly identified, with discrete cohesion and compact. Due to the lack of instrumentation, the survey was performed in qualitative but systematic way, which is sufficient for general information. The students could associate the chamber qualitative features to their structural behaviour: their stability is due to some low tensile material strength and plastic behaviour.

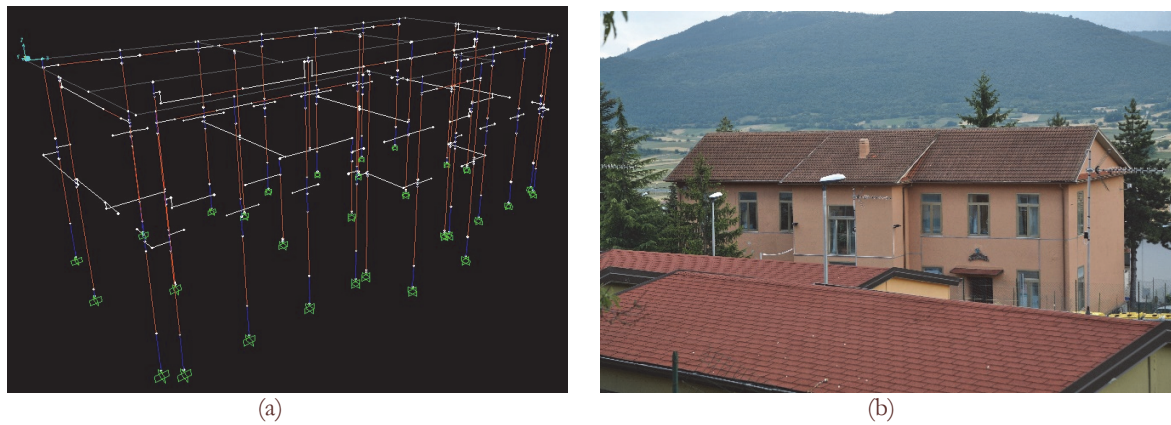
Figure 14: Case study of a municipality building: finite element model of a frame structure (a); actual building (b).

The last step of the campaign, performed by three student teams, was the structural analysis of selected case studies, such as schools and other strategic buildings. Simple linear dynamic analyses with computer-based programs were carried out (Fig. 14). For this purpose, the students dealt with the computation of the response spectra corresponding to the main seismic shock record. Moreover, the computed spectra were compared to that provided by the Italian Standards, confirming the results available in the literature [22] (Fig. 15) and the students verified that the spectrum given by the codes was underestimated. In this manner, they had an opportunity to directly apply their knowledge related to seismic analysis (similar to the real professional practice), and also gain a deeper perception of the issue of analyzing real structures through physical models.

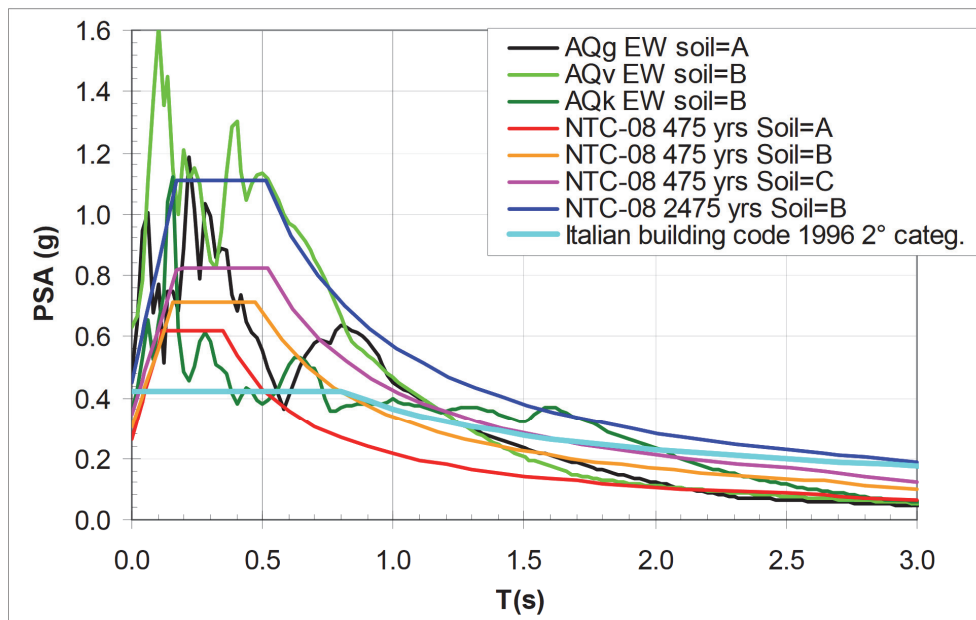
Figure 15: Comparison of the response spectra obtained by the seismic records (accelerometric station AQ=L'Aquila) with the response spectrum provided by the Italian Standards [22].

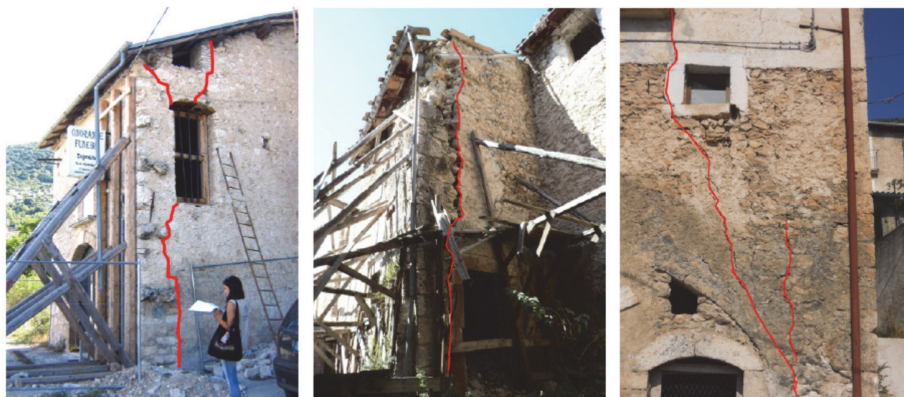
Figure 16: Observed building damage mechanisms, San Pio delle Camere.

Another activity consisted in performing kinematic analyses of several buildings damaged by the earthquake using the methods described in [14]. Firstly, the structural units were identified and the crack patterns with the activated damage mechanisms were detected (Fig. 16). The more evident damage mechanisms were afterwards analysed to obtain the actual peak ground acceleration (PGA) which was recorded during the earthquake. The methodology concerned the application of simple kinematics of rocking block models, taking into account the horizontal inertial forces and the stabilizing effects of the self-weight and of any tie rods [15-19]. In some cases, the kinematics was applied to thrusting arches and vaults, with the results later used for research purposes [20-21].
