Case Studies in Construction Materials

Case study

Coating's influence on wind erosion of porous stones used in the Cultural Heritage of Southern Italy: Surface characterisation and resistance

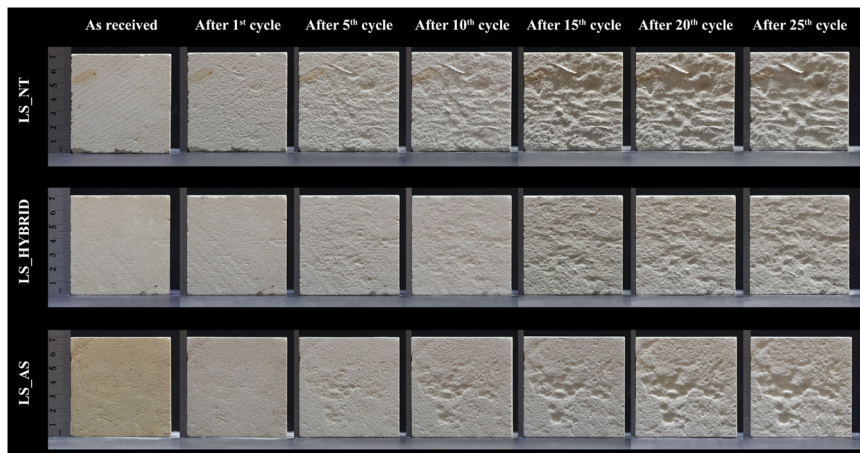
Fig. 3. LS_NT, LS_HYBRID and LS_AS samples during erosion test.

of decay. Indeed, HYBRID coating seems to protect uniformly the entire surface than AS. These last samples present a relevant degradation in correspondence with the maximum value of air-sand flow velocity (Fig. 3).

In this last figure, it can be noted that the treatment with HYBRID and AS coatings are particularly effective. Cohesive capability of used coatings minimises the abrasive effect by 3 times the initial value.

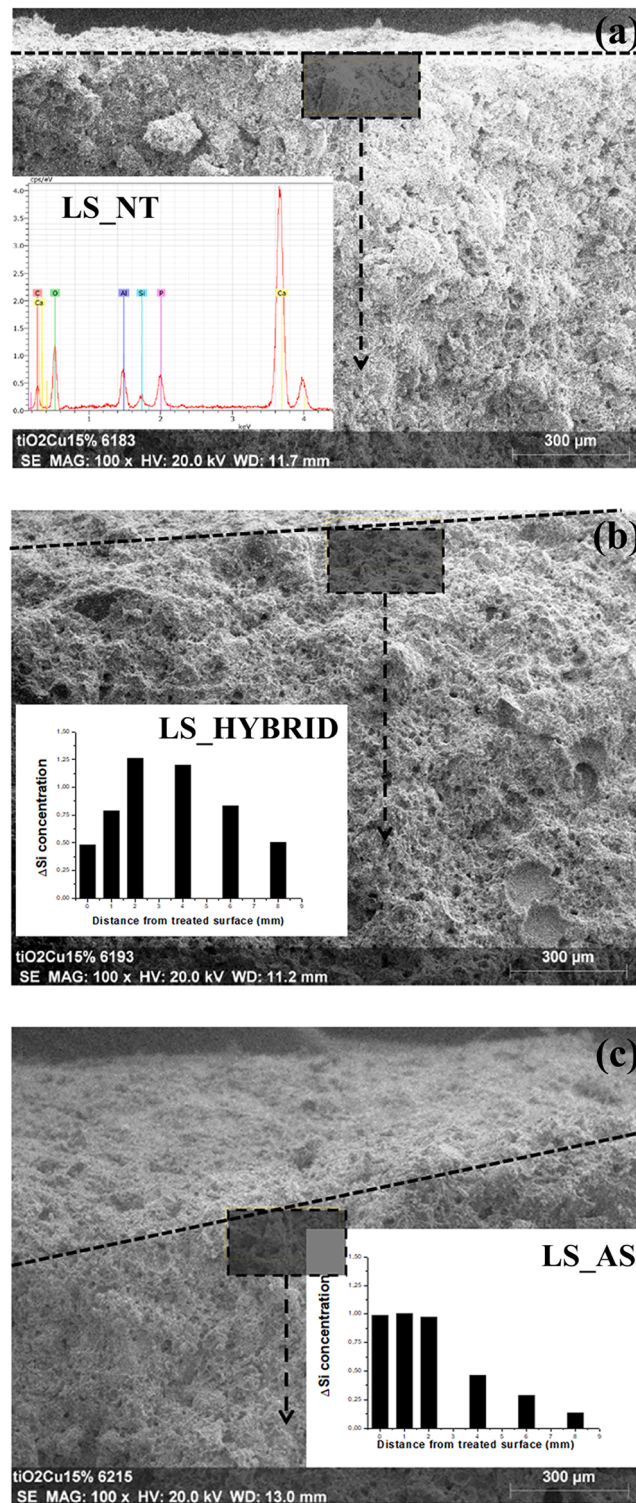
Fig. 4. SEM images of untreated and treated stone after aging test. a) LS_NT; b) LS_HYBRID; c) LS_AS.

SEM was employed to examine the LS face treated with both commercial products. The resulting micrographies, with the corresponding EDS analyses, of the coated and uncoated LS samples, after the accelerated erosion test, are reported in Fig. 4.

Each SEM micrograph shows a regular dispersal of each coating on the observed surface, showing the lack of imperfections and gaps. In addition, the erosion effect of the surface is more evident for untreated stone and slightly noticeable for LS treated with HYBRID. The most important components achieved by EDS analyses are visible in the inset of Fig. 4a for untreated stone. The same qualitative EDS spectrum was obtained for the treated stone specimens, showing that both uncoated and coated LS surfaces comprehend, as expected for calcarenitic limestones, calcium, silicon and carbon. Since the commercial products contained silane and siloxane, the EDS estimated the quantity of silicon (obtained eliminating the amount of Si due to the untreated stone) considering the distance from the outside surface of the substrate in order to estimate the penetration depth of the coatings. A slight abstraction of the HYBRID coating from the external surface of the stone was registered due to the accelerated erosion test. However, a high penetration depth of about 8 mm (see inset of Fig. 4b) was measured for the HYBRID coating, evidencing the presence of HYBRID on the external and the inner surface of the stone. Referring to the solvent-based product (see inset of Fig. 4c), the EDS analysis evidences that AS possesses a high penetration depth of about 8 mm, evidencing, in addition, a higher amount of the product on the external surface of the stone, even though it was exposed to the aging treatment. The presence of both commercial coatings inside the stone represents an important direct evidence of their excellent protective properties and durability, since both of them were not completely removed from the stone due to the accelerated erosion aging test.
