**ATINER's Conference Paper Series**

**ARC2014-1095**

**The Western Sardinian Coast Defensive  
Towers (16<sup>th</sup>-17<sup>th</sup> Century): An  
Interdisciplinary Approach for the  
Chronological Definition of Masonries**

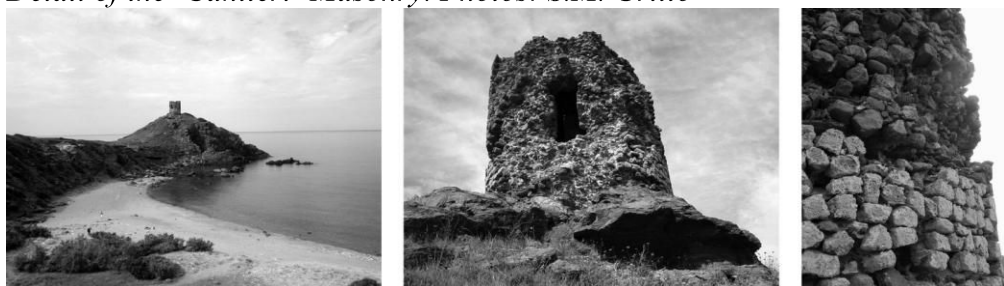
**Figure 1.** *Columbargia Tower. Panoramic View of the Tower, its Structure and Detail of the ‘Cantieri’ Masonry. Photos: S.M. Grillo*

The masonry is characterized by a rubble stones wall, with evident horizontal planes indicating the passage between two ‘*cantieri*’ high 55-60 cm. It is largely realized with medium-sized elements. The homogeneity of the masonry texture is interrupted by few rows of ‘*panchina tirreniana*’. They are characterized by a more regular size and shape.

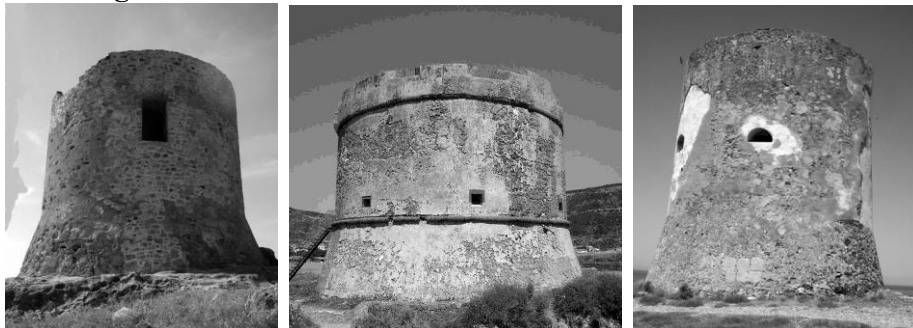
**Figure 2.** *Argentina, Bosa and Pittinurri Towers. Photos: S.M Grillo*

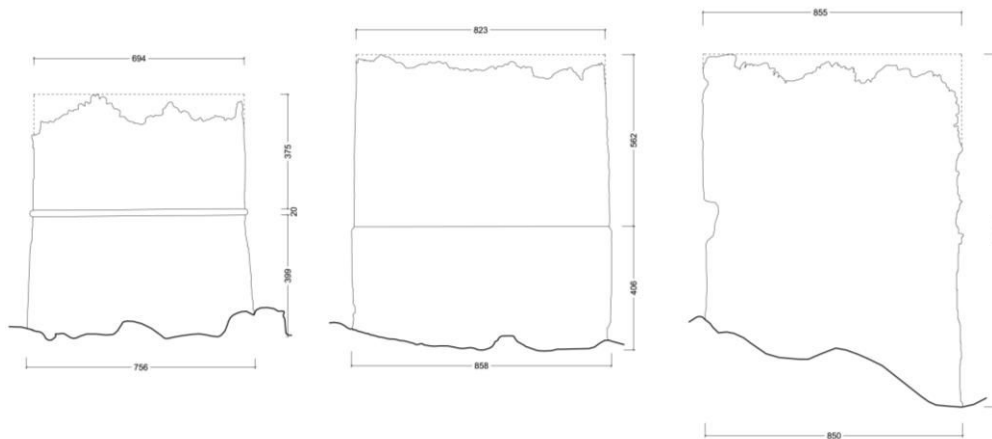
**Figure 3.** *Compositional Schemes Referring to the Three Types of Towers of the Investigated Area. Graphic Realization: S. Murru*

The dimensions of these towers are small, presenting a diameter usually included between 7 and 13 m and an height of 8-13 (Figure 3). The Bosa tower, as we will see, represents an exception by a dimensional point of view.

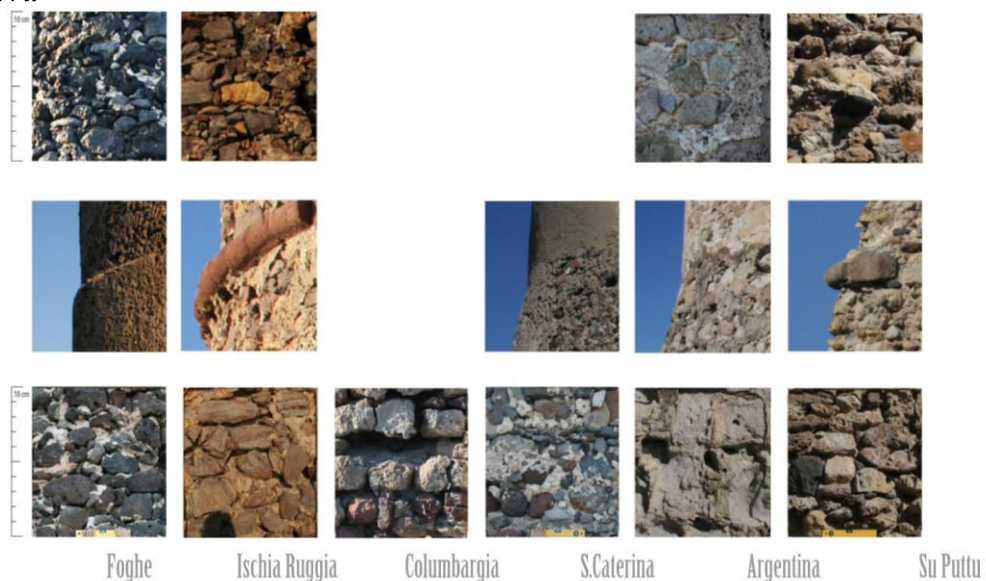
**Figure 4.** *Details of Masonry Referring to Some of the Towers Investigated. The Comparison Highlights the Different Masonry Textures that Characterize the Basis and the Upper Body of Each Tower and the Constructive Solution Adopted for the Connection between the Two Bodies. Graphic Realization: S. Murru*

The masonry technique used was ‘a cantieri’. This practice, deriving by the roman *opus incertum*, consisted in the preparation of two or three courses of rubbles, rough-hewed just in the external and support faces. The result was an irregular, coarse opus, with horizontal linings generally distanced 50-60 cm, characterized by thick joints between one another, with mortar of poor quality, sometimes signed by not slaked lime nodules. Very often the assembly of the rubble stony elements took place without paying attention to the stagger of vertical joints (Figures 4-5).

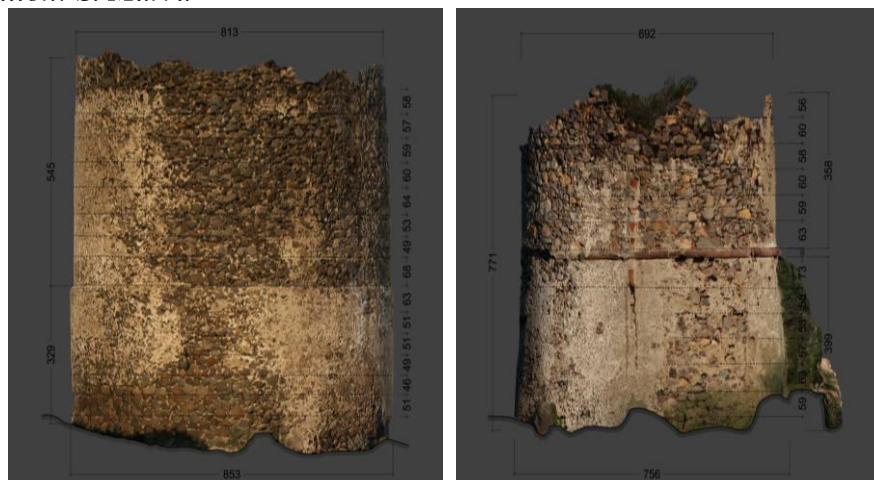
**Figure 5.** *Foghe and Iscra Ruia Tower. Orthogonal Perspective View Highlighting the Dimensional Relations and the Size of the ‘Cantieri’.* Graphic Realization: S. Murreu

Acidic calkalkine volcanic rocks are the most used building material found in the Argentina, Columbargia and Iskra Ruia towers. In the construction of the Columbargia tower also stones of the Panchina Tirreniana formation were used. Basalts and less phonolites were used for the Foghe tower (Figures 5-6).

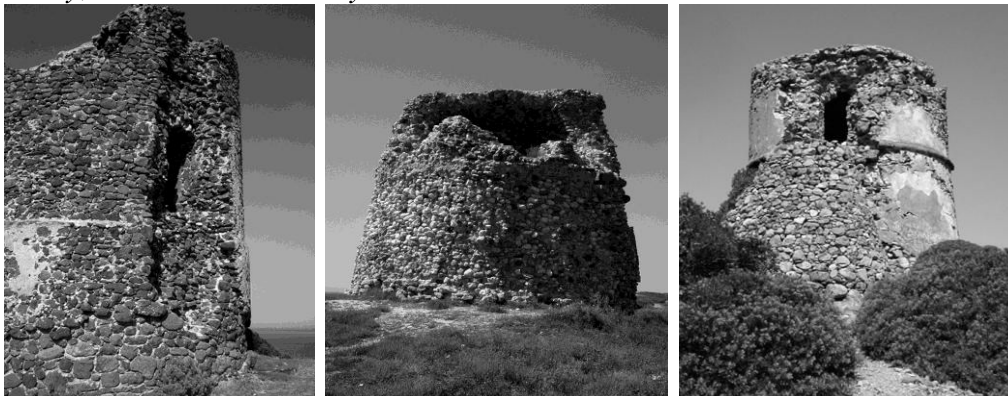
**Figure 6.** *Foghe, Su Puttu and Iskra Ruia Towers. All These Examples Are in Bad Conditions, because Neglected. All the Images Put in Evidence the Various Questions of Degradations, i.e. Erosion, Alveolization, Anthropical Decay, Structural Instability. Photos: S.M Grillo*

The walls of the towers generally were all made of irregularly and partly regularly cut blocks of different kind of rhyolites and sandstones and only in the construction of the Foghe tower mainly rounded river stones of basalts and phonolites were (Figure 6).

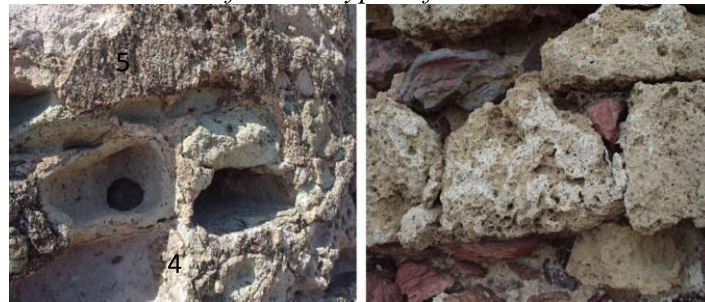
**Figure 7.** *Different Kinds of Rocks Used of Construction of the Towers and their Specific Weathering Phenomena. The Original Mortar Very Often is Strongly Weathered. The Figure Shows the Fundamental Differences in the Weathering Characteristics of These Types of Rocks. Photos: S.M Grillo*

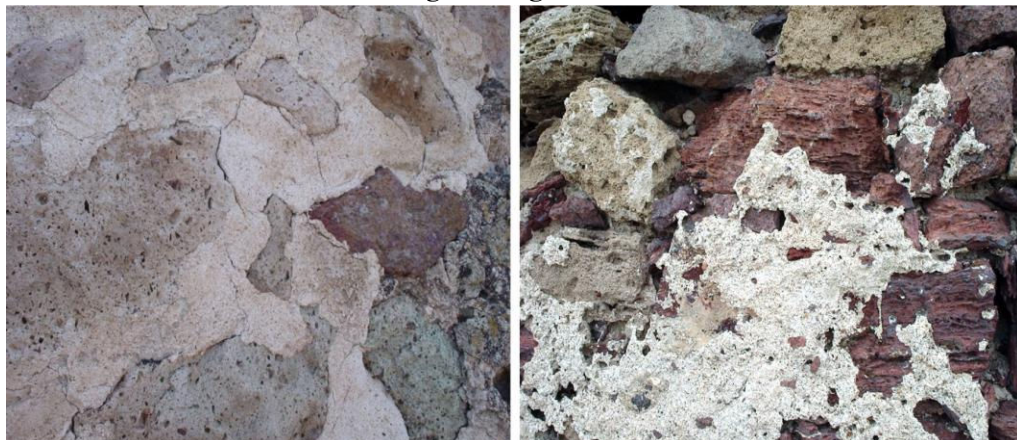
**Figure 8.** *The Original Plasters of the Towers are Conserved in Some Places, as for Example in the Columbargia Tower (Right Side). When the Original Plaster is Weathered, the Mortar Very Quickly is Washed Out, Seriously Damaging the Stability of the Wall. On the Left Side an Example of Recent Restoration is Shown, Concerning the Argentina Tower. Photos: S.M Grillo*

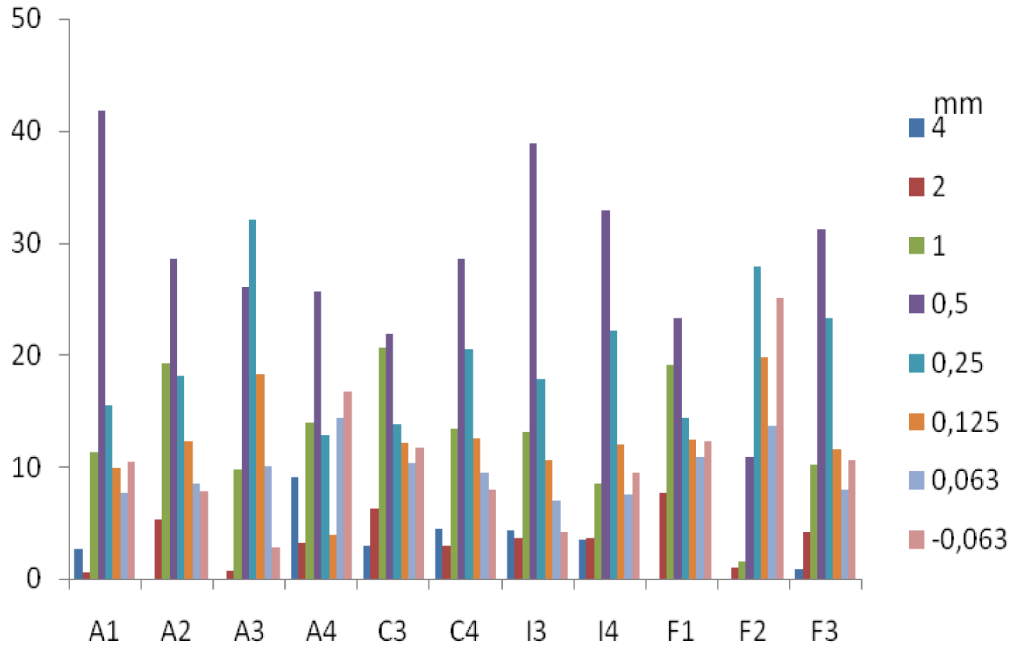
**Figure 9.** Grain Size Distribution After Sieving of Mortar and Plaster in the Different Towers. A) Argentina Tower: A1, A4 Plasters; A2, A3 Mortars; C) Columbargia Tower: C3 Plaster, C4 Old Mortar; I) Iskra Ruia: I3 Mortar, I4 Plaster; F) Foghe Tower: F1, F2, F3, Mortars

single components, their grain size and to estimate the proportions of binder/aggregate distribution the mortar samples were manually disaggregated and fractionated and sieved through UNI series of sieves (Figure 9).

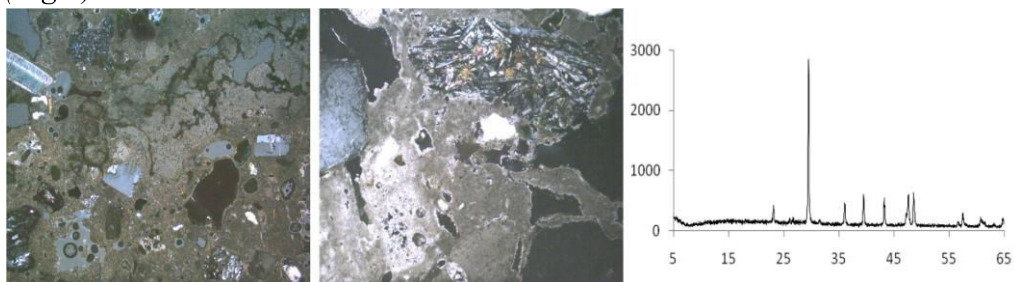
**Figure 10.** Thin-Section Photomicrographs (Crossed Polarizer) of Mortars and X-Ray Diffraction Powder Pattern of Binder. The Aggregate Consists of Coarse Grained Quartz-Feldspar, Fossil and Fragment of Acid Volcanic Rocks (Left) and Fragment of Basaltic Rocks (Center). The Binder Shows a Non-Homogeneous Texture Due to the Presence of Lumps, Cracks (Left and Center) and Exhibits a Typical Microcrystalline Aggregate Texture of Pure Calcite (Right)

In fact, the Argentina tower, built along the coast where rhyolitic rocks crop out and where sand beach formed by disaggregation of this kind of rocks are present, shows aggregates formed mainly of single-crystal quartz grains and feldspar, rhyolitic fragments and only few carbonatic micro-fossil. Columbargia and Iskra Ruia towers, built on the ignimbrite rhyolitic cliff locally covered with sedimentary rocks known as "Panchina Tirreniana", show, more than Argentina tower, the presence of carbonatic microfossil and shell fragments. On the contrary, the aggregate of Foghe tower, built on the basaltic cliff where sand beaches are not present, is mainly formed of fragment of basalt and fonolite rocks, quartz grain and feldspar grain as the ashlar coming from the near Rio Mannu. These difference in the mineralogical composition of the mortars have been confirmed by the investigation with optical microscope and X-Ray diffraction (Figure 10).

The X ray diffraction analysis shows that the binder of the investigated mortars consist essentially of calcite and only in few cases it is possible to see very weak indications of the presence of lumps observed also under the optical microscope. Finally the X-Ray analysis does not show any evidence for the presence of any phases typical of hydraulic mortar (Figure 10).
