Data in brief 27 (2019) 104675

Data Article

# A novel approach to systematically collect critical chloride contents in concrete in an open access data base

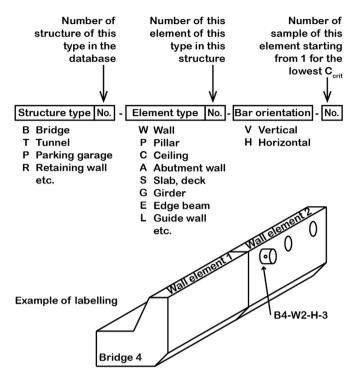
Each tested sample received an identification number to permit unambiguous assignments. The samples were labeled and numbered as schematically described in Fig. 1. The labels indicate the type of the engineering structure, the type of element within the structure, and the steel bar orientation within the structure (namely H and V). Numbers indicate the number of the structure in the database, the number of an element of a given type within the structure (sometimes, samples were taken from different elements within one structure), and finally, the number of the sample within an element. These last digits in the labeling string (Fig. 1) indicate the sample number, sorted according to the final result of  $C_{\text{crit}}$  (from lowest to highest). The highest sample number within an element is equal to the number of samples tested within this element.

Fig. 1 shows an example (B4–W2–H-3). Here, B4 means that this is the forth bridge in the data collection; within this bridge, samples were taken from different wall elements, and B4–W2–H-3 is the third sample taken from the second tested wall element in the bridge.

Fig. 1. Structure of labelling of each specific sample.

Reported information		Remarks
Sample identification number		Each tested sample has an identification
		number to permit unambiguous assignments
		(Fig. 1 and Chapter 2.2)
Engineering structure	Year of construction	based on documents about structure
information	Location	Geographic location of the structure
	Meters above sea level (m a.s.l.)	according to geographic location
	Type of structure	e.g. tunnel, bridge, etc.
	Element	The type of structural member from which th
		samples were taken (e.g. tunnel wall, tunnel
		ceiling, abutment wall, bridge deck/slab, etc.)
		(compare Fig. 1)
	Exposure class	According to EN Standard EN 206-1
	Area of sampling (m <sup>2</sup> )	Size of area (in m <sup>2</sup> of concrete surface), within
		which drilling cores were taken. This area
		applies to each sample series within an elemen
		(compare Fig. 1)
Concrete information	Cover depth (mm)	Cover depth measured on the drilling cores

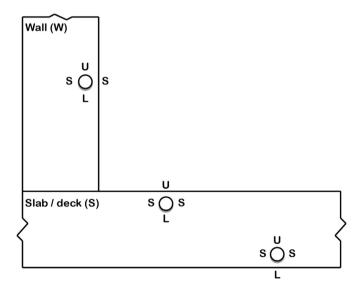
The diameter of the reinforcement in the drilling cores was measured. Moreover, the orientation of the reinforcement in the structure and with respect to the chloride exposure side is documented (Fig. 2). Reinforcement is either vertically (V) or horizontally (H) oriented. For horizontal bars, it is well-known that the concrete microstructure of the steel-concrete interface differs between upper and lower sides as well as the vertical parts of the cross-sectional circumference [9,10]. Thus, the data collection contains this information, with help of the labelling terminology illustrated in Fig. 2.

Fig. 2. Labelling of orientation of exposed side of horizontal reinforcement. The grey areas below the rebar represent the region of plastic settlement, where special conditions at the SCI might occur [10].

Steel-concrete interface (SCI)	characteristics at the initiation spot on the concrete Visually observable characteristics elsewhere on the concrete Visually observable characteristics at the initiation spot on the steel Location of corrosion initiation with respect to the rebar	Irregularities such as pores, cracks, tie wires, etc. at the SCI Irregularities such as pores, cracks, tie wires, etc. at the SCI, but at locations where no corrosion initiated This includes mainly if the initiation spot is on rib, adjacent to a rib, or between the ribs.
	characteristics at the initiation spot on the concrete Visually observable characteristics elsewhere on the concrete Visually observable characteristics at the initiation spot on the steel Location of corrosion initiation	Irregularities such as pores, cracks, tie wires, etc. at the SCI Irregularities such as pores, cracks, tie wires, etc. at the SCI, but at locations where no corrosion initiated This includes mainly if the initiation spot is on rib, adjacent to a rib, or between the ribs. See Fig. 2

For horizontally oriented reinforcement, the location of the corrosion spot is documented in relation to the structure. Fig. 2 depicts the orientation labelling of an initiation spot.
